Model: T-G1s		Date: 03-Sep-07	No.: RJ015001a
Subject: Firmware Release History Network I/F GX3		Prepared by: Y.Murata	
From: 1st Tech. Support Sec. Service Support Dept.			
Classification:	<input type="checkbox"/> Troubleshooting <input type="checkbox"/> Mechanical <input type="checkbox"/> Paper path <input type="checkbox"/> Product Safety	<input type="checkbox"/> Part information <input type="checkbox"/> Electrical <input type="checkbox"/> Transmit/receive <input checked="" type="checkbox"/> Other ()	<input type="checkbox"/> Action required <input type="checkbox"/> Service manual revision <input type="checkbox"/> Retrofit information

Model: T-G1s/T-G1W/T-MF1		Date: 3-Dec-07	No.: RJ015003
Subject: SC 979		Prepared by: Y. Murata	
From: 1st Tech. Support Sec. Service Support Dept.			
Classification:	<input checked="" type="checkbox"/> Troubleshooting	<input type="checkbox"/> Part information	<input type="checkbox"/> Action required
	<input type="checkbox"/> Mechanical	<input type="checkbox"/> Electrical	<input type="checkbox"/> Service manual revision
	<input type="checkbox"/> Paper path	<input type="checkbox"/> Transmit/receive	<input type="checkbox"/> Retrofit information
	<input

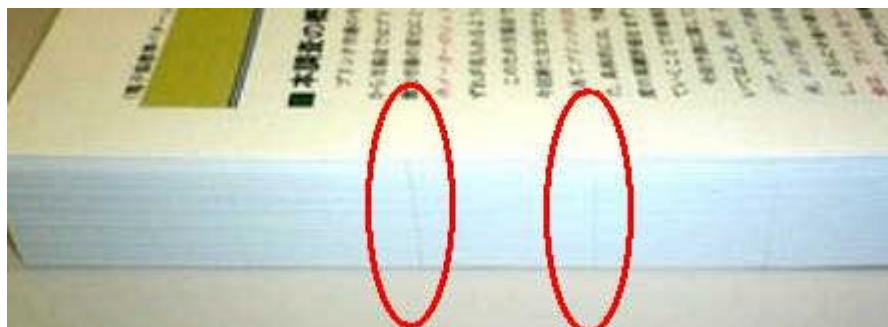
- One or more of the print nozzles gets clogged.
- The carriage scratches the edge of the paper or paper stack.

Edge of the paper stack is scratched

Paper dust or ink builds up on the nozzle cover and then scratches the paper/stack.

Clean the nozzle cover and nozzle plate.

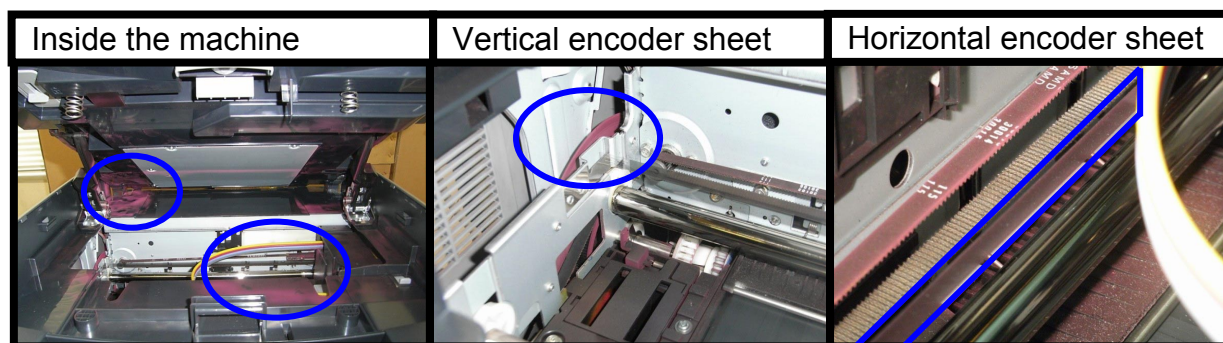
- 1) Carriage jam (operation panel display: "Remove Misfeed Top Cover")
- 2) White lines or banding

- The model in the photos is the T-MF1.
- The ink mist (see CAUSE below) has no effect on the function of the belts.
- In the photos above, the ink mist looks magenta when attached to a dark surface, and black when attached to a light surface. However, the actual amount of ink mist released is the same for each ink color.

Normally, a small amount of ink mist is discharged from the nozzles. When it does, air streams or the electrical charge on the transport belt can sometimes redirect the mist. As a result, this mist does not hit the target area (on the paper). This symptom is noticeable when printed under the conditions listed below.

- 1) Clean the horizontal encoder sheet and vertical encoder sheet.
- 2) Perform head cleaning.
- 3) Set the envelope lever to the standard position when printing onto standard/plain paper.
- 4) If the customer is only using paper with a high surface resistance, set **bit 6 of bit SW8** to a value of 1 (default: 0).

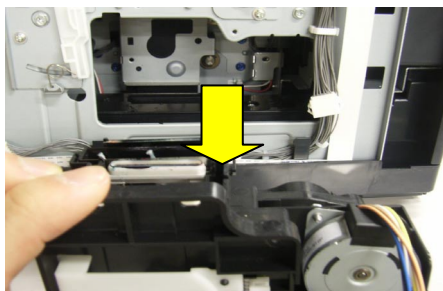
SC999 (motor lock) may occur on some machines at installation.

On the production line for the maintenance unit stepping motor (third vendor), the adhesive-drying step was skipped in some cases. As a result, the adhesive inside the motor could not vaporize correctly, causing the gear to stick to the shaft.

1. Remove the maintenance unit.
