Model: T-G1	Date: 5-Jun-06	No.: RJ007001b
-------------	----------------	----------------

Subject: Firmware Release History		Prepared by: Hiromoto Saitoh	
From: 1st Tech. Support Sec. Service Support Dept.			
Classification:	<input type="checkbox"/> Troubleshooting <input type="checkbox"/> Mechanical <input type="checkbox"/> Paper path <input type="checkbox"/> Product Safety	<input type="checkbox"/> Part information <input type="checkbox"/> Electrical <input type="checkbox"/> Transmit/receive <input checked="" type="checkbox"/> Other ()	<input type="checkbox"/> Action required <input type="checkbox"/> Service manual revision <input type="checkbox"/> Retrofit information

This RTB has been issued to announce the firmware release information for the controller

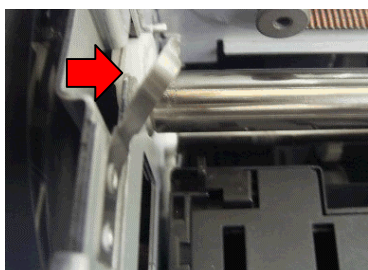
A multi-feed jam occurs and causes a critical EM condition (e.g. encoder sheet damage, print head damage, jammed paper remaining in the machine, etc. See below.)

The operator loads the paper incorrectly (does not set the end fence or side fence correctly, does not fan the stack, does not put the paper in the tray correctly, etc.). As a result, the feed roller feeds several sheets at the same time.

Advise the customer on the correct way to load the paper:

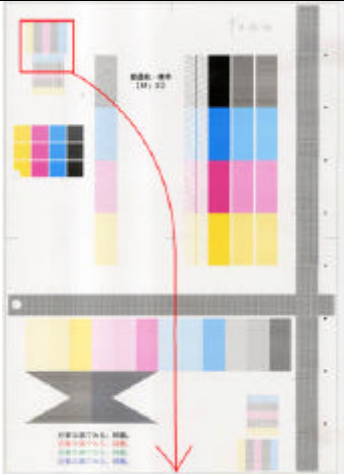
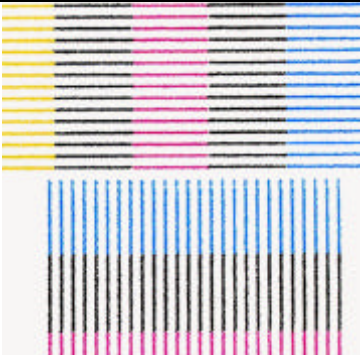
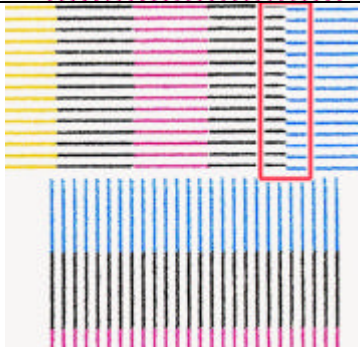
1.		Shifted Image	
Whole Image

1. Shifted Image (See the picture below)
2. Doubled Image (See the picture below)

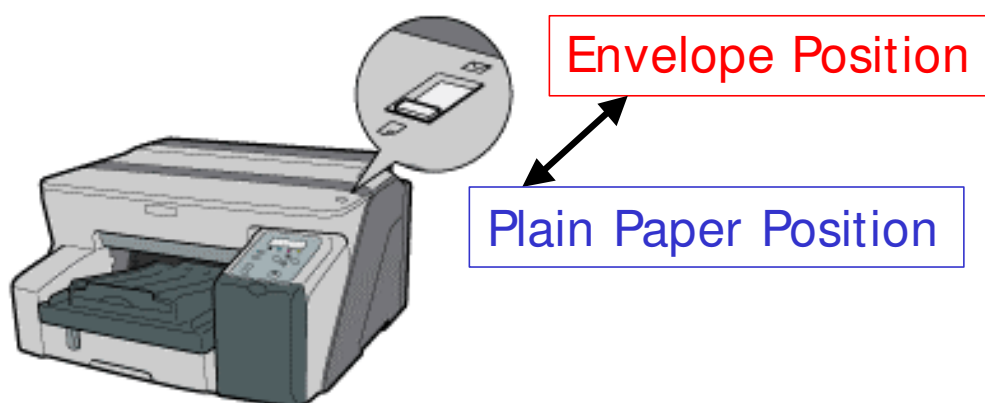
Note: Many of these cases reported in Japan are caused by operator errors when the upper cover is opened to remove jammed paper.

1. Do the "Adjust Print-head Positions" procedure (see the Operating Instructions).
2. Move the envelope lever back to the **envelope position** (see the illustration below).

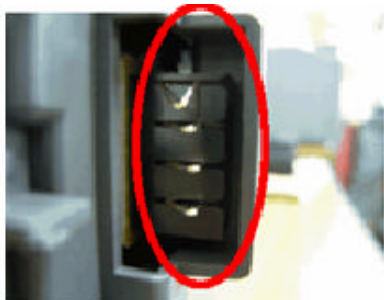
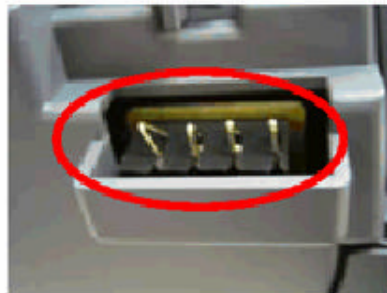
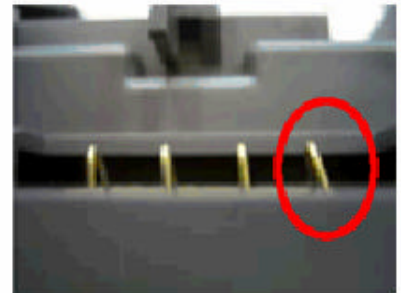
The duplex unit is opened/closed with excessive force many times. As a result, one or more of the terminal pins on the duplex unit connector is bent or damaged.

- Advise the customer to open/close the duplex unit more carefully
- Replace the duplex unit.

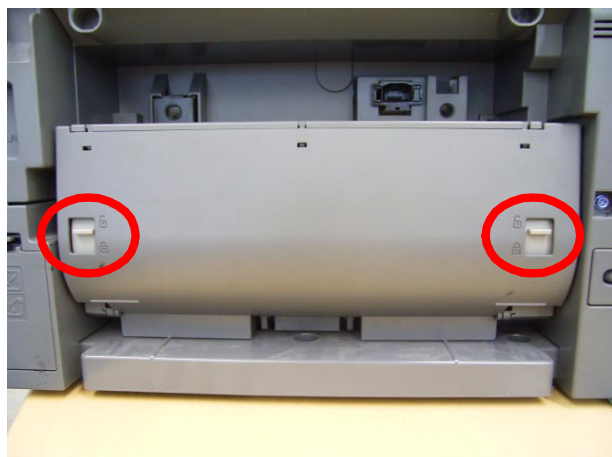
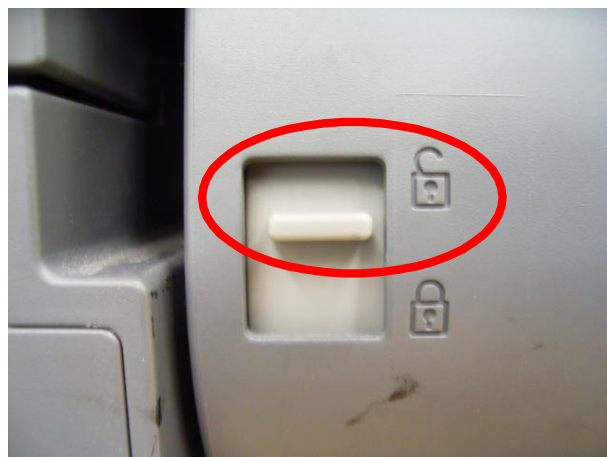
The duplex unit levers are in the “unlocked” position when the unit is attached.

Note: The machine cannot detect the position of the levers.

If this is reported from the field, advise the customer to lock the levers after attaching the unit.

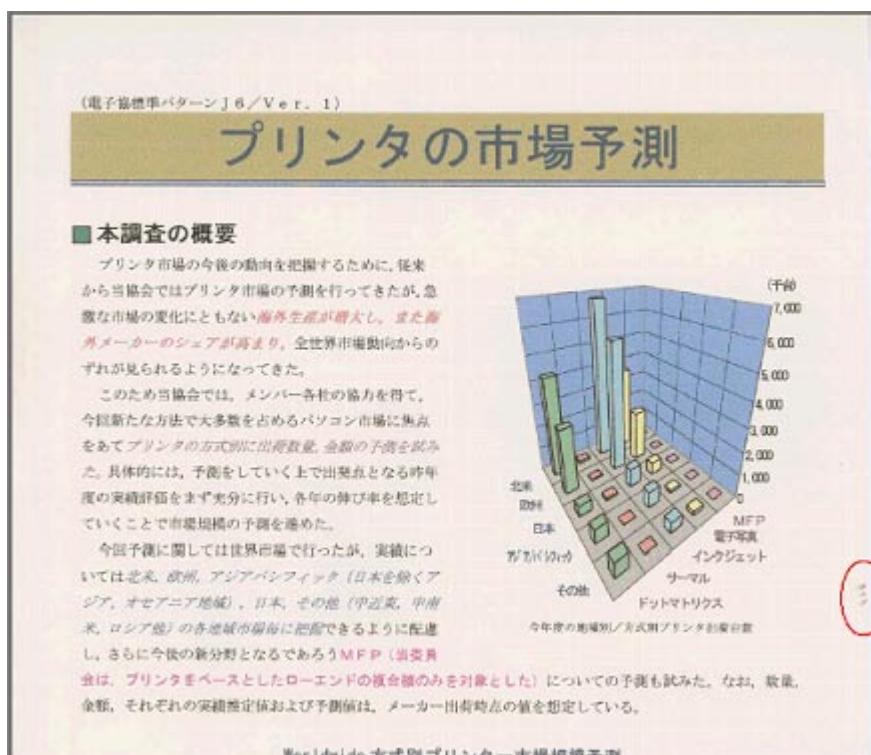
- One or more of the print nozzles gets clogged.
- The carriage scratches the edge of the paper or paper stack.

Edge of the paper is scratched

Clean the nozzle cover and nozzle plate.

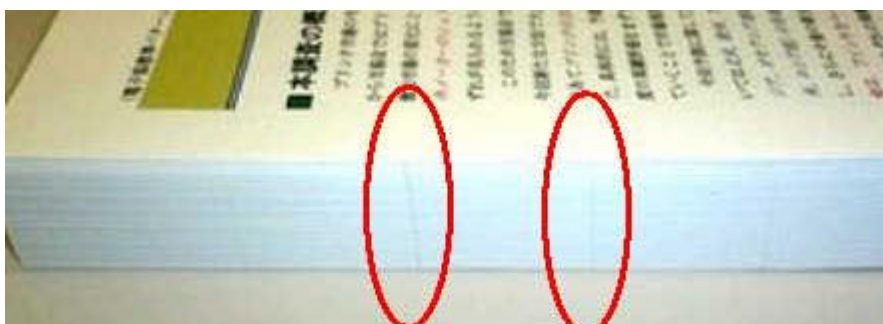
Edge of the paper stack is scratched

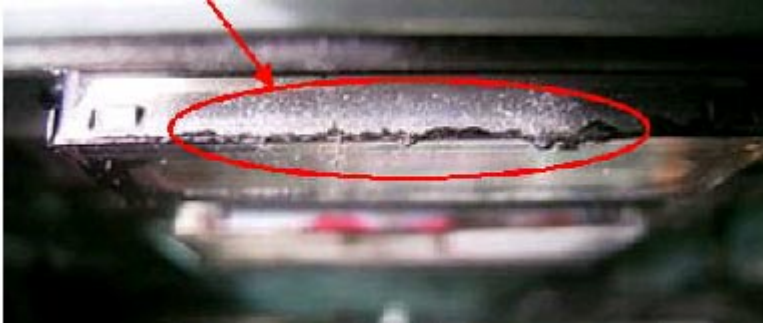
Paper dust or ink builds up on the nozzle cover and then scratches the paper/stack.

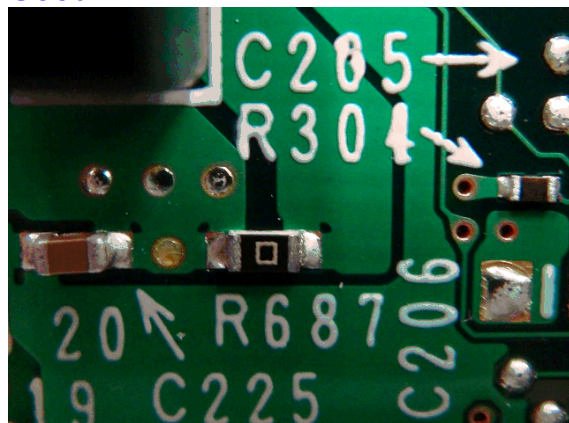
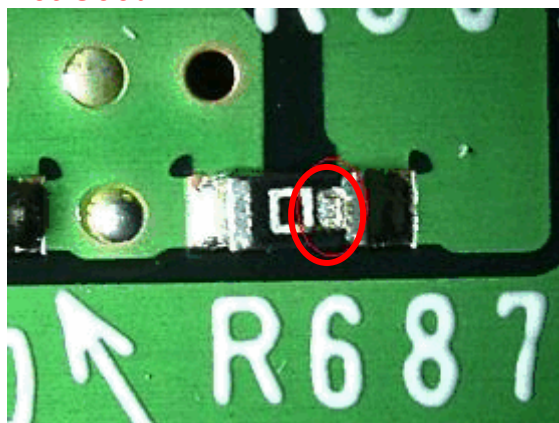
Note: The multi bypass tray has no problem.

Replace the main controller board. (No.2)

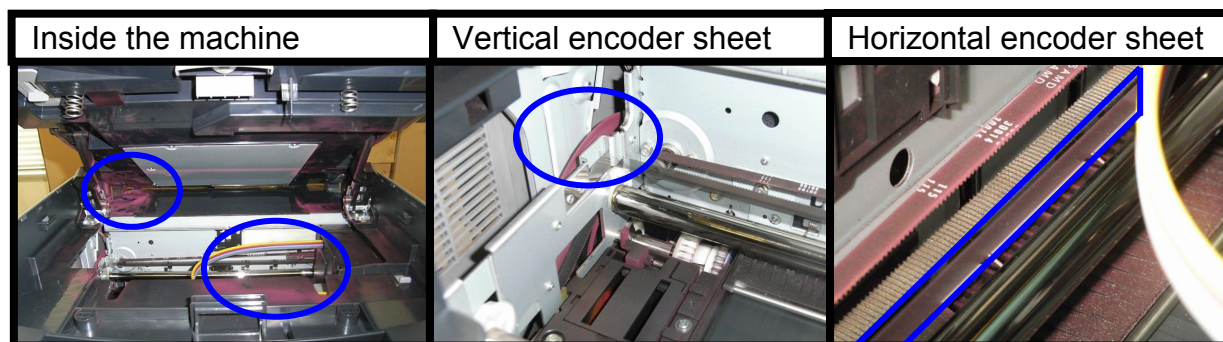
- 1) Carriage jam (operation panel display: "Remove Misfeed Top Cover")
- 2) White lines or banding

- The model in the photos is the T-MF1.
- The ink mist (see CAUSE below) has no effect on the function of the belts.
- In the photos above, the ink mist looks magenta when attached to a dark surface, and black when attached to a light surface. However, the actual amount of ink mist released is the same for each ink color.
