Model: T-G1W	Date: 07-Aug-07	No.: RJ016001a
--------------	-----------------	----------------

Subject: Firmware Release History		Prepared by: Gimpei Hirao	
From: 1st Tech. Support Sec. Service Support Dept.			
Classification:	<input type="checkbox"/> Troubleshooting	<input type="checkbox"/> Part information	<input type="checkbox"/> Action required
	<input type="checkbox"/> Mechanical	<input type="checkbox"/> Electrical	<input type="checkbox"/> Service manual revision
	<input type="checkbox"/> Paper path	<input type="checkbox"/> Transmit/receive	<input type="checkbox"/> Retrofit information
	<input type="checkbox"/> Product Safety	<input checked="" type="checkbox"/> Other ()

This RTB has been issued to announce the firmware release information for the engine

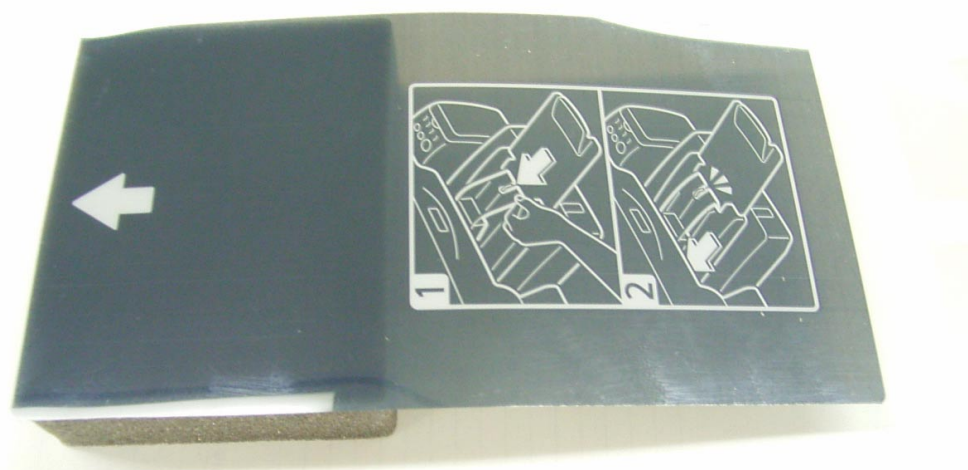
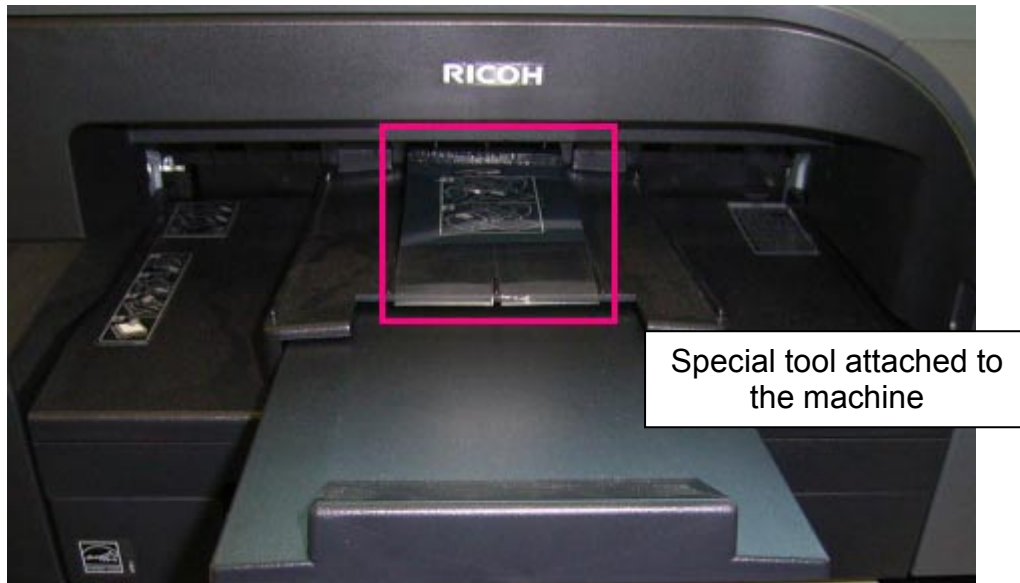
When printing a job consisting almost entirely of solid image areas onto A3 sheets, it is possible that paper curl may occur and paper is not stacked properly.

When a large amount of ink is used on the paper, the paper has a tendency to curl along the direction of the paper fibers.

A special tool will be prepared which customers can use to improve the paper stacking quality. To improve paper stack quality, it is important to minimize the height difference between the paper exit position and the exit tray.

We will prepare this countermeasure part. If a customer has this problem, please arrange to send it.

P/N	Description
J006 9951	Pad - Exit

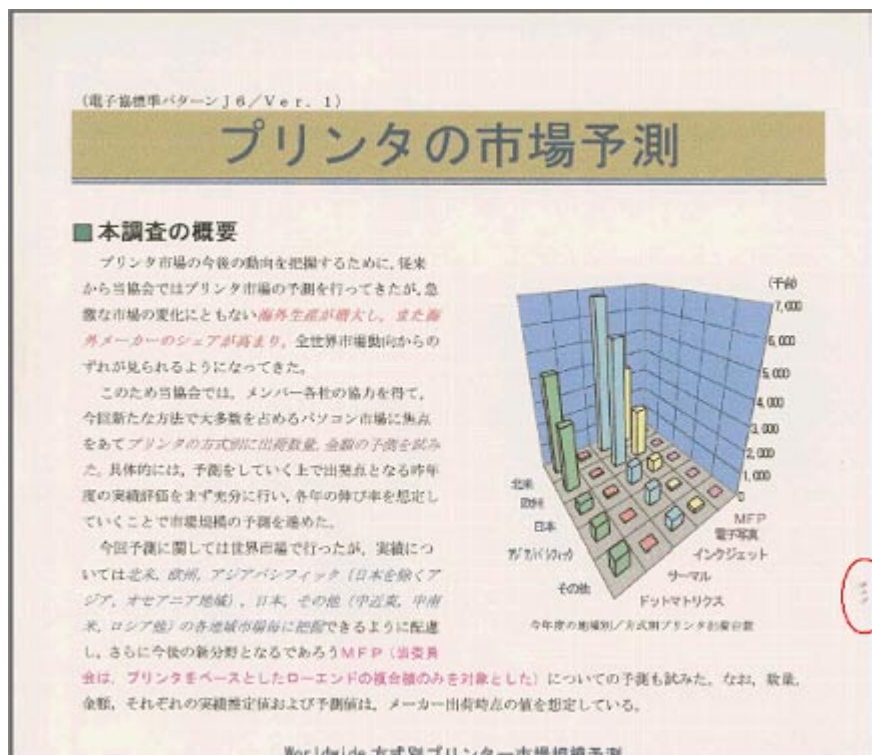
Edge of the paper is scratched

Paper dust or ink builds up on the nozzle cover and then scratches the paper/stack.

Clean the nozzle cover and nozzle plate.

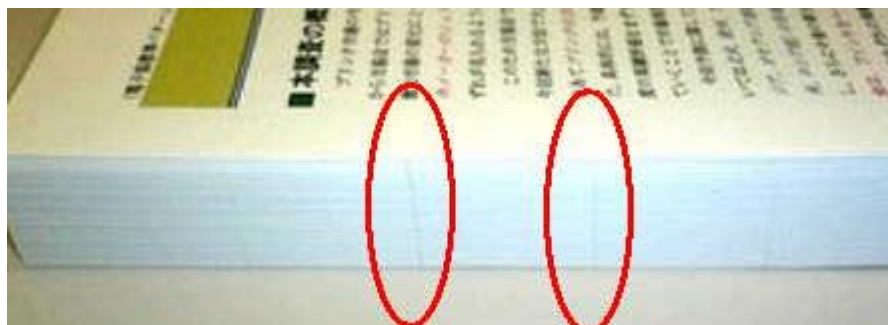
Edge of the paper stack is scratched

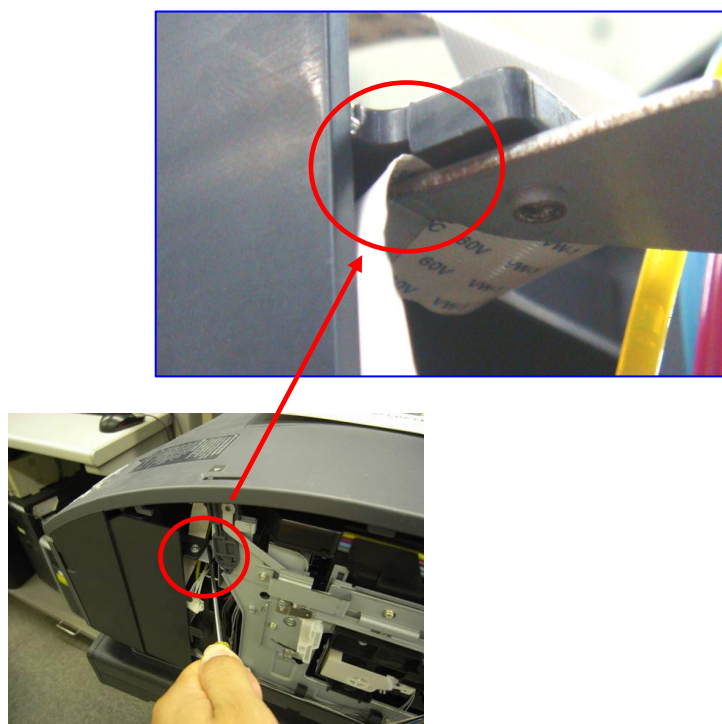
- Operation panel does not light up
- Main power does not turn ON
- Main power does not turn OFF

The operation harness was assembled while caught on the front stay. This may cause an electrical short in the harness and smoke can be generated from the short area.

Re-assemble the operation harness according to the procedure below.

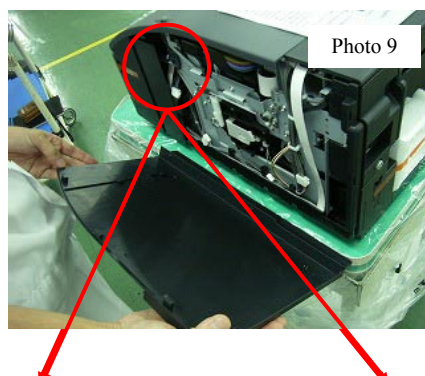
NG: Harness is pinched

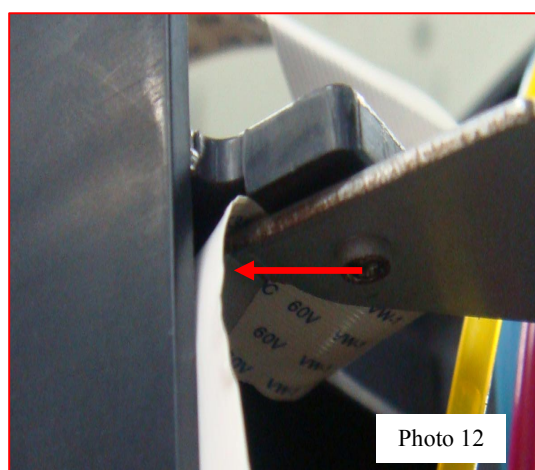
NG: harness is pinched

- Push the harness in the direction of the arrow (Photo 12). If the harness comes free when you push it, it will return to the normal position shown in the "OK" photo. No further action is required.
- If it does not come free, this means it is stuck, and action is required (see the next page).

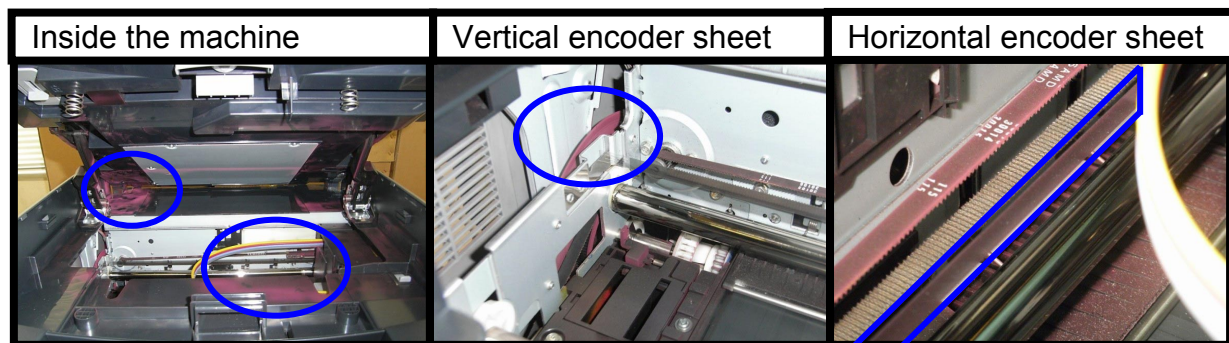
- 1) Carriage jam (operation panel display: "Remove Misfeed Top Cover")
- 2) White lines or banding

- The model in the photos is the T-MF1.
- The ink mist (see CAUSE below) has no effect on the function of the belts.
- In the photos above, the ink mist looks magenta when attached to a dark surface, and black when attached to a light surface. However, the actual amount of ink mist released is the same for each ink color.

Normally, a small amount of ink mist is discharged from the nozzles. When it does, air streams or the electrical charge on the transport belt can sometimes redirect the mist. As a result, this mist does not hit the target area (on the paper). This symptom is noticeable when printed under the conditions listed below.

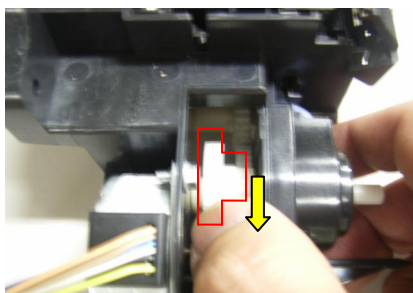
Note: As described above, this occurrence of SC999 is caused by a motor rotation failure. It is not related to SC999 caused by ink clogging.

2. Turn the motor shaft manually in the direction of the arrow until the motor lock is released.

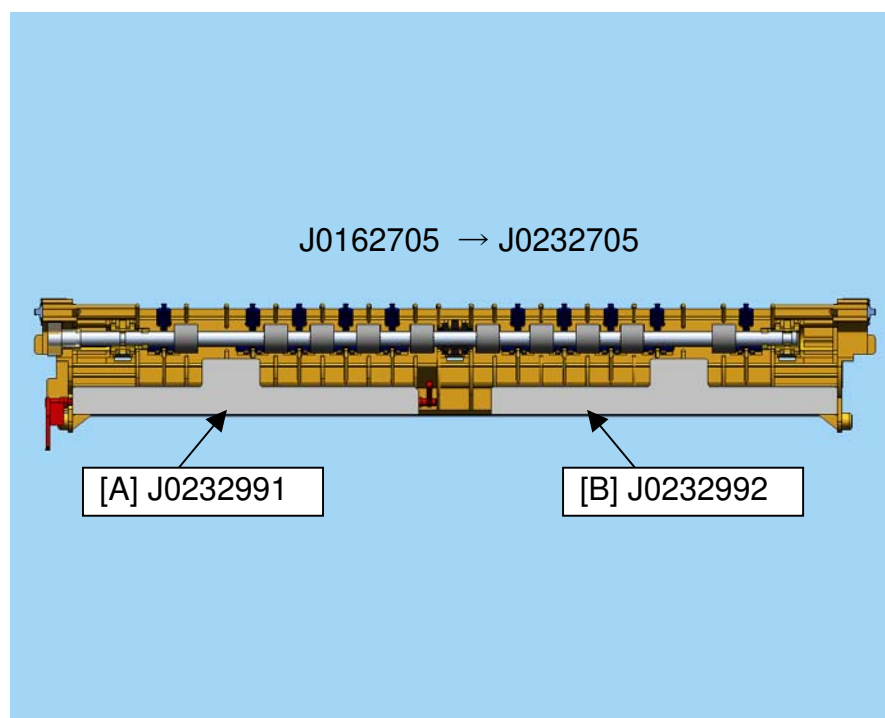
Reason: To further ensure that paper is fed straight and does not crease around the reverse guide area.

- 1) The shape of the Left Guide Sheet [A] was changed.
- 2) The Right Guide Sheet [B] was added.
