Model: M-G1a	Date: 25-May-09	No.: RJ017001j
--------------	-----------------	----------------

Subject: Firmware Release Note: Engine/Controller		Prepared by: Y. Gaman	
From: 1st Tech Service Sect., MFP/Printer Tech Service Dept.			
Classification:	<input type="checkbox"/> Troubleshooting <input type="checkbox"/> Mechanical <input type="checkbox"/> Paper path <input type="checkbox"/> Product Safety	<input type="checkbox"/> Part information <input type="checkbox"/> Electrical <input type="checkbox"/> Transmit/receive <input checked="" type="checkbox"/> Other ()	<input type="checkbox"/> Action required <input type="checkbox"/> Service manual revision <input type="checkbox"/> Retrofit information <input checked="" type="checkbox"/> Tier 2

This RTB has been issued to announce the firmware release information for the **Engine/Controller**.

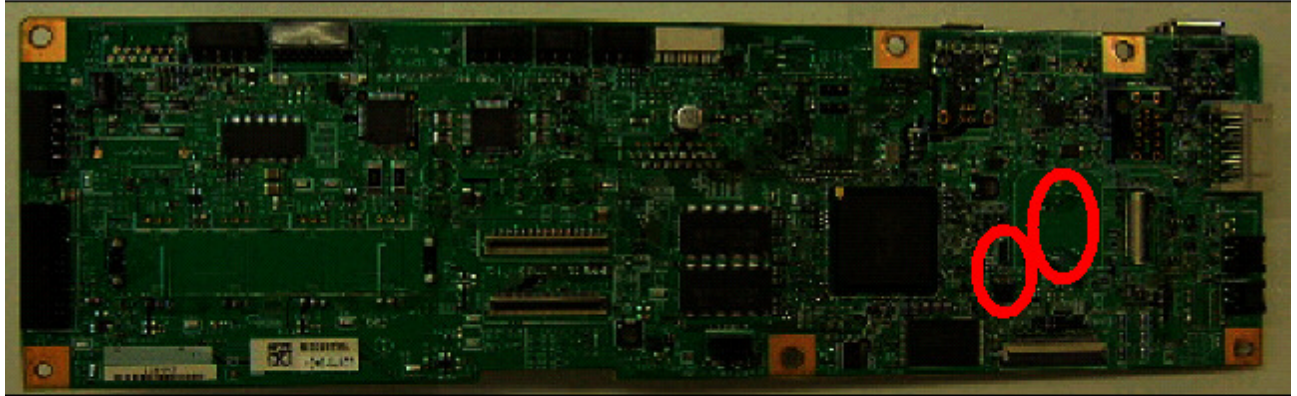
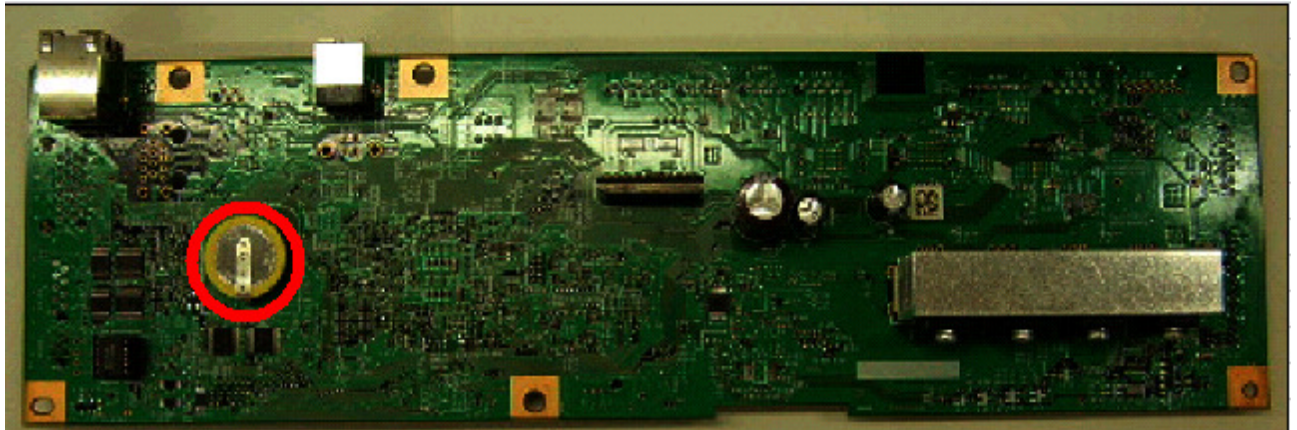
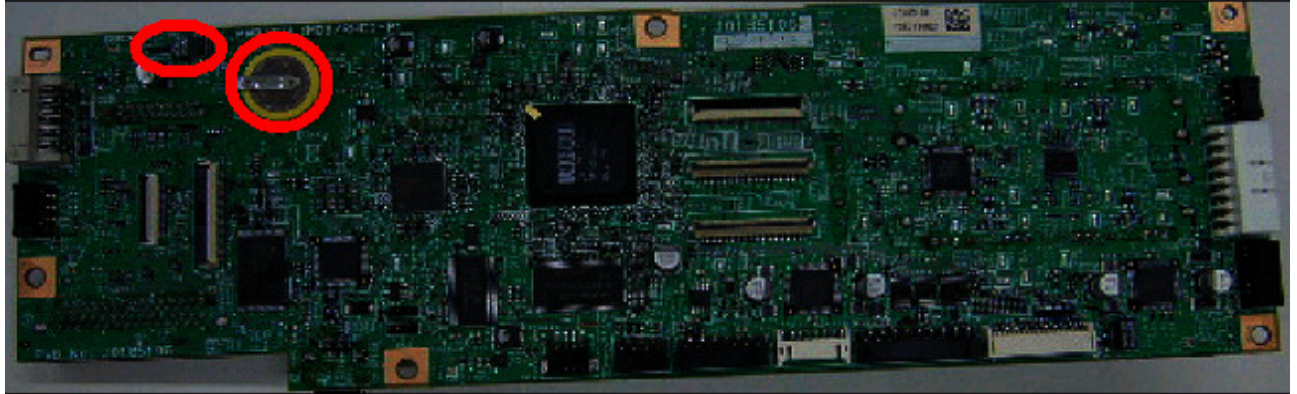
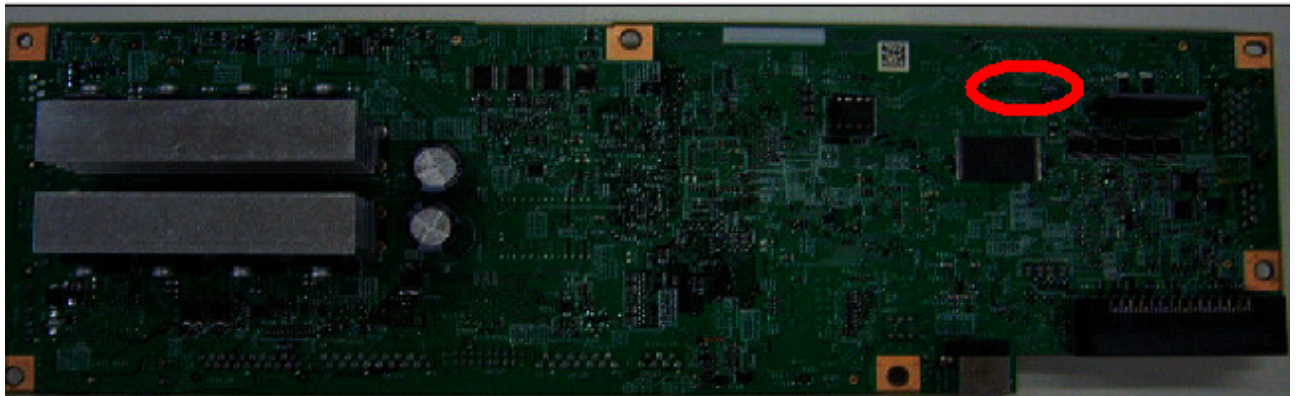
- When you replace the controller board, **DO NOT touch the areas circled in red below directly or with anything metallic.** If you do, **SC974** (RTC* malfunction) may occur.
 * **RTC: Real Time Clock**
- ***If SC974 occurs, turn the main power OFF/ON. If this does not clear the error, replace the controller board.***

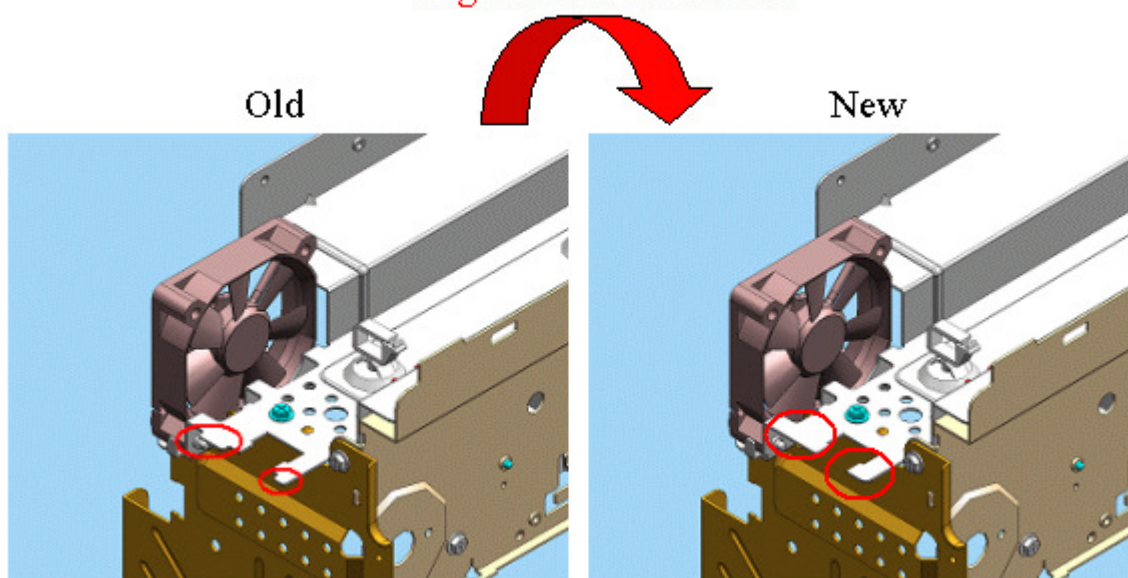
Slight tabs are removed

The small tabs on the tip of the bracket were removed.

Important: If you need to replace the cover on a machine produced before the cut-in serial numbers (see below), install the new cover and PCB **together as a set**.

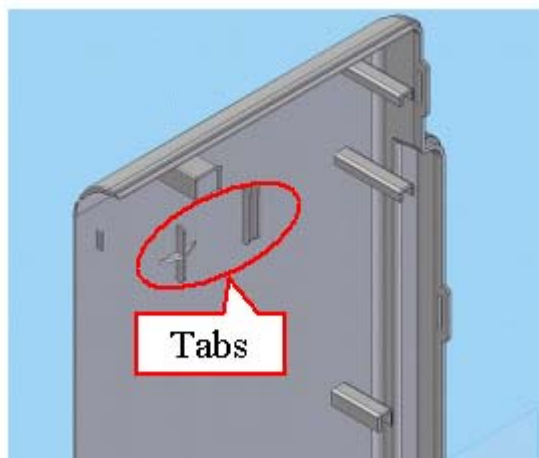
COVER: LEFT: MOS-P1: EU
 Tabs were added.

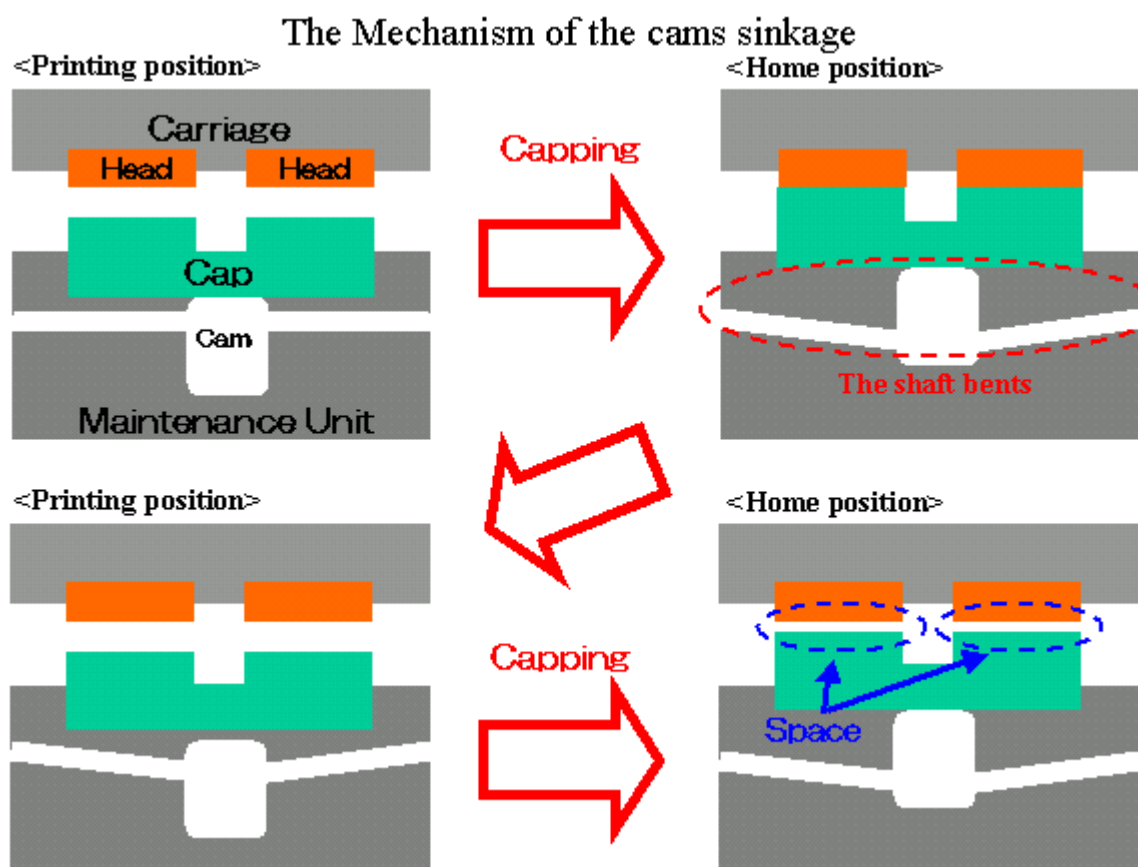
The carriage position lever is mistakenly set to the envelope position (rear position), which raises the carriage unit. A gap develops between the print heads and caps on the maintenance unit. As a result, the machine cannot properly perform ink suction (which causes the SC) or head cleaning (which causes the white lines).

Note: As the capping process for the carriage heads is repeated over time, the camshaft on the maintenance unit bends slightly. If the carriage position lever is left in the envelope position when the machine performs the maintenance tasks mentioned above, a gap develops between the carriage heads and caps on the maintenance unit.

1. Please remind users not to move the carriage position lever to the envelope position when performing ink initialization. Also, remind them that the lever should be set to the front position except when printing onto envelopes.

2. For users that print onto envelopes only, replace the maintenance unit.

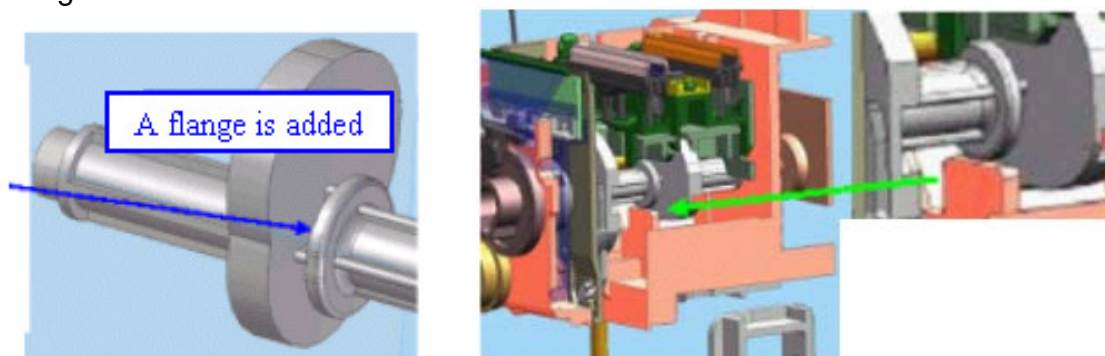
A flange was added to the cam on the maintenance unit.

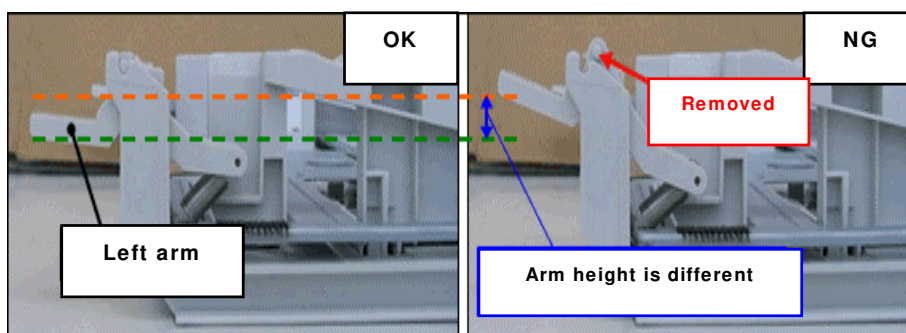
The trailing edge sensor is broken, which triggers a paper feed jam.

This sensor can be damaged if the cassette tray is loaded with the left arm unseated. When the tray is dropped, the base plate hits the arm, then the arm becomes unseated).

- Replace the trailing edge sensor.
- Make sure that the left arm on the cassette tray is correctly attached before inserting the tray.
- Replace the cassette tray and the left side fence with the modified ones mentioned above.

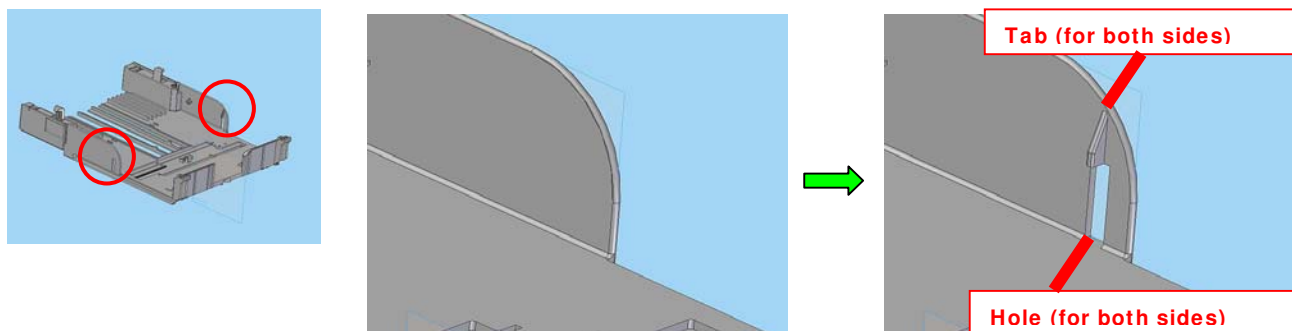
Tabs and holes were added to the left and right sides of the tray. This is to prevent the base plate from hitting the left arm.

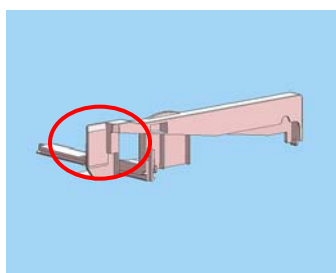
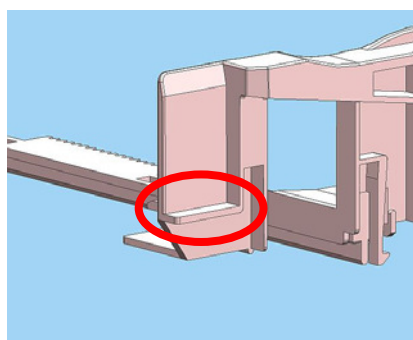
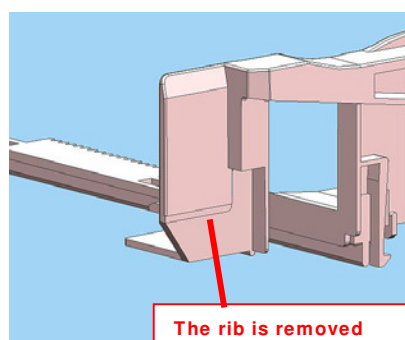
The rib was removed so that the left arm will not hit the trailing edge sensor even if the tray is set with the left arm incorrectly attached.

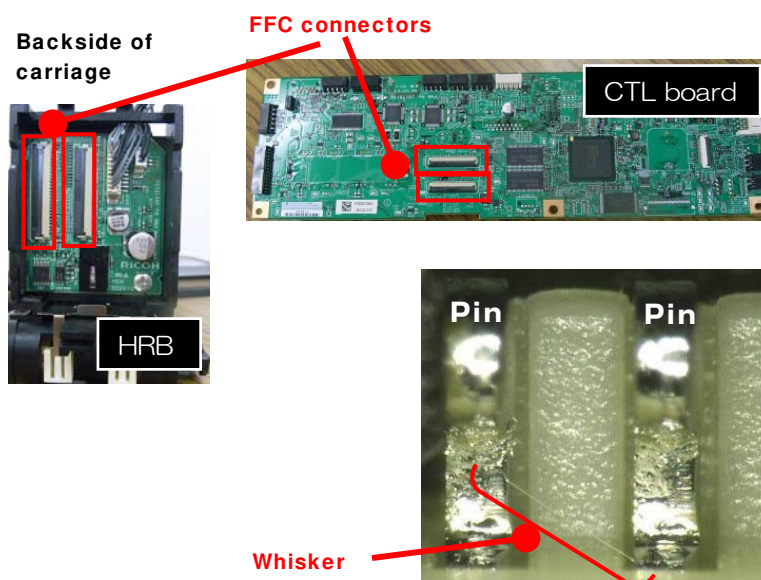
The FFC connector pins are short-circuited, causing a paper misfeed or abnormal temperature condition to be mis-detected.

The short circuit occurs when a metallic fiber (whisker) attaches itself so that it connects the pins at the FFC connectors, which are located on the controller board and the rear side of the carriage unit.

Remove the FFC from the two main PCB connectors, and then reconnect them. If the symptom still occurs, do the same for the carriage PCB connectors. **Otherwise, please replace the modified parts mentioned above.**
