Model: M-G1L	Date: 12-Feb-10	No.: RJ021001f
--------------	-----------------	----------------

Subject: Firmware Release Note: Engine/Controller		Prepared by: Y. Gaman	
From: 1st Tech Service Sect., MFP/Printer Tech Service Dept.			
Classification:	<input type="checkbox"/> Troubleshooting	<input type="checkbox"/> Part information	<input type="checkbox"/> Action required
	<input type="checkbox"/> Mechanical	<input type="checkbox"/> Electrical	<input type="checkbox"/> Service manual revision
	<input type="checkbox"/> Paper path	<input type="checkbox"/> Transmit/receive	<input type="checkbox"/> Retrofit information
	<input type="checkbox"/> Product Safety	<input checked="" type="checkbox"/> Other (Firmware)	<input checked="" type="checkbox"/> Tier 2

Subject: Countermeasure for the left cover whitening		Prepared by: K. Nakano	
From: 2nd Overseas Tech Support Sec., 2nd PQM Dept.			
Classification:	<input type="checkbox"/> Troubleshooting <input type="checkbox"/> Mechanical <input type="checkbox"/> Paper path <input type="checkbox"/> Product Safety	<input checked="" type="checkbox"/> Part information <input type="checkbox"/> Electrical <input type="checkbox"/> Transmit/receive <input ty

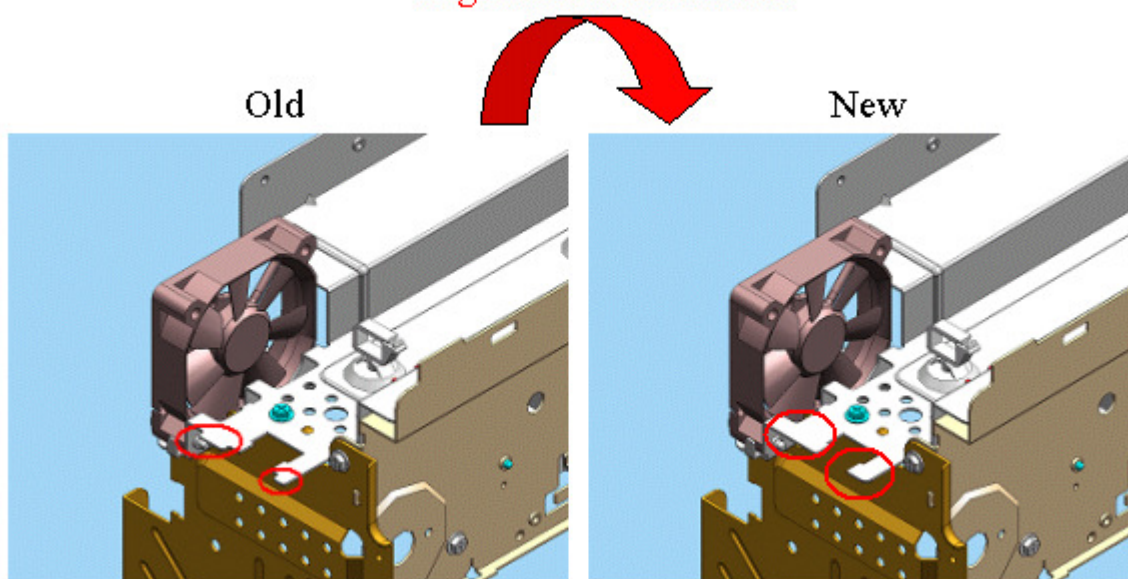
BRACKET: PCB: CONTROL

**Reason:** To provide further protection against shock and vibration during product shipping.

The small tabs on the tip of the bracket were removed.

**Slight tabs are removed**

**Important:** If you need to replace the cover on a machine produced before the cut-in serial numbers (see below), install the new cover and PCB **together as a set**.

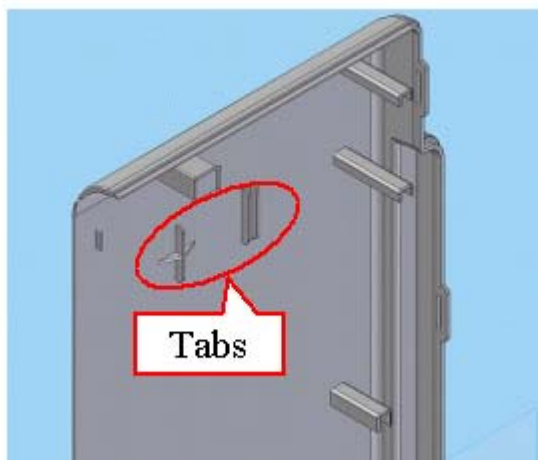
COVER: LEFT: EU

Tabs were added.

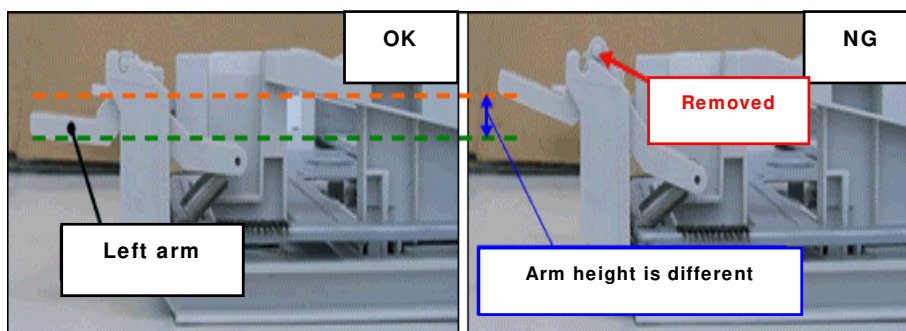
The trailing edge sensor is broken, which triggers a paper feed jam.

This sensor can be damaged if the cassette tray is loaded with the left arm unseated. When the tray is dropped, the base plate hits the arm, which then the arm becomes unseated).

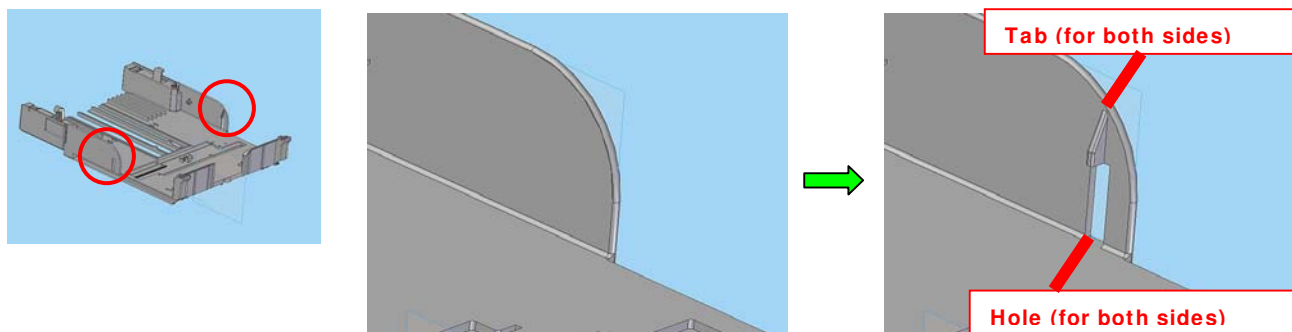
#### 1. Cassette tray:

Tabs and holes were added to the left and right sides of the tray. This is to prevent the base plate from hitting the left arm.

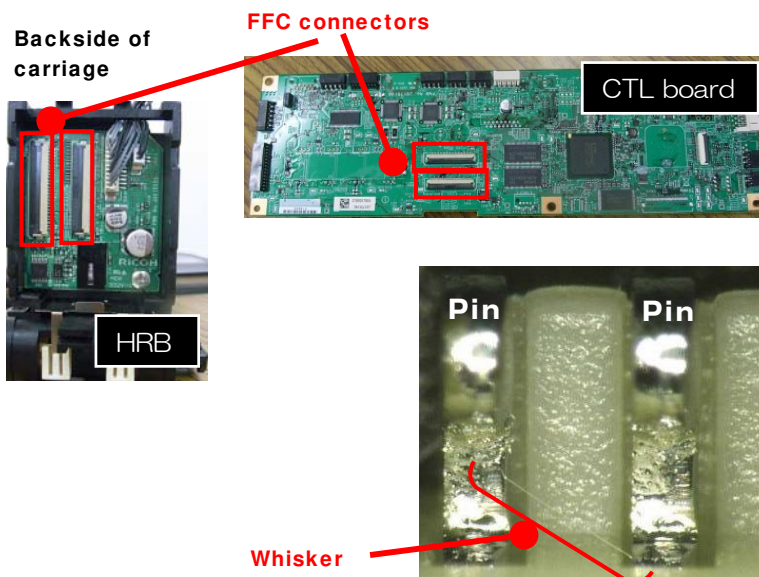
The FFC connector pins are short-circuited, causing a paper misfeed or abnormal temperature condition to be mis-detected.

The short circuit occurs when a metallic fiber (whisker) attaches itself so that it connects the pins at the FFC connectors, which are located on the controller board and the rear side of the carriage unit.

Remove the FFC from the two main PCB connectors, and then reconnect them. If the symptom still occurs, do the same for the carriage PCB connectors. **Otherwise, please replace the modified parts mentioned above.**

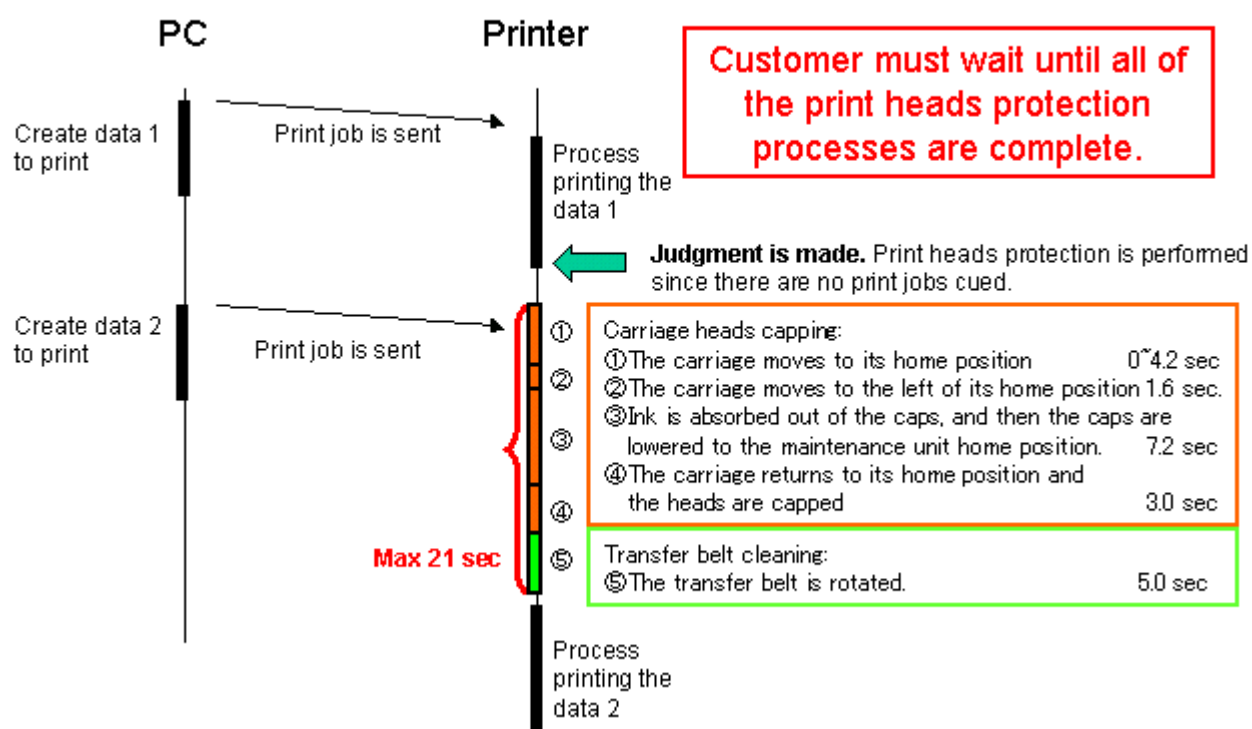
### Before firmware modification (no jobs in the cue)

The waiting time between jobs increases (maximum 21 seconds) if the machine receives a new print job just after finishing the current job.

The machine performs "Print-heads protection maintenance" after completing a print job. This involves performing several operations (please see the diagram below for each operation). Therefore, the customer must wait until all the operations are complete.

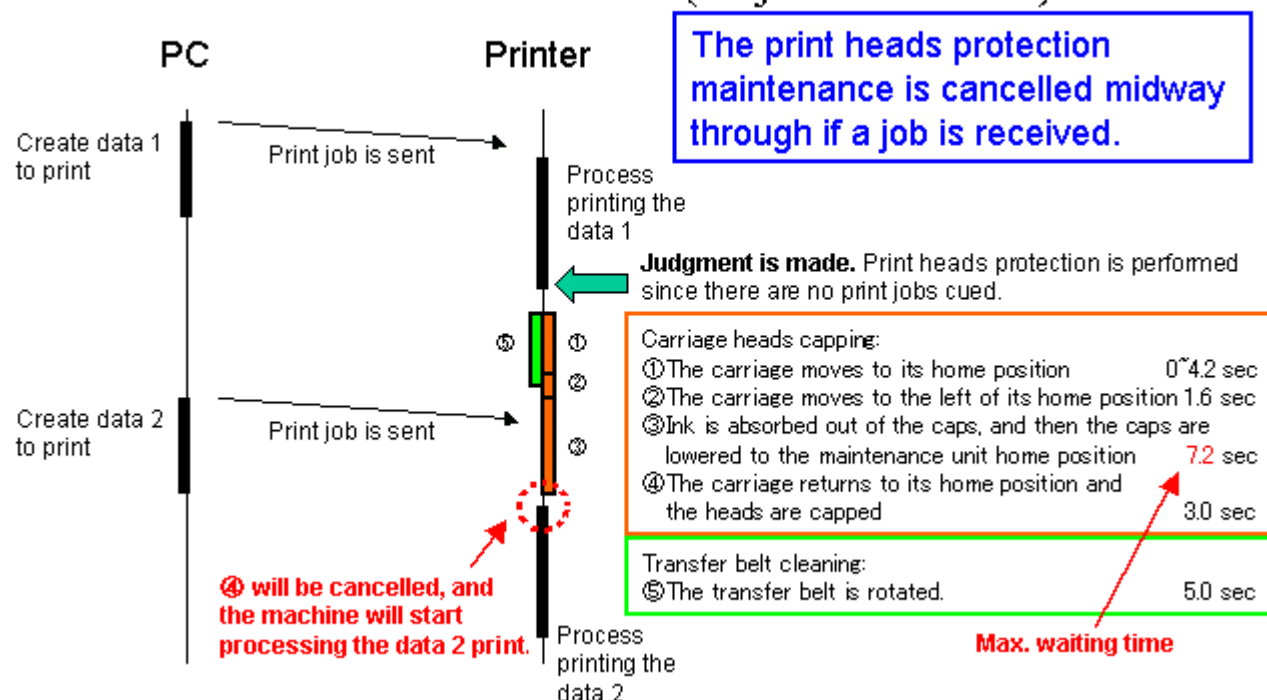
### After firmware modification (no jobs in the cue)

1. If the machine receives a new print job while performing the "print heads protection maintenance", it will be able to cancel the maintenance and print out the job. In other words, the maximum waiting time will be shortened to 7.2 sec (③ for the carriage heads capping process)

1. The cleaning interval was changed from every print job to every 250 pages.
2. Belt cleaning and carriage head capping are performed at the same time.

If the symptom is reported, advise the user to try updating to **V1.03 or later**.

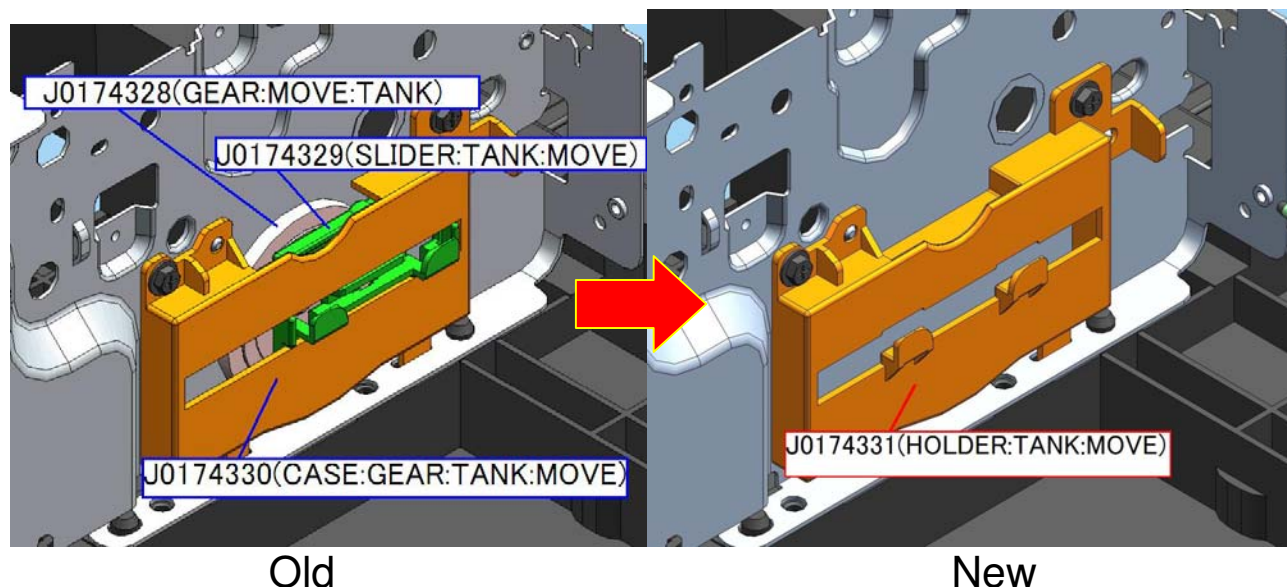
- 1) The gear and slider were deleted.
- 2) The shape of the case was changed.

**Important:** When you install the new holder (J0174331) for the first time, make sure to remove the gear (J0174328) and the slider (J0174329).
