Model: Haokan-P1		Date: 26-Oct-17	No.: RJ089001
Subject: Notes on replacing the cassette stand/carriage		Prepared by: K. Tsutsui	
From: System Strategy Dept. IP Business Center			
Classification:	<input type="checkbox"/> Troubleshooting <input type="checkbox"/> Mechanical <input type="checkbox"/> Paper path <input type="checkbox"/> Product Safety	<input checked="" type="checkbox"/> Part information <input type="checkbox"/> Electrical <input type="checkbox"/> Transmit/receive <input type="checkbox"/> Other ()	<input type="checkbox"/> Action required <input checked="" type="checkbox"/> Service manual revision <input type="checkbox"/> Retrofit information <input checked="" type="checkbox"/> Tier 2 <input type="checkbox"/> Tier 0.5

Model: Haokan-P1		Date: 11-Dec-17	No.: RJ089002
Subject: FSM correction - Finisher Firmware Update		Prepared by: Tsutsui	
From: System Strategy Dept. IP Business Center			
Classification:	<input checked="" type="checkbox"/> Troubleshooting <input type="checkbox"/> Mechanical <input type="checkbox"/> Paper path <input type="checkbox"/> Product Safety	<input type="checkbox"/> Part information <input type="checkbox"/> Electrical <input type="checkbox"/> Transm

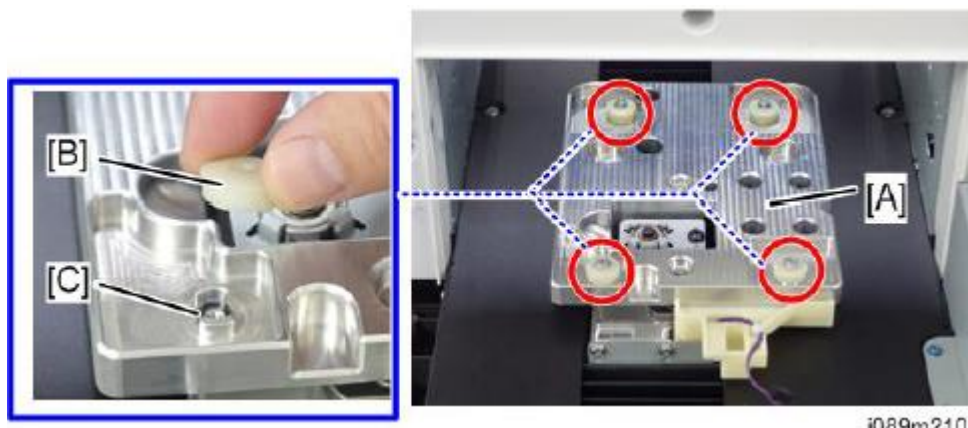
- When replacing the cassette stand and/or carriage, make sure to replace the two components supplied in the box together as a set, because the height and level of the stand are precisely adjusted accordingly with the carriage at the factory.

The height and level are adjusted at four points (circled in red above) on the carriage [A] with caps [B] and spacers [C].

- The position of the caps/spacers are also specified for each set of stand/carriage. Do not change the position of the caps/spacers.

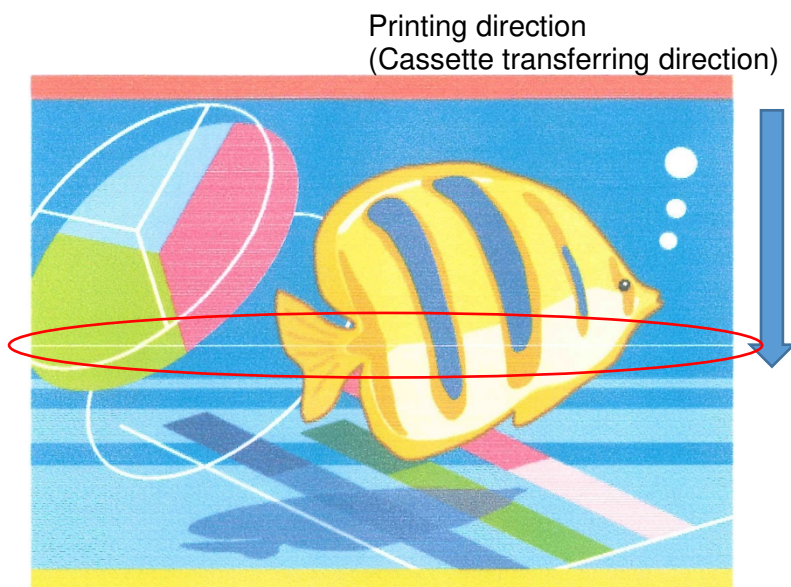
The image and its printing operation (single scan) are for the former products (Aficio SG series), and white lines and color unevenness may occur when printing the image on paper with Ri 100.

Ex1. When printed on paper, white line (red circles) occurs at the center of the printing direction.

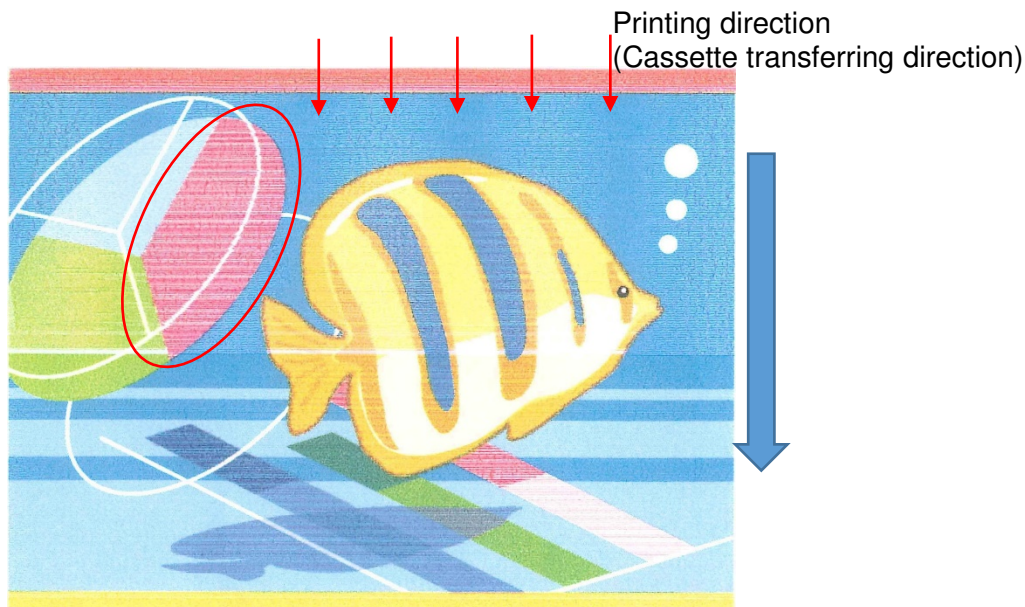
Ex.2 When printing on paper, color unevenness (pointed by red arrows) occurs in the blue image in parallel to the printing direction, or multiple white lines (ex. magenta portion in the red circle) in magenta, orange, and dark blue image portion.

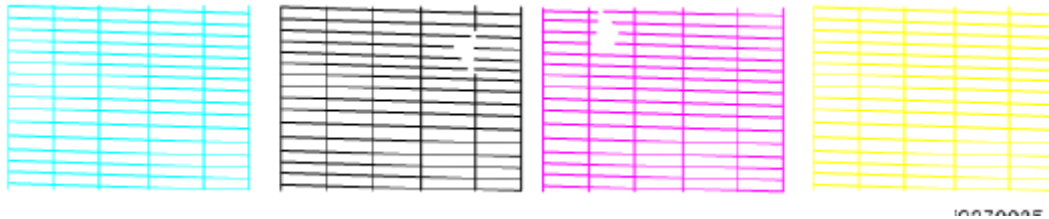
For the Nozzle Check, confirm only line chipping (caused by clogged nozzle).
Ex. The below printing patterns show that black and magenta nozzles are clogged.

Execute in the order of the above (Head cleaning: 3 times -> Head flushing: 1 time -> leaving), print the Nozzle Check pattern again, and please check the condition of recovery.
