| Model: BRG-G1b | Date: 8-May-12 | No.: RJ028001k |

| Subject: Firmware Release Note: Engine/Controller | | Prepared by: Y. Saitoh | |

This RTB has been issued to announce the firmware release information for the **Engine/Controller**.

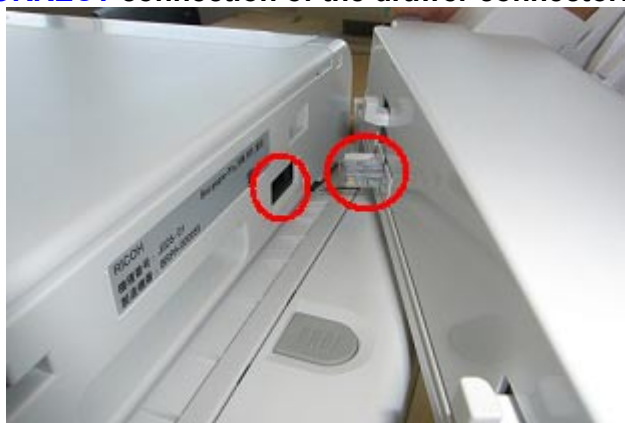
CORRECT connection of the drawer connector:

Nothing is displayed on the LCD after the main switch is turned on, and the main power cannot be turned off with the main switch.

The customer mistakenly connects a USB cable or LAN cable to the drawer connector of the by-pass tray while the machine power is still on. As a result, over-current may flow through the controller board circuit and damage the transistor.

The following show the correct and incorrect ways to connect the drawer connector (photos show the rear side of the machine):

- Replace the controller board.
- Advise the customer never to connect a USB or LAN cable to the drawer connector port. Also advise the customer on the correct ports to connect the LAN and USB cables, as shown in the photos below.
-

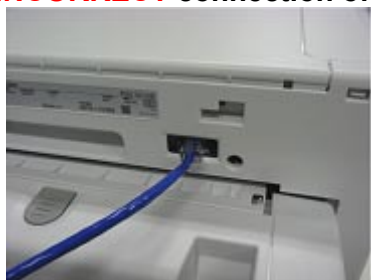
LAN cable

INCORRECT connection of the drawer connector:

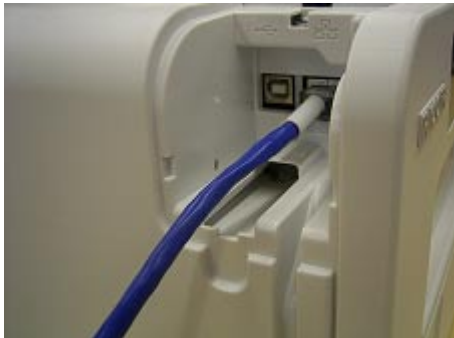
LAN cable

The following show the correct ports to connect the USB and LAN cables to (photos show the left side of the machine):

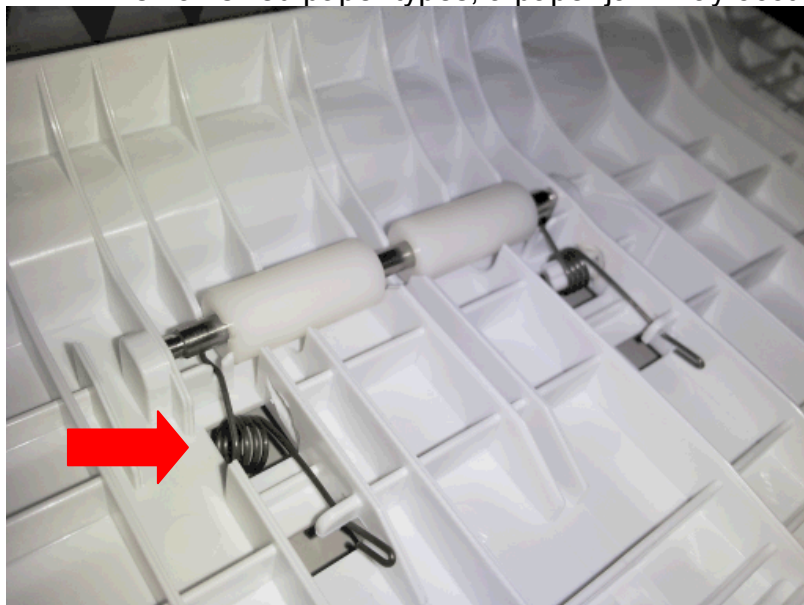
The fulcrum for the roller tension spring breaks.

Note: With normal paper types, paper jams and paper skew do not occur. With thick or small-sized paper types, a paper jam may occur.

The oil on the tension spring causes the plastic pivot to corrode, reducing its strength.

The tension spring was changed to an oil-free nickel-plated spring (Applied from: Sept. 2012 production).

If a paper jam or paper skew occurs due to a broken fulcrum, replace the guide plate assembly (**J0252758**). [If this problem occurs, a replacement part can be ordered with a retrofit part number J0271551 \(=J0252758\).](#)

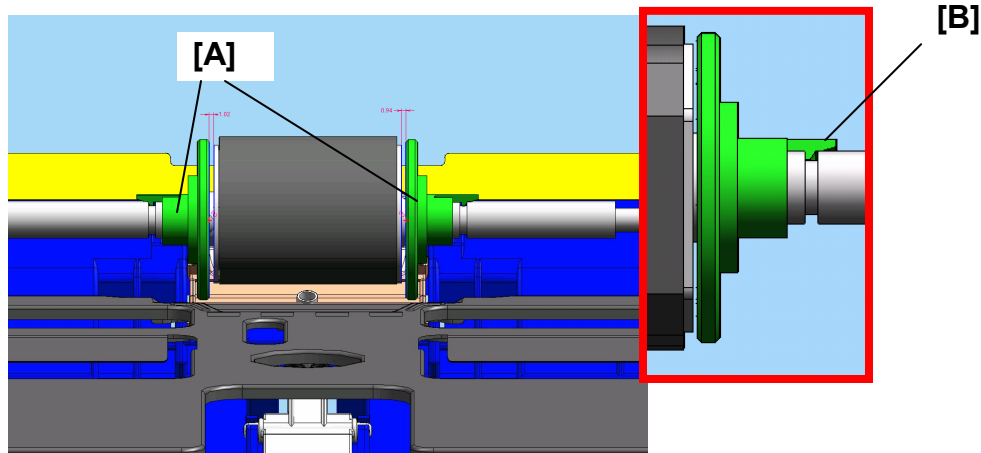
Old

To eliminate the scraping noise of the feed roller collars [A], the stopper [B] of the collar has been changed to a retaining ring [C]. The shaft [D] of the roller has also been changed to fit the groove with the retaining ring.
