Model: BRG-MF1a	Date: 18-Oct-12	No.: RJ030001j
-----------------	-----------------	----------------

Subject: Firmware Release Note: Engine/Controller		Prepared by: J. Mochizuki	
From: 3rd Tech Service Sect., MFP/Printer Tech Service Dept.			
Classification:	<input type="checkbox"/> Troubleshooting <input type="checkbox"/> Mechanical <input type="checkbox"/> Paper path <input type="checkbox"/> Product Safety	<input type="checkbox"/> Part information <input type="checkbox"/> Electrical <input type="checkbox"/> Transmit/receive <input checked="" type="checkbox"/> Other (Firmware)	<input type="checkbox"/> Action required <input type="checkbox"/> Service manual revision <input type="checkbox"/> Retrofit information <input checked="" type="checkbox"/> Tier 2

This RTB has been issued to announce the firmware release information for the **Engine/Controller**.

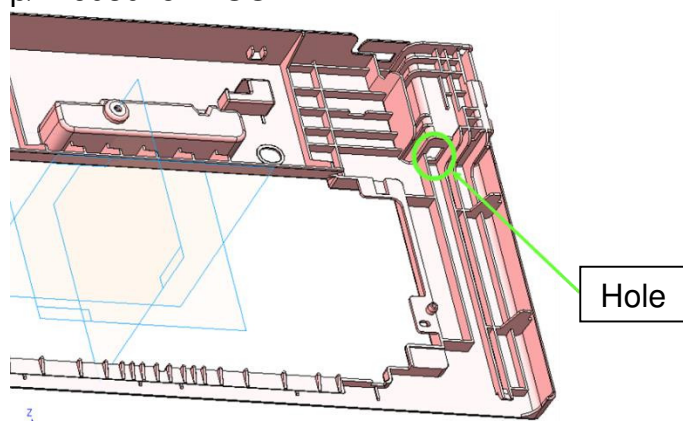
p/n: J0301541 COVER:REAR:MF

- A hole in the rear cover was filled.
- A projection on the right side plate was removed.
- The Mylar does not have to be attached to the new rear cover. (The Mylar is needed only for the old rear cover.)

Reason: To further minimize static electricity

Before

Old part number	New part number	Description	Q'ty	Int	Page	Index	Note
J0301541	J0301545	COVER:REAR:MF	1 → 1	X/X	5	10	
J0301544	-	SHEET:HINGE:RIGHT:MF	1 → 0

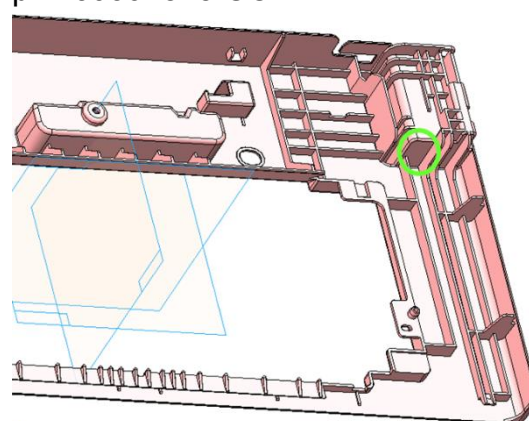
p/n: J0301545 COVER:REAR:MF

After

Important: The new Rear Cover can be installed only on units that have the new Right Side Plate. See the next page for an illustration of the right side plate and serial number information.
