Model: Model CV-P1	Date: 18-Apr-08	No.: RM000001a
--------------------	-----------------	----------------

Subject: Firmware Release Note: Engine		Prepared by: Y.Gaman	
From: 2nd Tech. Support Sec. Service Support Dept.			
Classification:	<input type="checkbox"/> Troubleshooting	<input type="checkbox"/> Part information	<input checked="" type="checkbox"/> Action required
	<input type="checkbox"/> Mechanical	<input type="checkbox"/> Electrical	<input type="checkbox"/> Service manual revision
	<input type="checkbox"/> Paper path	<input type="checkbox"/> Transmit/receive	<input type="checkbox"/> Retrofit information
	<input type="checkbox"/> Other (       )

Model: Model CV-P1		Date: 02-Feb-09	No.: RM000003
Subject: Model CV-P1 Fuser Damage		Prepared by: Y. Gaman	
From: 1st Tech. Support Sec. Service Support Dept.			
Classification:	<input type="checkbox"/> Troubleshooting <input type="checkbox"/> Mechanical <input type="checkbox"/> Paper path <input checked="" type="checkbox"/> Other (      )	<input type="checkbox"/> Part information <input type="checkbox"/> Electrical <input type="checkbox"/> Transmit/receive	<input type="checkbox"/> Action required <input type="checkbox"/> Service

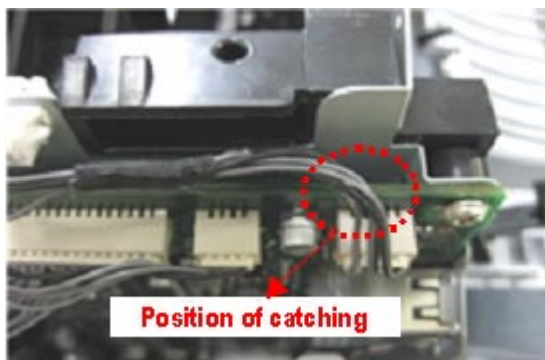
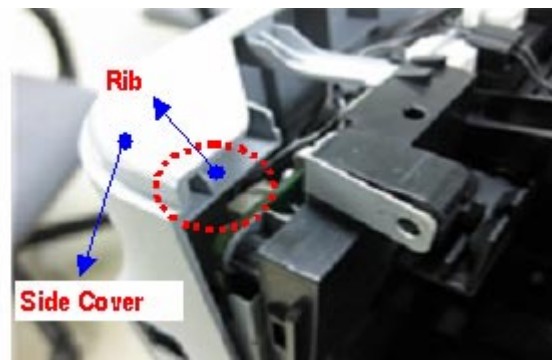
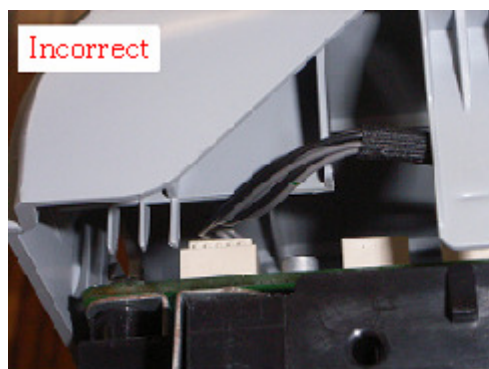
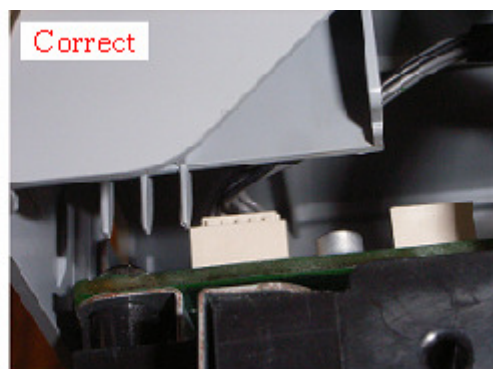
***One of the following occurs, which causes*** the surfaces of the hot roller and pressure roller to partially melt:

- 1. Thermistor malfunction: Spot welding was incorrectly applied to the thermistor.***
- 2. Unstable power supply: This can create excess electrical noise (and surge current, in some cases), which interferes with the function of the fusing unit.***
- 3. Damage to the thermistor harness: This can happen if the harness is caught in the rib of the side cover when the side cover is attached in the field.***

**Solution****1. Thermistor malfunction:**Upgrade to Engine firmware **ver1.50.01.35** or newer

*The resistance of the R53 resistor on the main board (ADC port) was increased from 1Kohm to 33Kohms, which greatly increases the temperature protection for the rollers and other hardware.*

*The wiring of the harness was changed as follows, to prevent the possibility of the harness being pinched or damaged.*

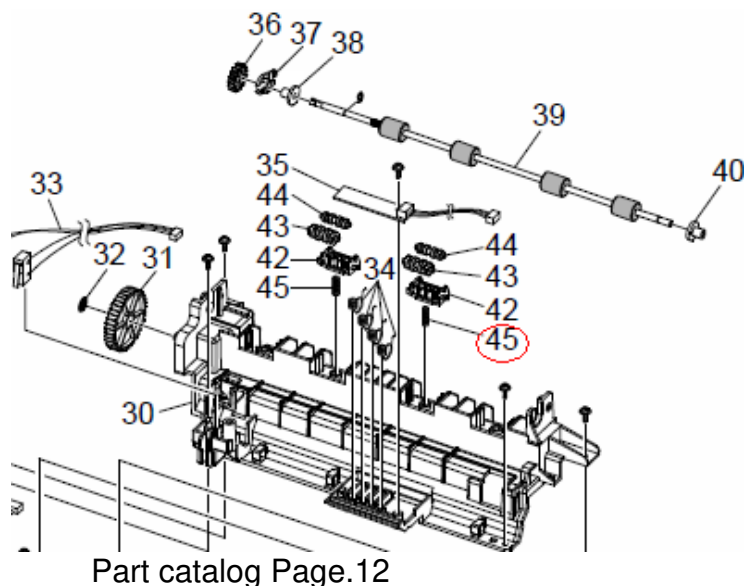
A wrong part number was found in part catalog Page.13 Index No.45.

Index No.	Correct Part No.	Description	Q'ty
45	<b>M0001015</b>	Spring CS	2
