Model: S-P1	Date: 15-Jan-07	No.: RG176001a
-------------	-----------------	----------------

Subject: Firmware Release Note: Engine for S-P1b (31ppm)		Prepared by: Y.Murata	
From: 1st Tech. Support Sec. Service Support Dept.			
Classification:	<input type="checkbox"/> Troubleshooting <input type="checkbox"/> Mechanical <input type="checkbox"/> Paper path <input checked="" type="checkbox"/> Other ()	<input type="checkbox"/> Part information <input type="checkbox"/> Electrical <input type="checkbox"/> Transmit/receive	<input type="checkbox"/> Action required <input type="checkbox"/> Service manual revision <input type="checkbox"/> Retrofit information

This RTB has been issued to announce the firmware release information for the Engine.

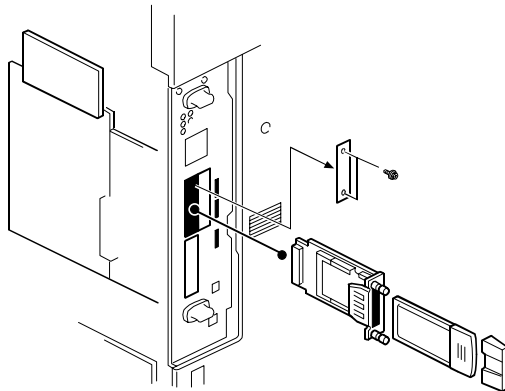
Previous types:
PCB, LAN card, and cover are
separate

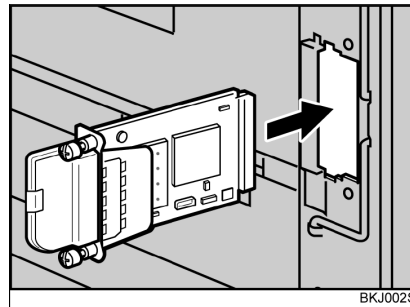
1. Production of a new wireless LAN option, the **IEEE 802.11b Interface Unit Type N**, began in March 2008. This will replace the current wireless LAN options listed below, as the vendor discontinued production on a key part contained in these options.
2. Make sure to see below for the target models and action in the field, including the necessary firmware versions.

New Type (IEEE802.11b
Interface Unit Type N):
Pre-assembled

Action in the Field

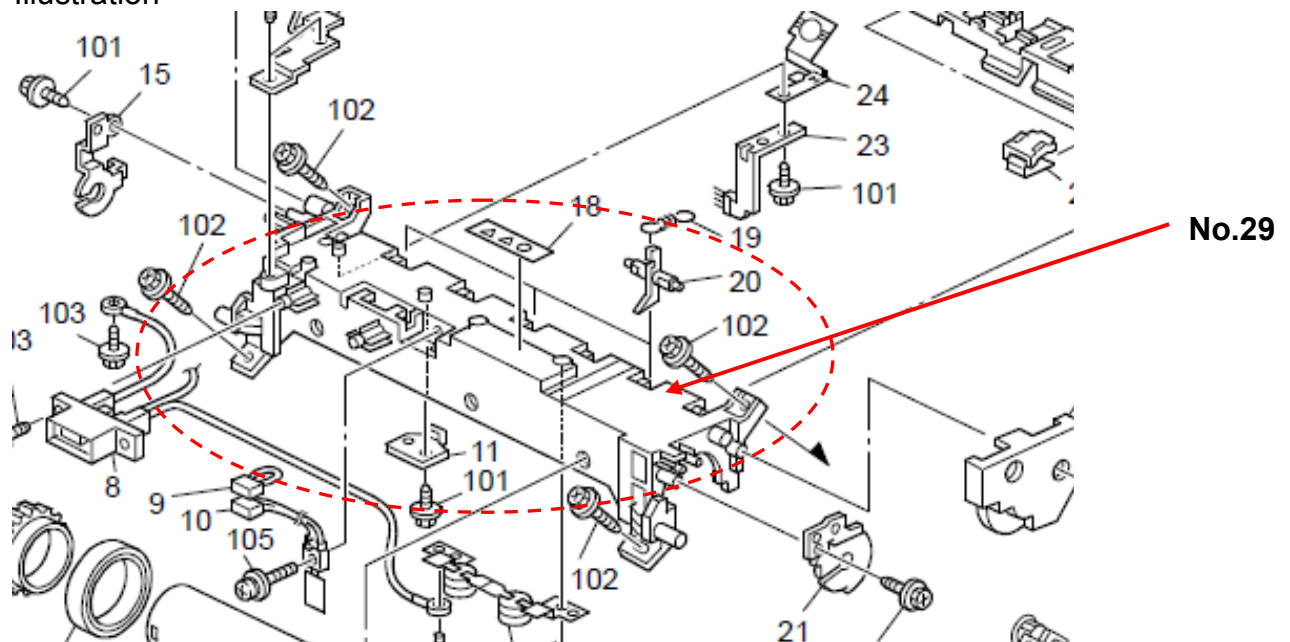
Change/Reason: Added the following parts.

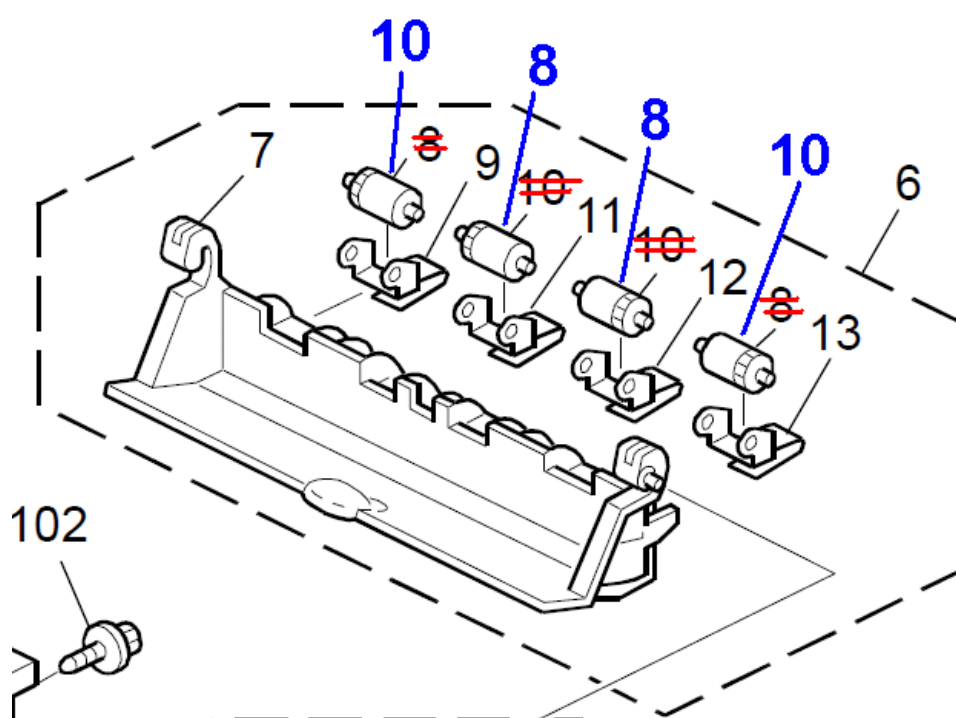
Parts Catalog, pg. 2

Change/Reason: Indices #8 and #10 were corrected (they were reversed).

6	G096 1509	Paper Exit Sub-unit Ass'y	1
7	G096 1512	Exit Cover	1
8	G052 4875	Inner Exit Cover Roller	2
9	G052 4871	Left Holder - Exit Driven Roller	1
10	G052 4873	Outer Exit Cover Roller	2
11	G052 4876	Left Spring Plate	1
