Model: S-P3	Date: 07-Jun-11	No.: RM080001a
-------------	-----------------	----------------

Subject: Firmware Release Note: Engine		Prepared by: K.Nakano	
From: 2nd Tech Service Sect., MFP/Printer Tech Service Dept			
Classification:	<input type="checkbox"/> Troubleshooting <input type="checkbox"/> Mechanical <input type="checkbox"/> Paper path <input type="checkbox"/> Product Safety	<input type="checkbox"/> Part information <input type="checkbox"/> Electrical <input type="checkbox"/> Transmit/receive <input checked="" type="checkbox"/> Other (Firmware)	<input type="checkbox"/> Action required <input type="checkbox"/> Service manual revision <input type="checkbox"/> Retrofit information <input checked="" type="checkbox"/> Tier 2

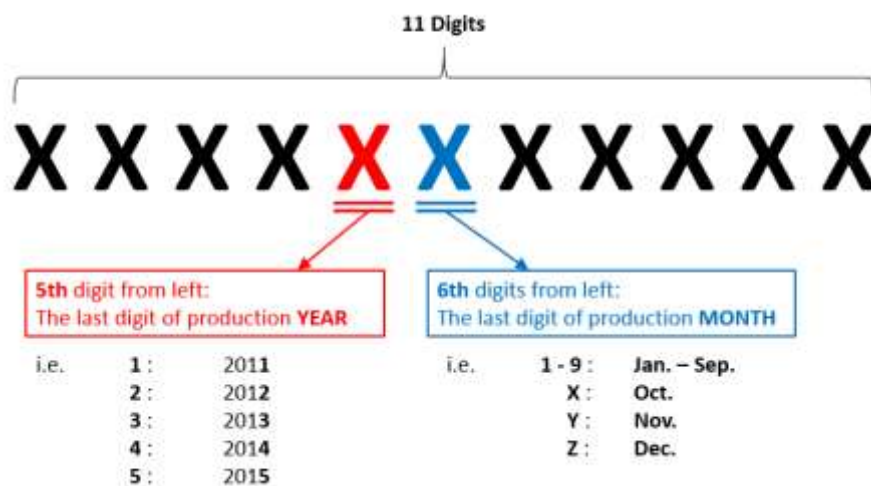
Model: S-P3		Date: 15-Jun-15	No.: RM080024
Subject: Dirty background or dirty edge after installing a new AIO		Prepared by: K.Nakano	
From: Field Quality Management Dept.			
Classification:	<input checked="" type="checkbox"/> Troubleshooting <input type="checkbox"/> Mechanical <input type="checkbox"/> Paper path <input type="checkbox"/> Product Safety	<input type="checkbox"/> Part information <input type="checkbox"/> Electrical <input type="checkbox"/> Transmit/receive <input type="checkbox"/> Other (     )	<input type="checkbox"/> Action required <input type="checkbox"/> Service manual revision <input type="checkbox"/> Retrofit information <input type="checkbox"/> Tier 2

Replace the AIO with one produced in **November 2014 or later**.

Determining the production month/year from the AIO Serial Number:
