Technical Bulletin

Model: Model SY-P1	Date: 07-Jan-08	No.: RG186001c
--------------------	-----------------	----------------

Model: SY-P1	Model: SY-P1			e: 30-Apr-	10	No.: RG186005	
Subject: Replace	Subject: Replacement of bushing for pressure roller					Hamada	
From: 1st Overseas Tech Support Sec., 1st PQM Dept.							
Classification:		☐ Part info	ormation				
	☐ Mechanical	☐ Electric	al		Service	ce manual revision	
☐ Paper path ☐ Transmit		it/rec	eive	☐ Retrof	fit information		
	☐ Product Safety	$\hfill \square$ Other ()	☐ Tier 2

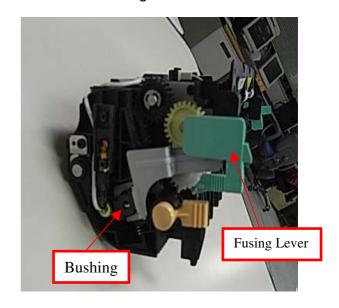
SYMPTOM

Noise is generated after jammed paper is removed from the fusing unit.

CAUSE

The vendor that produces the pressure roller bushing used the wrong material on the production line. As a result, the bushing breaks when the fusing lever is pushed upward to remove the jammed paper.

SOLUTION

If this symptom is reported on the affected units (see below), replace the bushing with the following part (replacement procedure below):

P/N G1869900 Bushing: Pressure roller

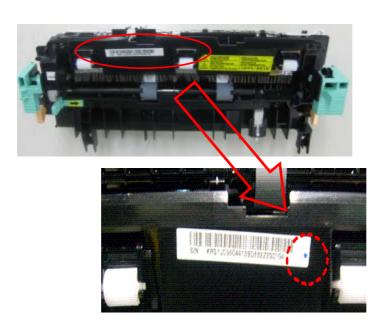
Important: Bushings have already been replaced on fusing units that are marked with a blue dot (see the photo). You DO NOT need to replace these units for this symptom.
