Model: Sh-P1	Date: 10-Aug-11	No.: RM020001a
--------------	-----------------	----------------

Subject: Firmware Release Note: Engine		Prepared by: K. Hamada	
From: 1st Overseas Tech Support Sec., 1st PQM Dept.			
Classification:	<input type="checkbox"/> Troubleshooting <input type="checkbox"/> Mechanical <input type="checkbox"/> Paper path <input type="checkbox"/> Product Safety	<input type="checkbox"/> Part information <input type="checkbox"/> Electrical <input type="checkbox"/> Transmit/receive <input checked="" type="checkbox"/> Other (Firmware)	<input type="checkbox"/> Action required <input type="checkbox"/> Service manual revision <input type="checkbox"/> Retrofit information <input checked="" type="checkbox"/> Tier 2

This RTB has been issued to announce the firmware release information for the **Engine**.

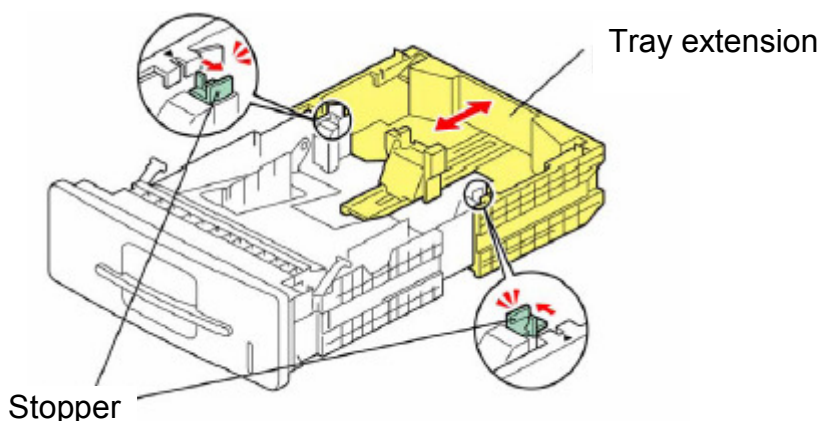
CAUSE

The stopper breaks and the tray extension extends out too far, causing the end fence to retract.

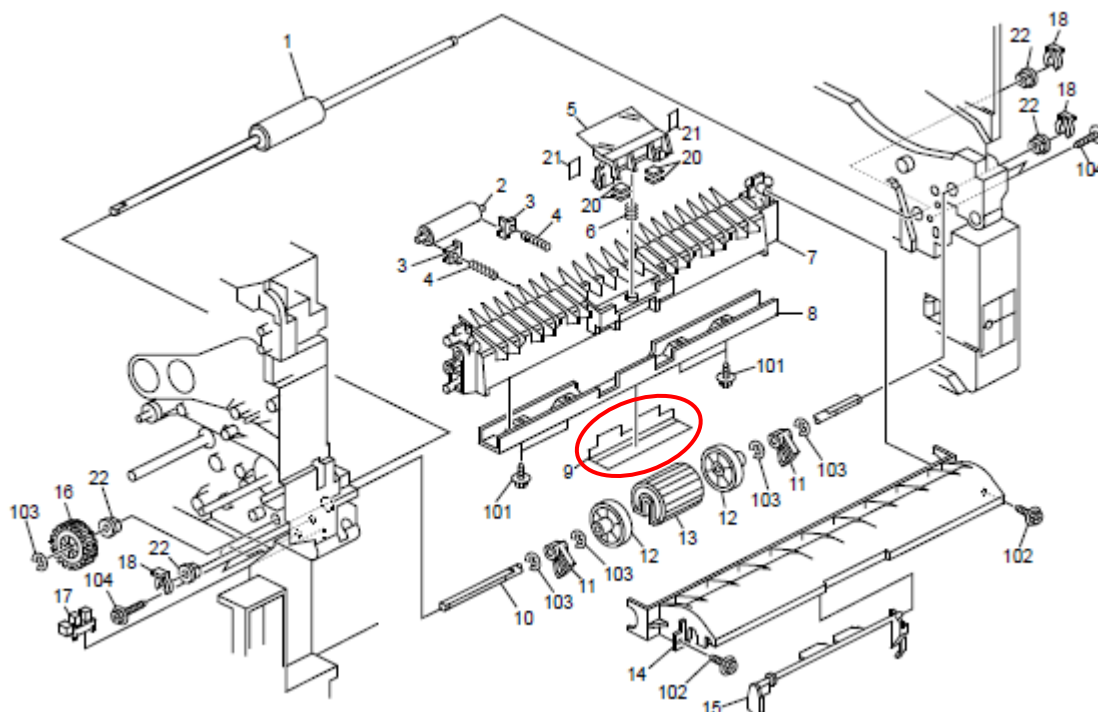
Paper feed section

- Paper Jam (Code: B)
- Damage to the leading edge of the paper

CAUSE

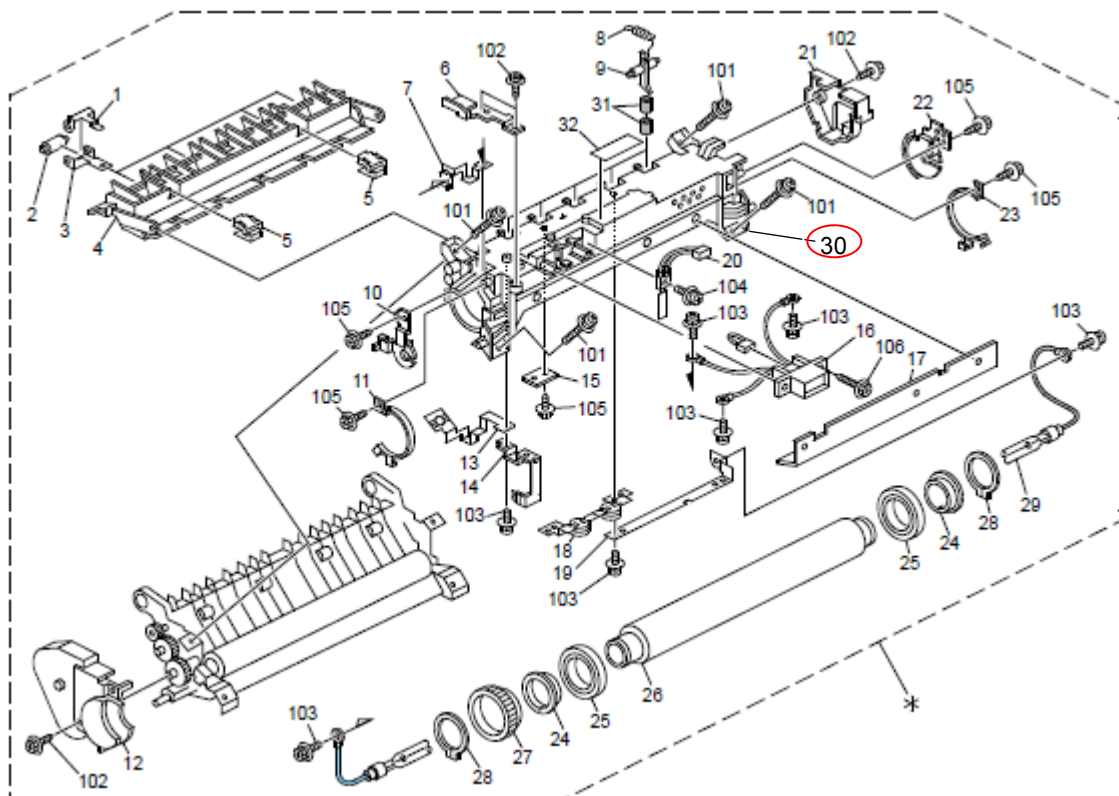
10.Fusing Unit 1 (M020/M021)

Change/Reason: Index #30 was added (it was missing from the illustration).

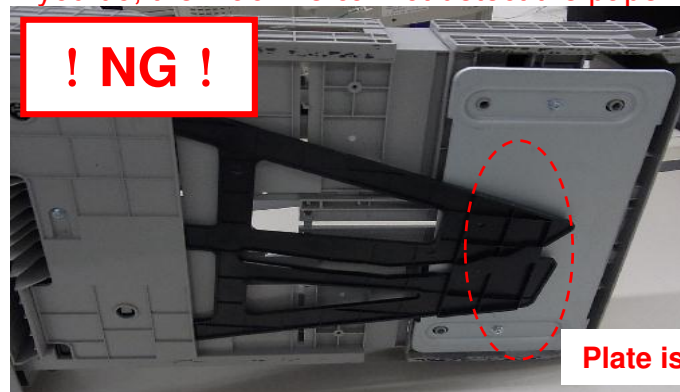
Plate is positioned outside the guide

IMPORTANT: Do not attach the size detection plate outside the guide.
If you do, the machine cannot detect the paper size, and a jam will occur.
