Model: Kr-P2	Date: 10-Nov-09	No.: RM047001f
--------------	-----------------	----------------

Subject: Firmware Release Note: PS3/PDF		Prepared by: Y. Nishida	
From: MFP/Printer Tech Service Dept., 3rd Tech Service Sect..			
Classification:	<input type="checkbox"/> Troubleshooting	<input type="checkbox"/> Part information	<input type="checkbox"/> Action required
	<input type="checkbox"/> Mechanical	<input type="checkbox"/> Electrical	<input type="checkbox"/> Service manual revision
	<input type="checkbox"/> Paper path	<input type="checkbox"/> Transmit/receive	<input type="checkbox"/> Retrofit information
	<input type="checkbox"/> Product Safety	<input checked="" type="checkbox"/> Other (Firmware)	<input checked="" type="checkbox"/> Tier 2

This RTB has been issued to announce the firmware release information for the **PS3/PDF**.

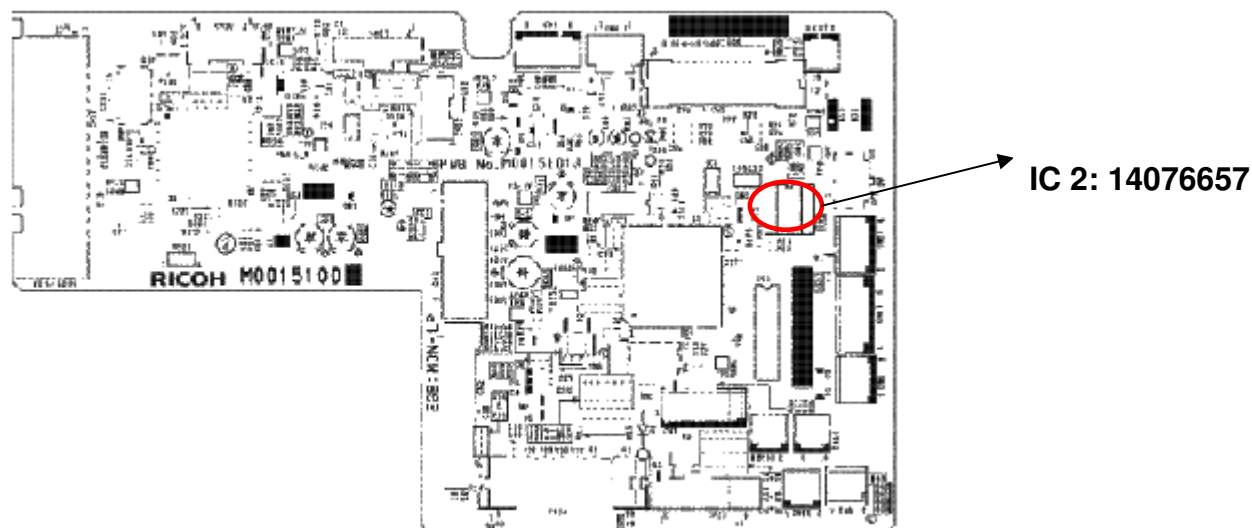
Reason/Change: The NVRAM (P/N 14076657, IC 2) on the EGB is now available as a service part. The part number for the NVRAM (P/N M0479590, IC 19) on the Controller Board was updated.

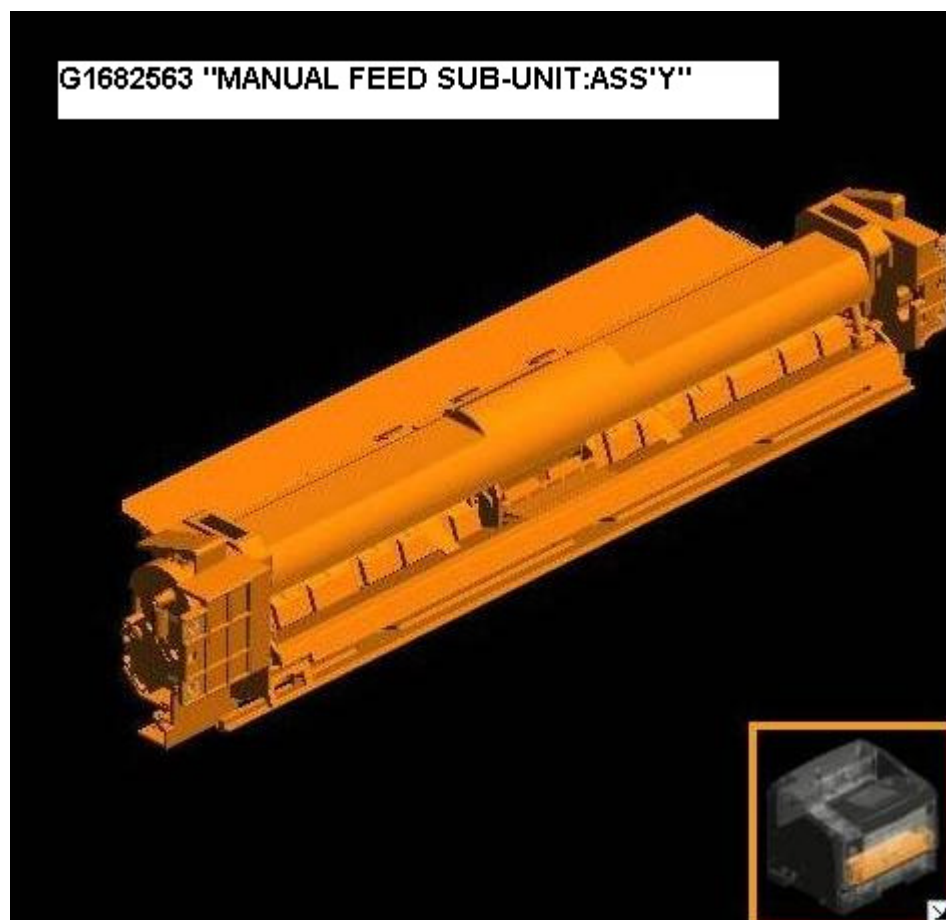
Reason/Change: The "Manual Feed Sub-unit Ass'y" (P/N G1682563) was missing in the 3D Parts Catalogue.
