Model: Da-P1d	Date: 19-Mar-15	No.: RM187004
----------------------	-----------------	---------------

Subject: Firmware Release Note: NetworkDocBox		Prepared by: Y. Gaman	
From: 3rd Tech Service Sect., MFP/Printer Tech Service Dept.			
Classification:	<input type="checkbox"/> Troubleshooting <input type="checkbox"/> Mechanical <input type="checkbox"/> Paper path <input type="checkbox"/> Product Safety	<input type="checkbox"/> Part information <input type="checkbox"/> Electrical <input type="checkbox"/> Transmit/receive <input checked="" type="checkbox"/> Other (Firmware)	<input type="checkbox"/> Action required <input type="checkbox"/> Service manual revision <input type="checkbox"/> Retrofit information <input checked="" type="checkbox"/> Tier 2

Model: Da-P1d		Date: 14-May-15	No.: RM187013
Subject: Squeaking Noise from Paper Exit Area		Prepared by: J. Mochizuki	
From: Field Quality Management Department			
Classification:	<input checked="" type="checkbox"/> Troubleshooting <input type="checkbox"/> Mechanical <input type="checkbox"/> Paper path <input type="checkbox"/> Product Safety	<input type="checkbox"/> Part information <input type="checkbox"/> Electrical <input type="checkbo

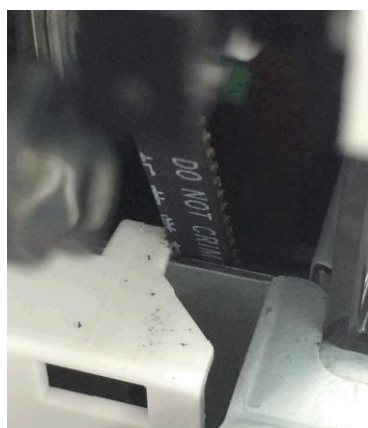
A squeaking noise is heard from the paper exit area (occurrence rate: 0.5%).

Variations in parts dimensions and assembly conditions can sometimes result in a small (or no) clearance between the fusing unit drive belt and exit cover (as shown in the photo).

The position of the claw was shifted to create enough gap between the belt and the cover.
Applied from: April 2015 production

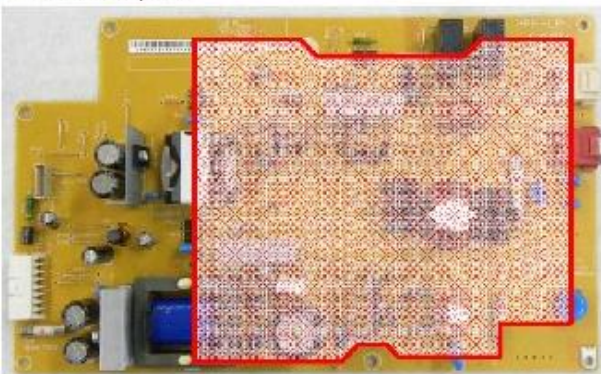
M187:DOM/NA

NEVER touch the areas outlined in red in the photos below to prevent electric shock caused by residual charge.

Residual charge of about 100V-400V remains in the AC circuits on the PSU board for several months even when the board has been removed from the machine after turning off the machine power and unplugging the power cord.

The procedure to discharge residual charge from the machine by unplugging the power cord from the AC wall outlet and pressing the main power switch works only for the DC circuits on this board. Residual charge remains in the AC circuits.

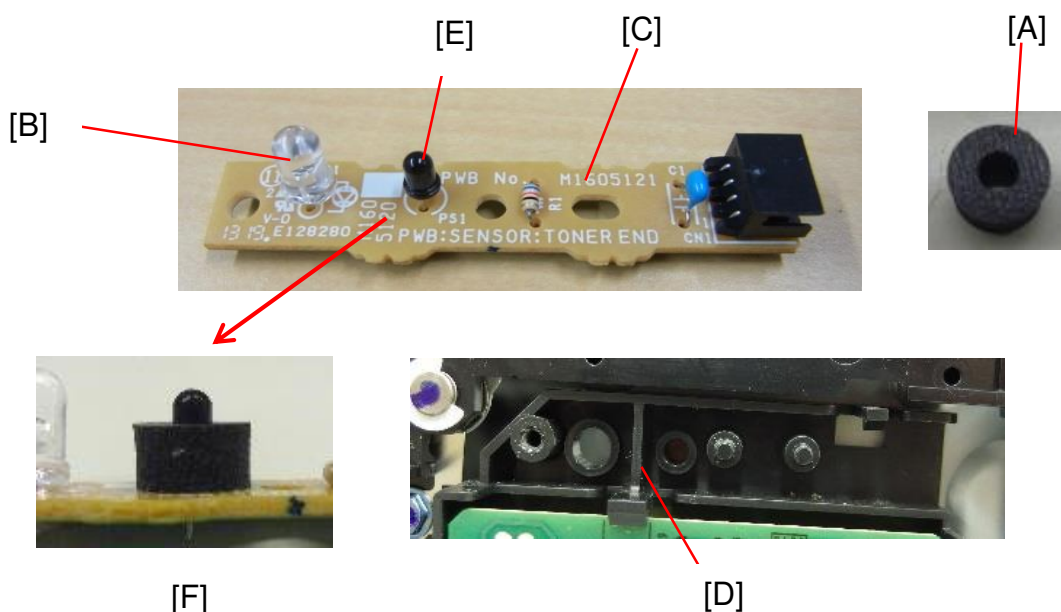
Reason: To further ensure SC332 is detected correctly.

Note: This SC can be mis-detected if light from the LED [B] is leaked between the toner end sensor board [C] (M1605120) and rib [D] on the sensor base (which is then picked up by the photo-detector [E]). The seal [A] will cover the lower part of the photo-detector.

Change: The following seal [A] was added.

IMPORTANT: Attach this seal as shown [F] if SC332 occurs in the field and the cause is not a mechanical issue with the toner transportation system.

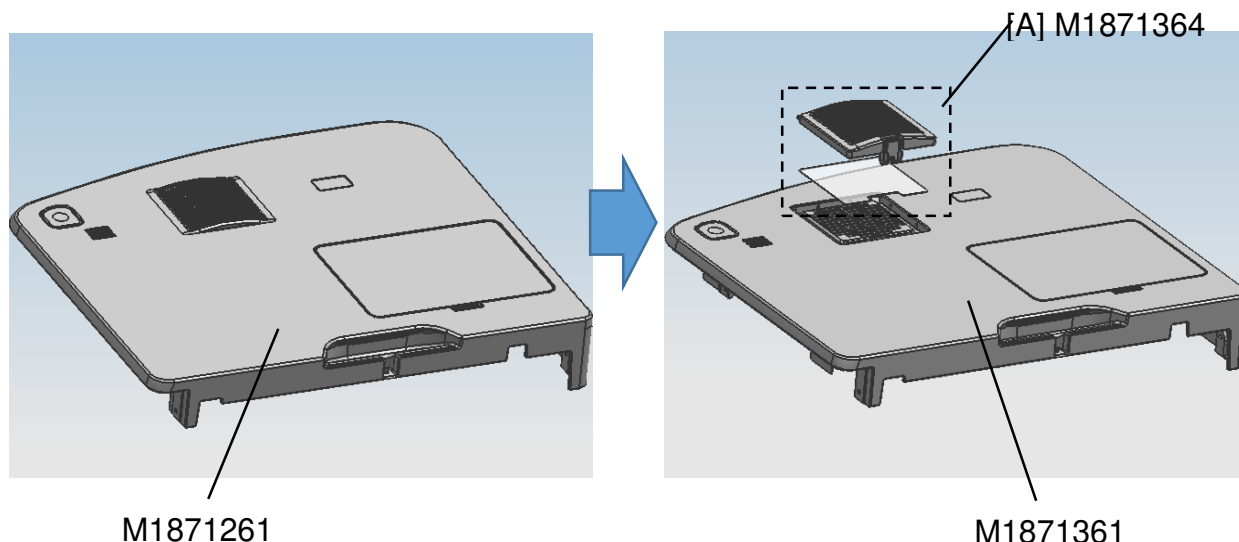
Reason: To prevent OPC damage caused by foreign objects entering through the air intake fan.

Note: This can cause vertical black lines on the image.

Change: The louver on the right cover was changed to a detachable air filter [A] from June 2016 production.

- Replace the filter periodically as part of the maintenance kit. This is because if a long duplex job is run with a clogged filter, the machine internal temperature will rise and cause toner dropping and/or image problems.
- The filter is included with the maintenance kit from June 2016 mass-production.
- When you install this filter on machines produced before June 2016, replace the right cover with the modified one (P/N M1871361).
