Model: AI-P1	Date: 13-Mar-08	No.: RG179001c
--------------	-----------------	----------------

Subject: Firmware Release Note: Network DocBox		Prepared by: K.Hamada	
From: 1st Overseas Tech Support Sec., 1st PQM Dept.			
Classification:	<input type="checkbox"/> Troubleshooting	<input type="checkbox"/> Part information	<input type="checkbox"/> Action required
	<input type="checkbox"/> Mechanical	<input type="checkbox"/> Electrical	<input type="checkbox"/> Service manual revision
	<input type="checkbox"/> Paper path	<input type="checkbox"/> Transmit/receive	<input type="checkbox"/> Retrofit information
	<input checked="" type="checkbox"/> Other (      )

This RTB has been issued to announce the firmware release information for the **Network DocBox**.

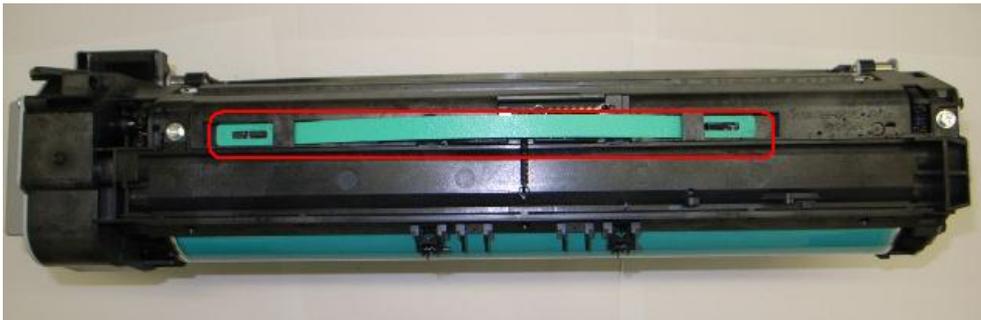
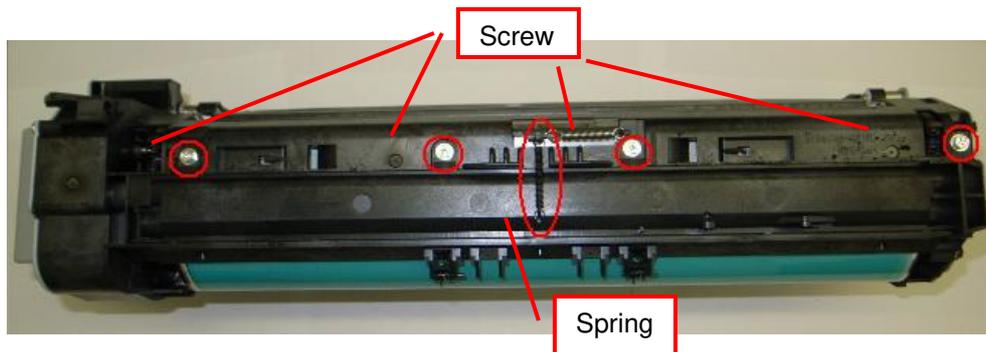
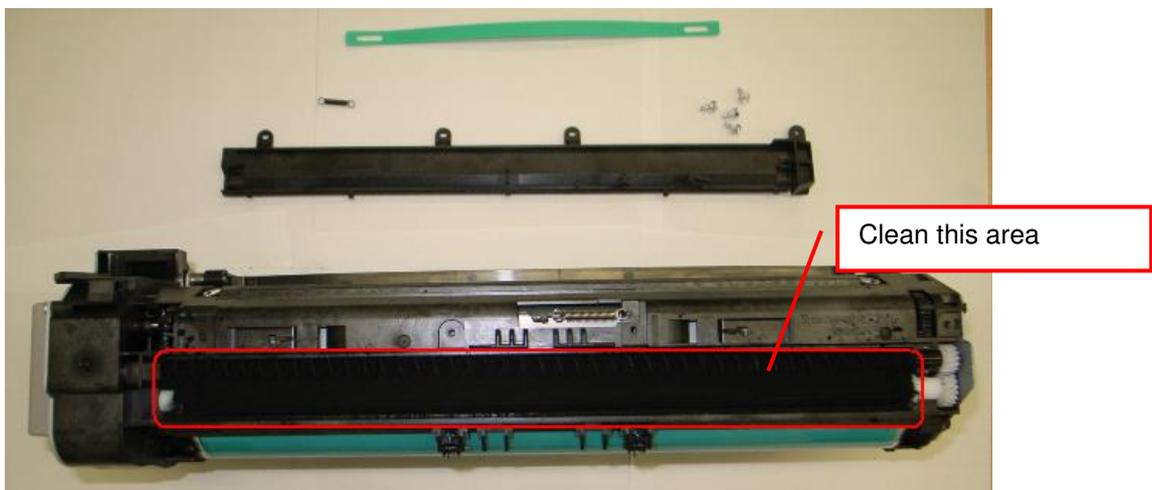
**I. Cleaning the pathway for recycled toner inside the PCDU**

**CAUSE**

When one of the following conditions is met, the chargeability of the toner is decreased, and the machine responds by increasing the toner concentration (TC). As a result, toner filming on the development roller is accelerated, and the poorly-charged toner is easily transferred onto the non-image areas of the OPC surface.

1. Turn the machine main power OFF.
2. Remove the PCDU.
3. Remove the green handle.

4. Remove 4 screws and 1 spring.

5. Remove the upper cover then clean out the recycled toner with a vacuum cleaner.

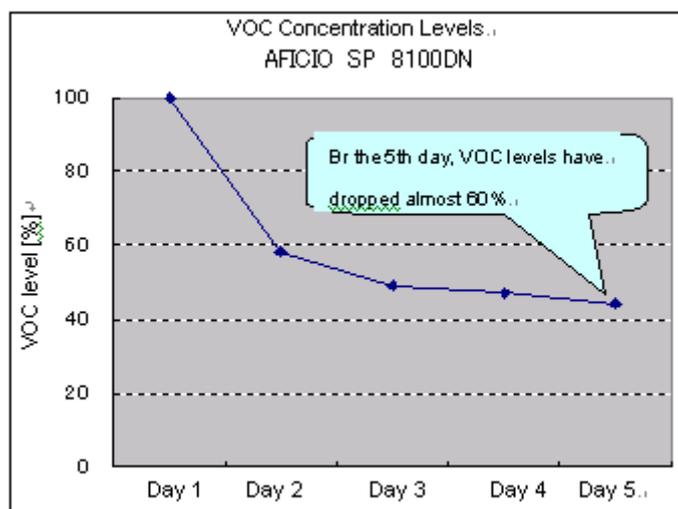
**Fig. 1**

- Volatile Organic Compounds (VOC) are particles of the component materials (glues, plastics, chemicals, etc.) that Ricoh devices are built with. VOC are the primary source of the odors produced by Ricoh devices, so tracking VOC levels produced by Ricoh devices is a good indicator of the strength of the odors. Figure 1 shows the VOC levels of a brand new Aficio SP 8100DN during the first 5 days of use. As the graph shows, the amount of VOC has dropped by almost 60%.

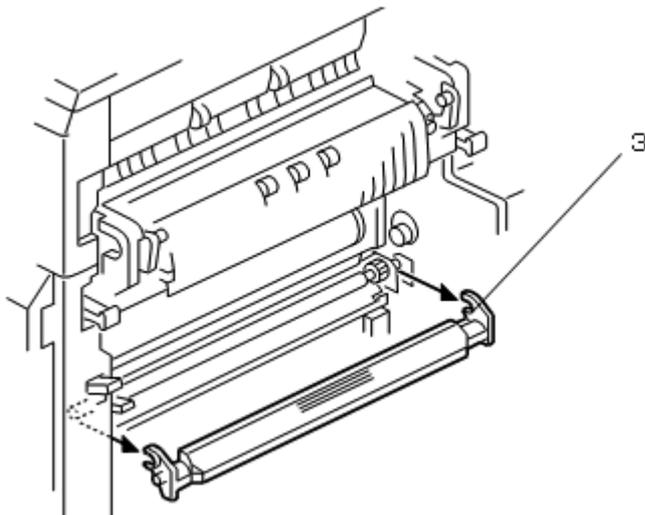
**Current method:**

The guide plate is fixed by mounting the ends of the shaft and fixing it in place with spring pressure.

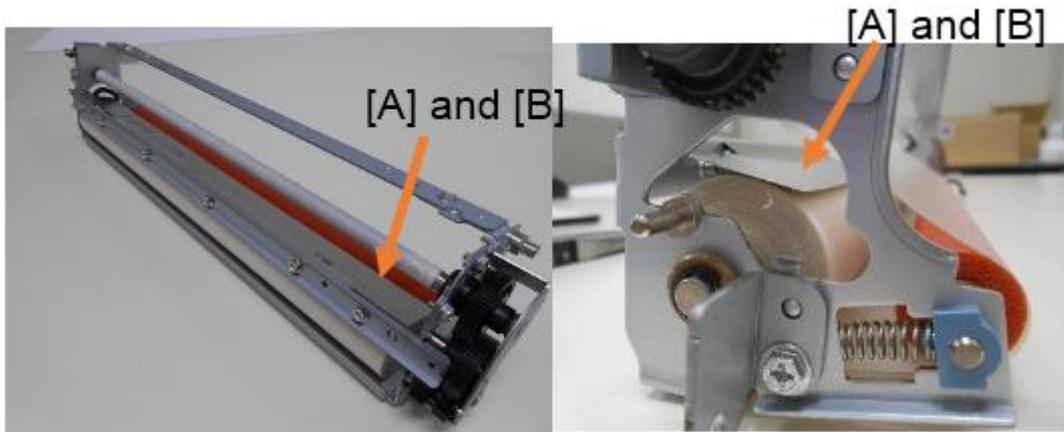
**For details of [1], please refer to the following pictures.**

[A] and [B] are the variable brake.

Please install a new cleaning unit (p/n: D1294304) when the cleaning web issue occurs, because individual parts are not compatible due to changing of the frame of the fusing unit. After that, individual parts can be replaced.

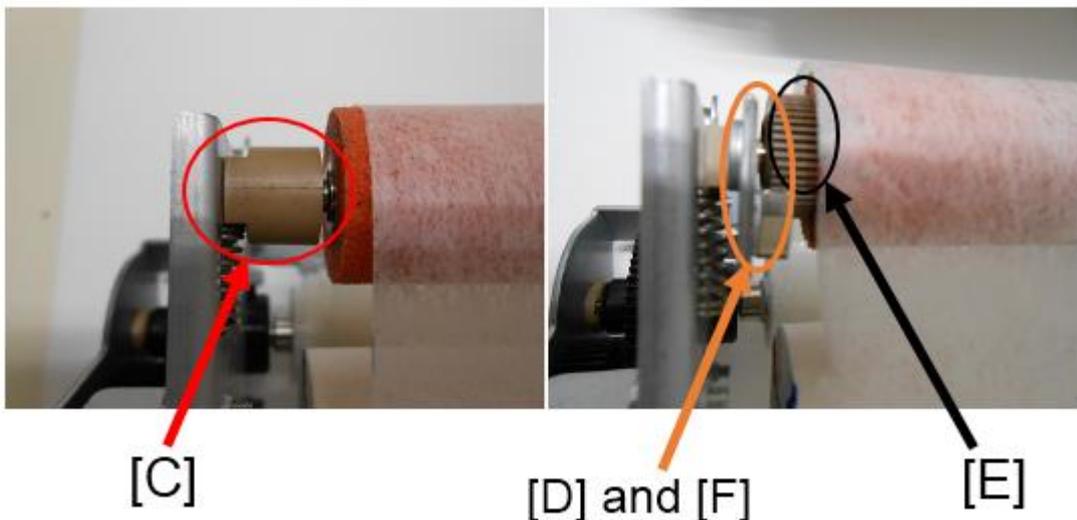
**For details of [2], please refer to the following picture.**

One-way clutch method was used before. Ratchet method is used after.

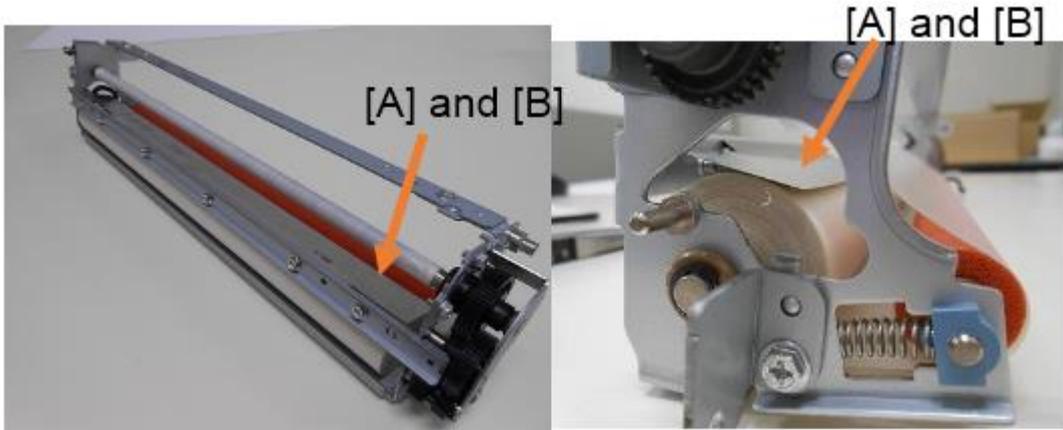
**[1] Variable brake**

[A] and [B] are the variable brake.

Please install a new cleaning unit (p/n: D1294304) when a cleaning web issue occurs, because individual parts are not compatible due to modification of a frame on the fusing unit. After that, individual parts can be replaced.

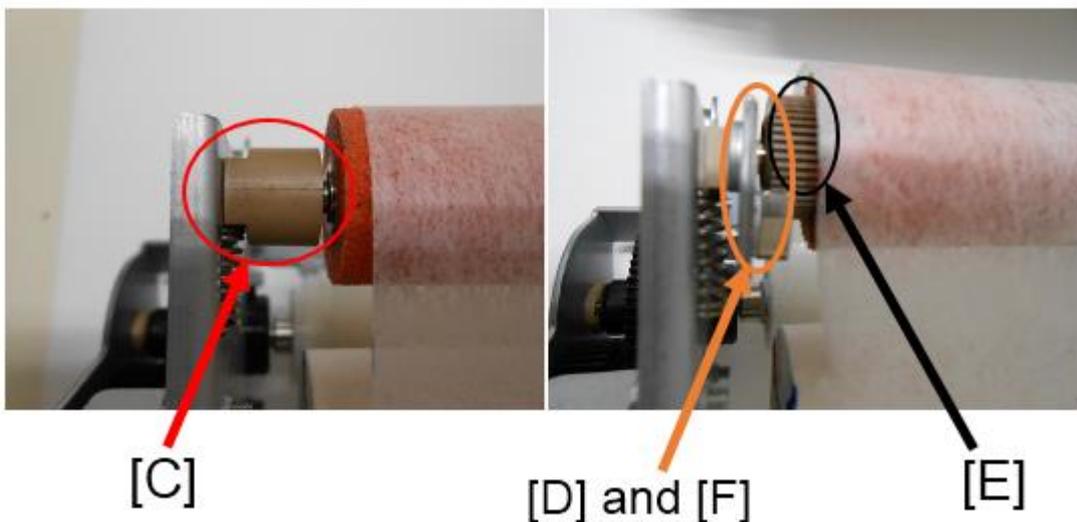
**[2]: One way clutch method**

One-way clutch method is before.  
One-way clutch method

Ratchet method is after.  
Ratchet method

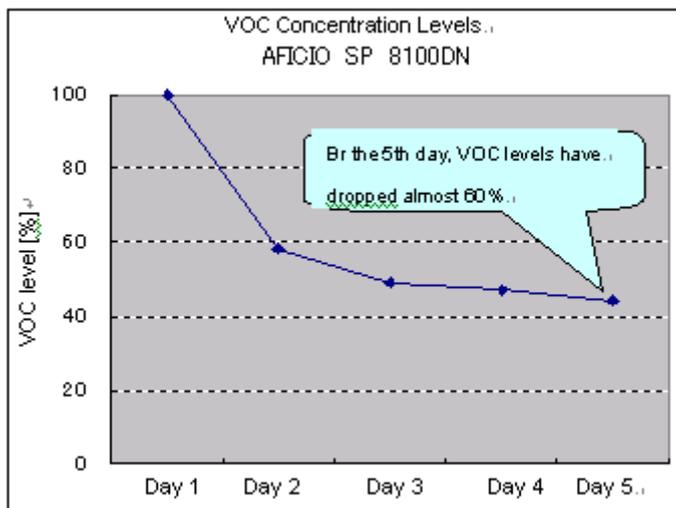
**Fig. 1**

- Volatile Organic Compounds (VOC) are particles of the component materials (glues, plastics, chemicals, etc.) that Ricoh devices are built with. VOC are the primary source of the odors produced by Ricoh devices, so tracking VOC levels produced by Ricoh devices is a good indicator of the strength of the odors. Figure 1 shows the VOC levels of a brand new Aficio SP 8100DN during the first 5 days of use. As the graph shows, the amount of VOC has dropped by almost 60%.
