Model: AI-P2	Date: 28-Sep-12	No.: RM132001a
--------------	-----------------	----------------

Subject: Firmware Release Note: Engine		Prepared by: T. Hirakawa	
From: 2nd Tech Service Sect., MFP/Printer Tech Service Dept.			
Classification:	<input type="checkbox"/> Troubleshooting <input type="checkbox"/> Mechanical <input type="checkbox"/> Paper path <input type="checkbox"/> Product Safety	<input type="checkbox"/> Part information <input type="checkbox"/> Electrical <input type="checkbox"/> Transmit/receive <input checked="" type="checkbox"/> Other (Firmware)	<input type="checkbox"/> Action required <input type="checkbox"/> Service manual revision <input type="checkbox"/> Retrofit information <input checked="" type="checkbox"/> Tier 2

This RTB has been issued to announce the firmware release information for the **Engine**.

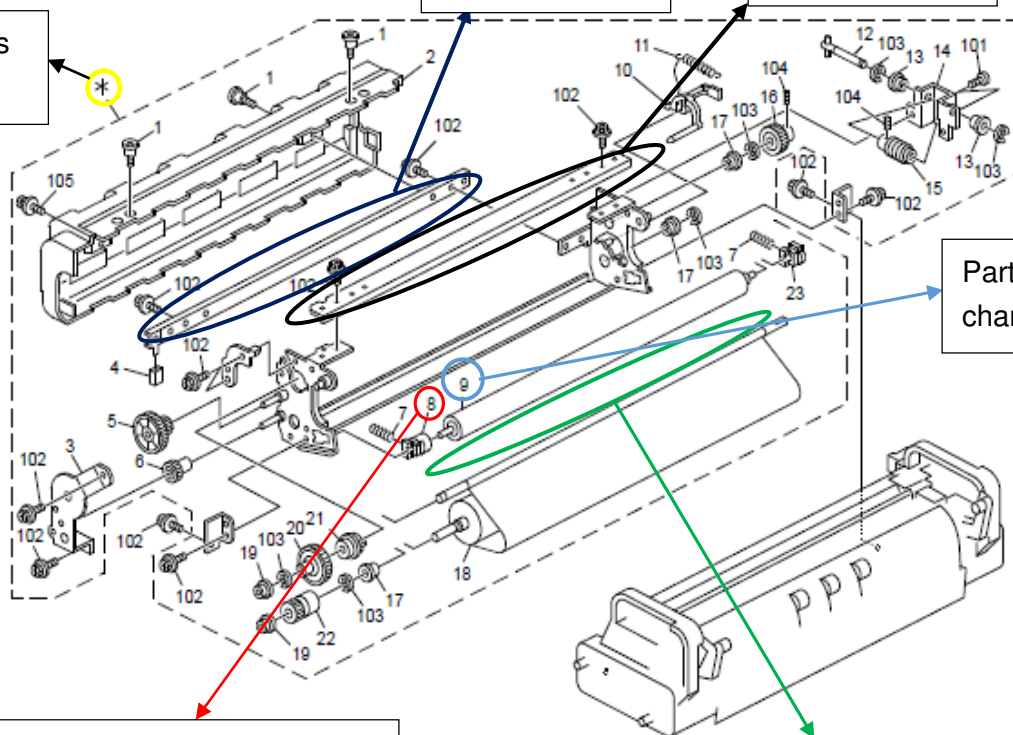
Change/Reason: To prevent the cleaning web from coming loose, the following parts are changed or newly added to the fusing unit.

29** is added.

30** is added.

Part number is changed

This is deleted.
Instead, 26** and 27** and
28** are added for [2].

Please install a new cleaning unit (p/n: D1294304) when a cleaning web issue occurs, because individual parts are not compatible due to modification of a frame on the fusing unit. After that, individual parts can be replaced.

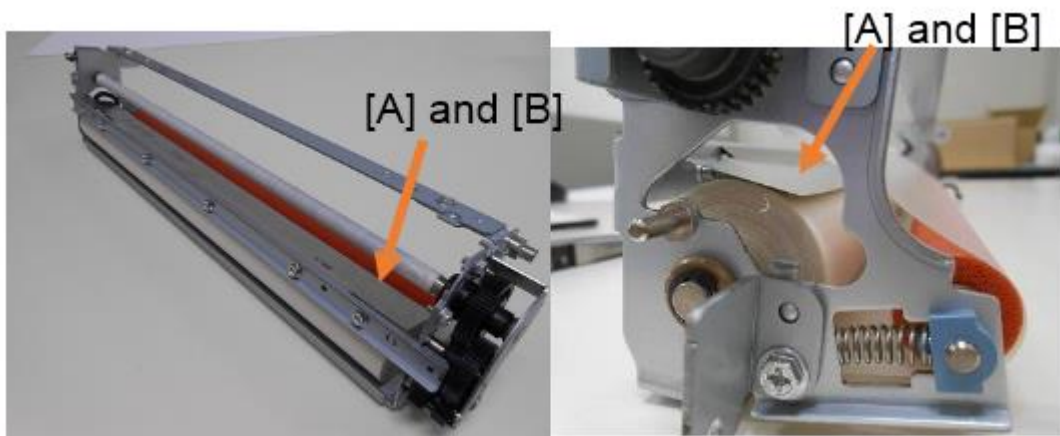
[1] Variable brake

[A] and [B] are the variable brake.

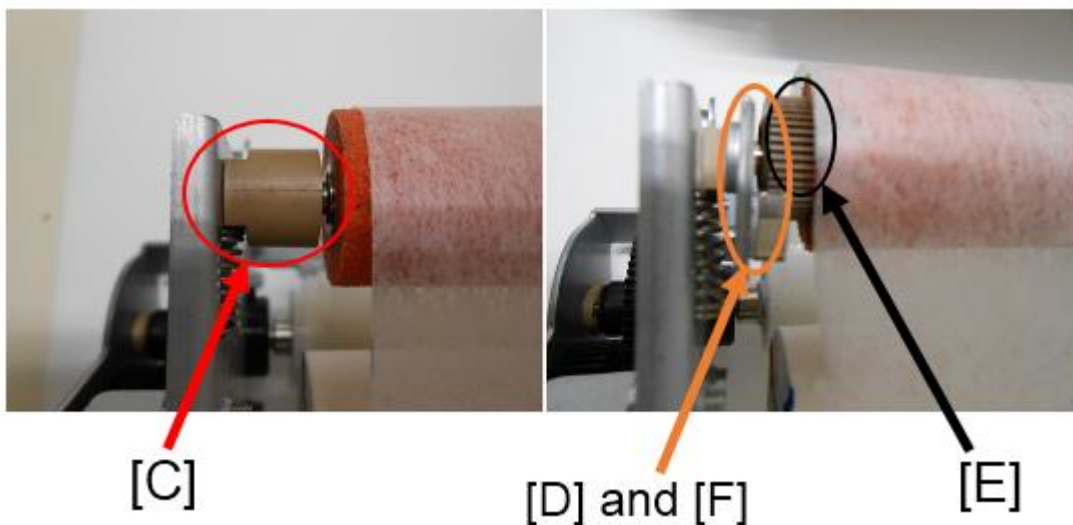
Ratchet method is after.

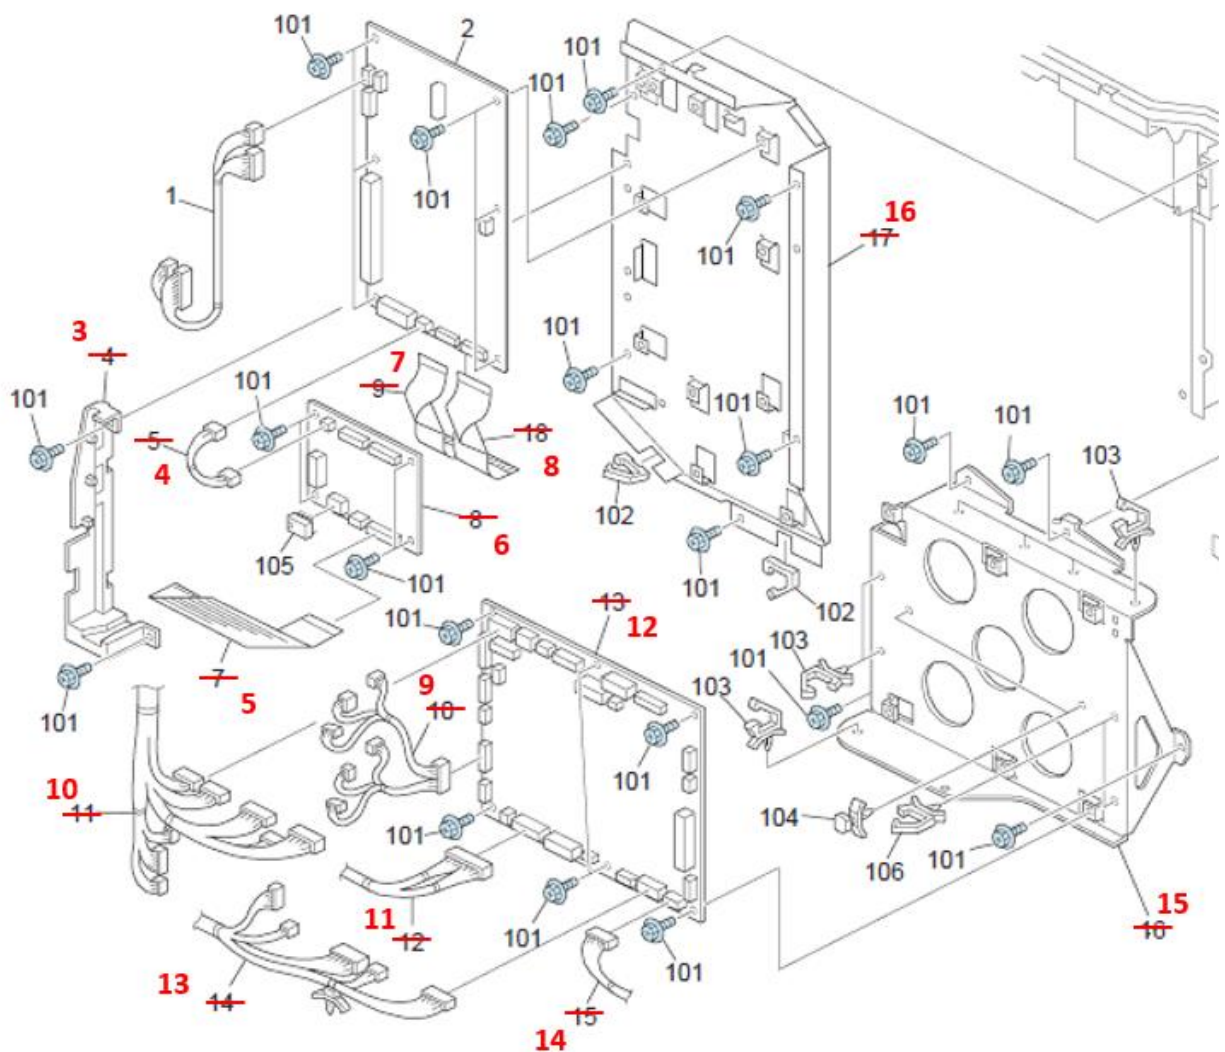
31. Electrical Section 4 (M132)

The index numbers in Electrical Section 4 (page.61) were corrected as follows.

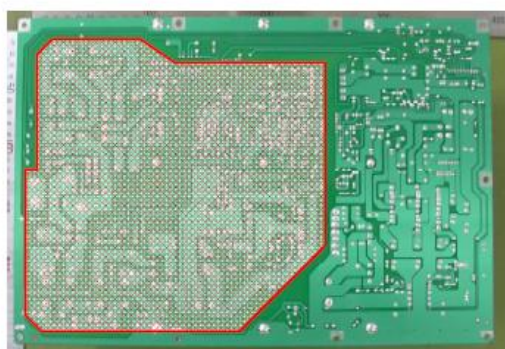
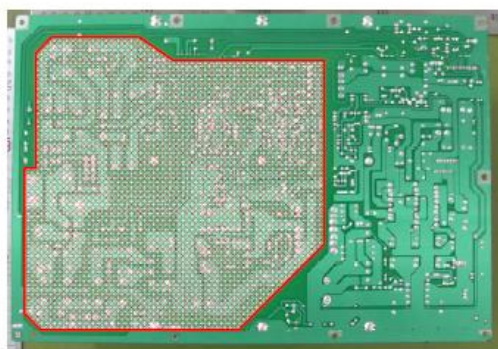
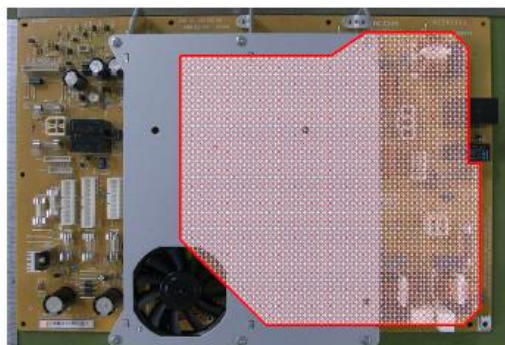
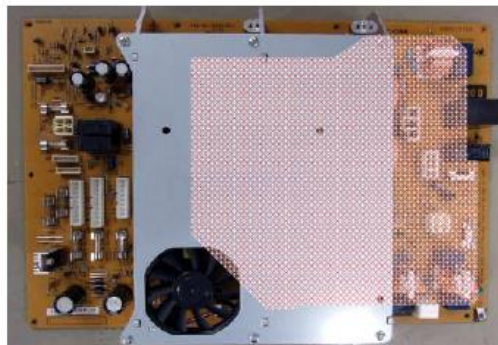
NEVER touch the areas outlined in red in the photos below to prevent electric shock caused by residual charge.

The areas outlined in red on the bracket show where the residual charge of about 100V-400V remains on the PSU board under the bracket.

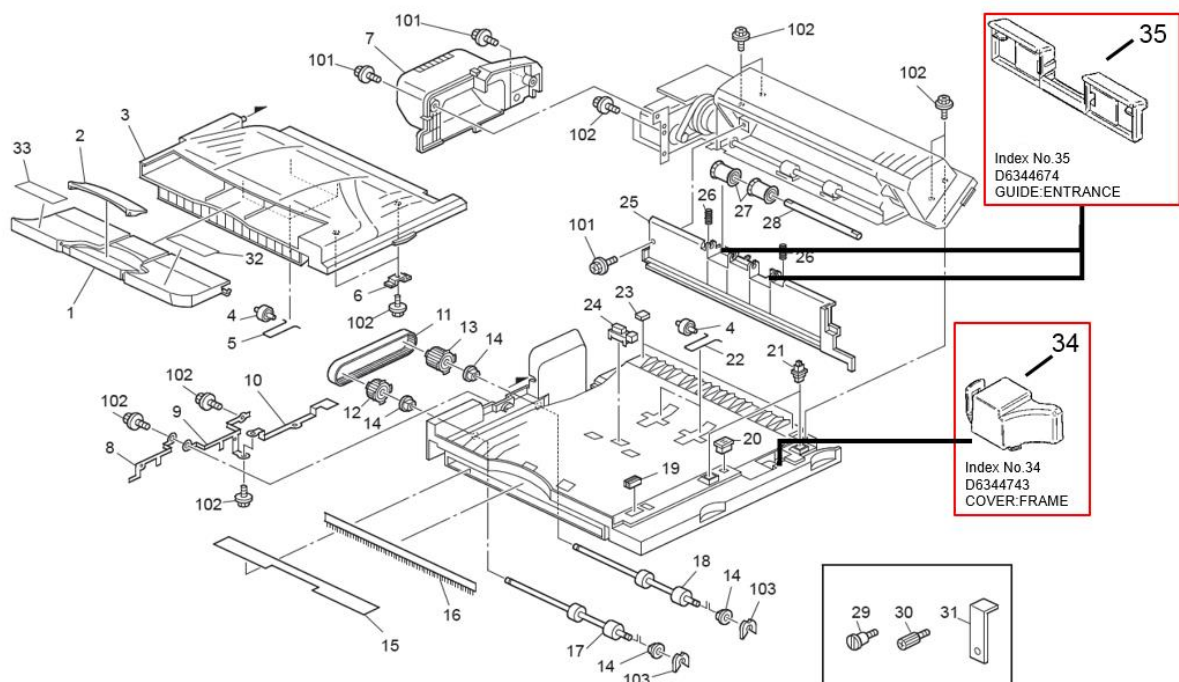
1.BRIDGE UNIT 1 (D634)

Part number	Description	Q'ty	Page	Index	Note
D6344743	COVER:FRAME	1	3	34	
D6344674	GUIDE:ENTRANCE	1	3	35

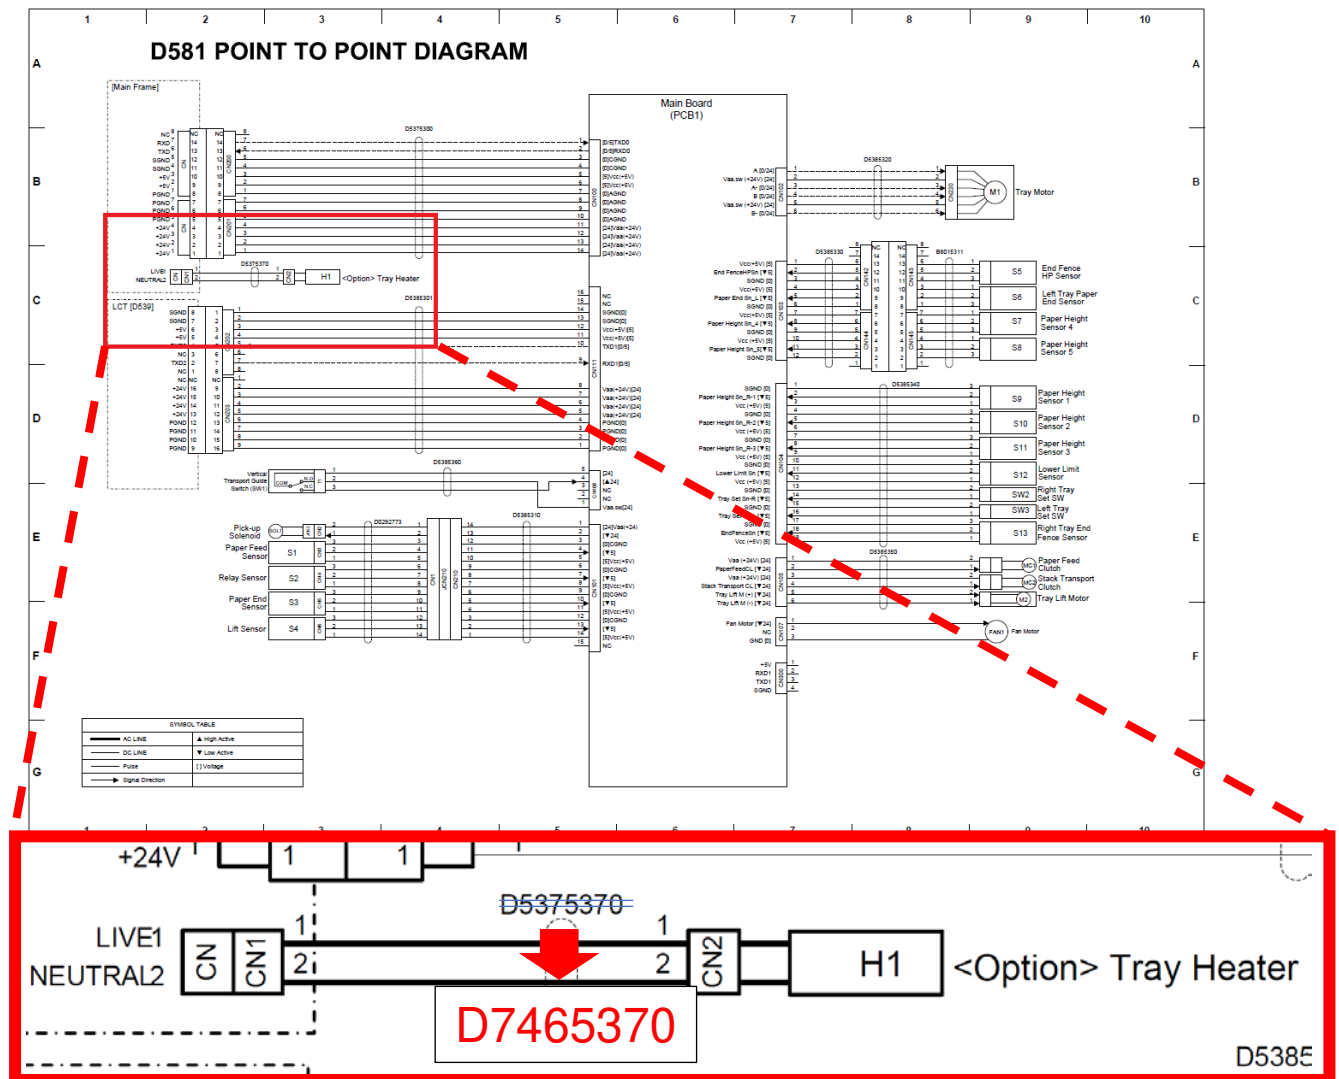
The part number (D5375370) of the Tray Heater's harness is old.
The correct part number is D7465370 shown in the figure below.
