Model: Cor-P1.5			Date: 9	-Jun-17	No.: RM0AN001
Subject: Notice P1.5	for Mailbox CS3010 attack	Prepared I	by: Y.Taniguchi		
From: 1st FQM S	ect., 1st FQM Dept.				
Classification:					required e manual revision it information

Important Notice about Installing the Mailbox CS3010

Technical Bulletin

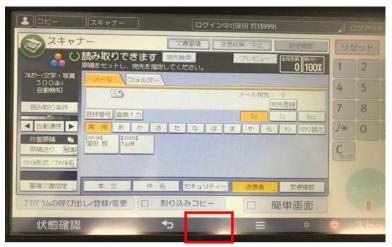
• This is because there is a bug with the operation panel feature.

With firmware combination #3 below, the Home button is not displayed, making it impossible to switch between applications.

• To ensure this does not occur, downgrade the Legacy UI to ver. 1.22. Update the Cheetah System to 1.31 or newer.
