Model: Model PE –P1/MF1		Date: 28-Dec-07	No.: RG165001a
Subject: Firmware History - Engine		Prepared by: H.K.	
From: 1st Tech. Support Sec. Service Support Dept.			
Classification:	<input type="checkbox"/> Troubleshooting <input type="checkbox"/> Part information <input type="checkbox"/> Action required <input type="checkbox"/> Mechanical <input type="checkbox"/> Electrical <input type="checkbox"/> Service manual revision <input type="checkbox"/> Paper path <input type="checkbox"/> Transmit/receive <input type="checkbox"/> Retrofit information <input checked="" type="checkbox"/> Other (Firmware History)

Model: Model PE -P1/MF1		Date: 15-Jan-08	No.: RG165002
Subject: Firmware History - Main Control Unit		Prepared by: H.K.	
From: 1st Tech. Support Sec. Service Support Dept.			
Classification:	<input type="checkbox"/> Troubleshooting <input type="checkbox"/> Part information <input type="checkbox"/> Action required <input type="checkbox"/> Mechanical <input type="checkbox"/> Electrical <input type="checkbox"/> Service manual revision <input type="checkbox"/> Paper path <input type="checkbox"/> Transmit/receive <input type="checkbox"/> Retrofit information <input checked="" type="chec

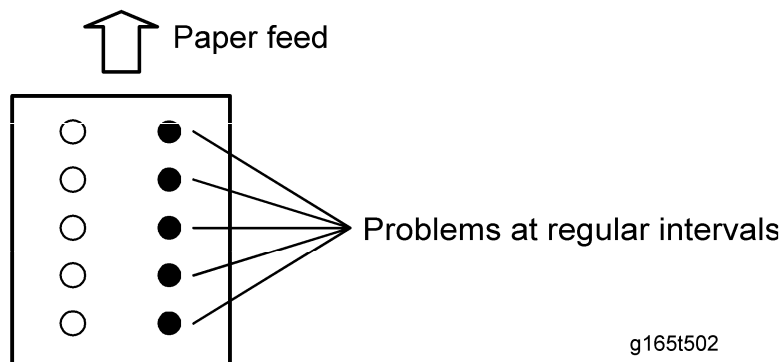
Image problems may appear at regular intervals that depend on the circumference of certain components. The following diagram shows the possible symptoms (black or white dots at regular intervals).

- Abnormal image at 24-mm intervals: Paper feed roller
- Abnormal image at 25.5-mm intervals: Image transfer belt unit
- Colored spots at 27-mm intervals: Print cartridge (Development roller)
- Abnormal image at 30-mm intervals: Charge roller
- Abnormal image at 38-mm intervals: Registration roller
- Abnormal image at 60-mm intervals: Transfer roller
- Colored spots at 76-mm intervals: Print cartridge (OPC drum)
- Abnormal image at 110-mm intervals: Fusing unit (Pressure roller)
- Abnormal image at 115.5-mm intervals: Fusing unit (Heat roller)

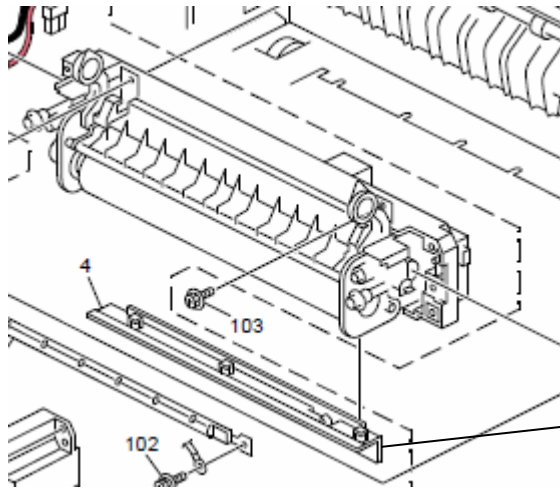
Fusing Entrance Guide - LOWER

A fusing jam occurs and the lower fusing entrance guide (G1664072) breaks.

If this is reported from the field, advise operators that they must lower the fusing unit lever before they removed jammed paper. If the fusing entrance guide has been damaged, replace it.

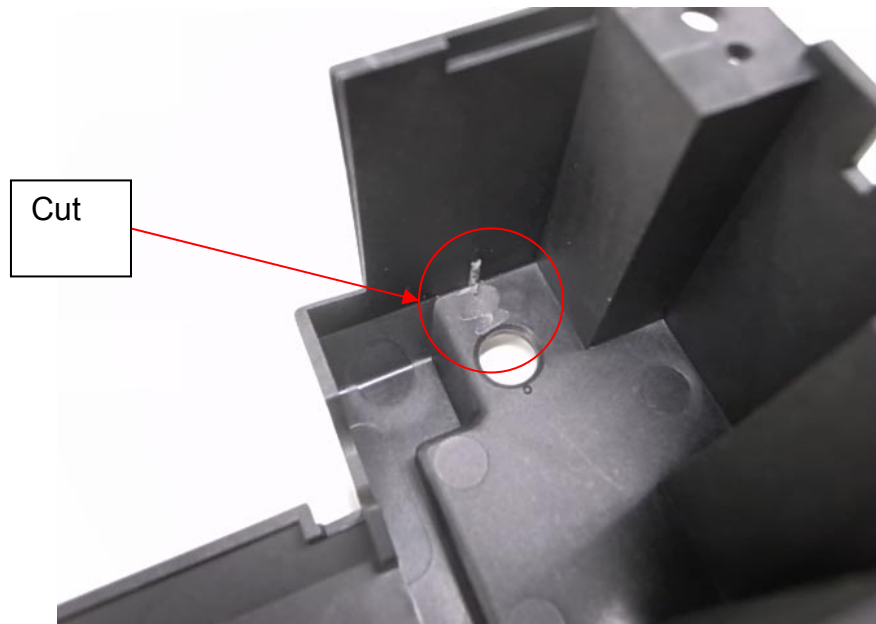
When you are replacing the front cover, if there is a rib on the cover (see the photo of the "New front cover" below), cut off the rib using a pair of needle-nose pliers.

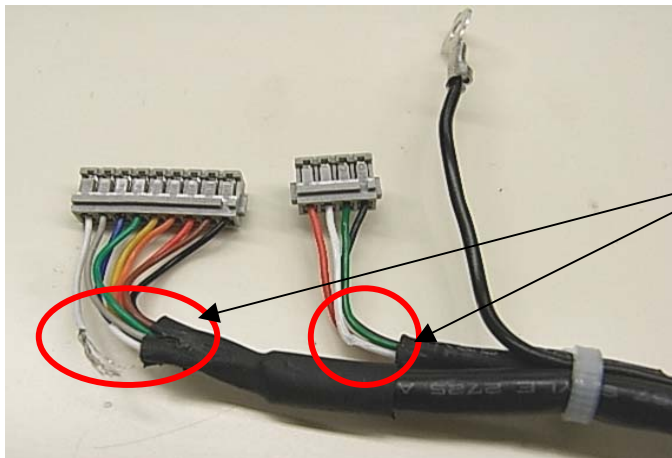
Pinched Scanner Interface Harness

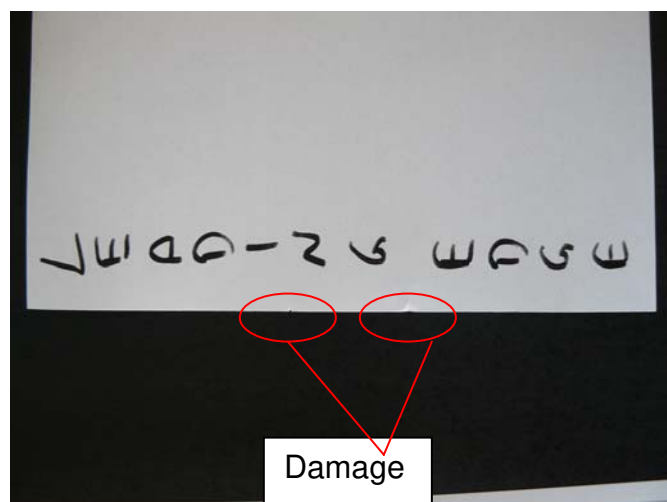
The leading edge of the original may sometimes be damaged when feeding from the ADF.

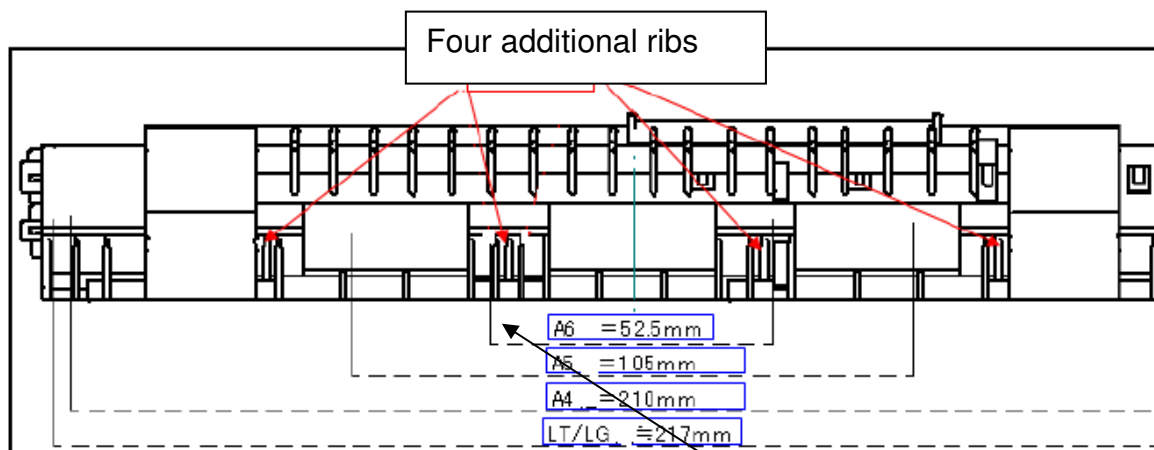
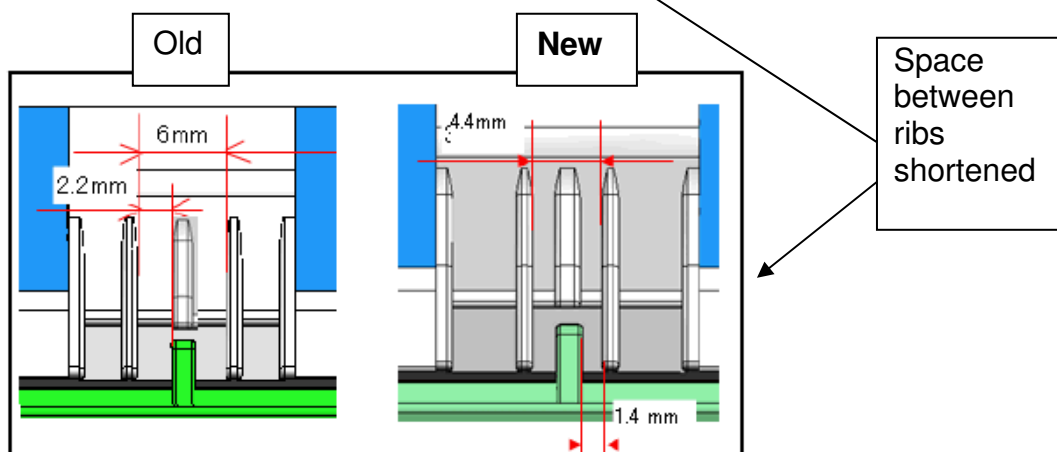
Four ribs added to Guide:Feed:Driven

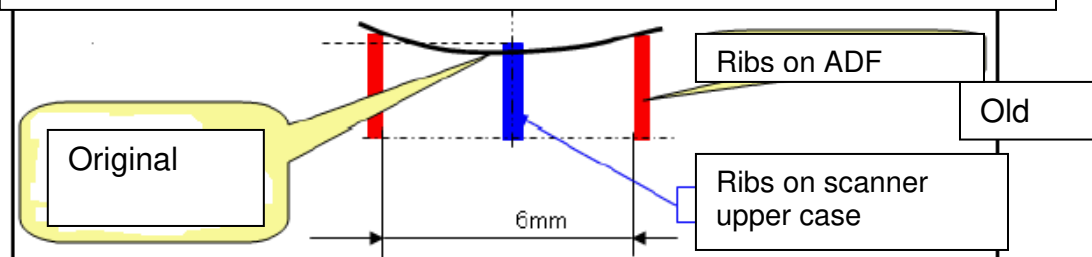
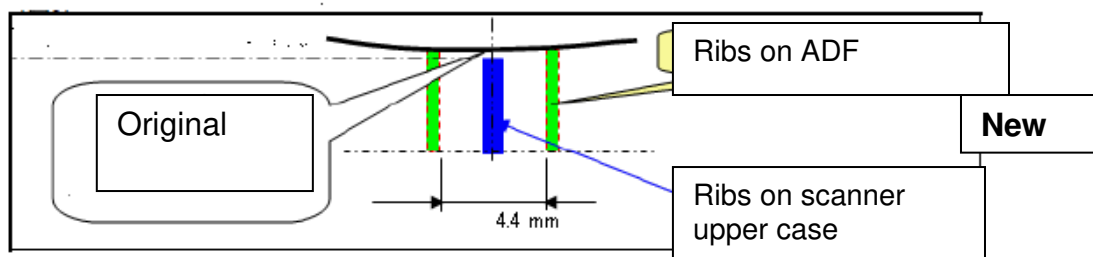
Height of ribs on ADF increased by 1 mm

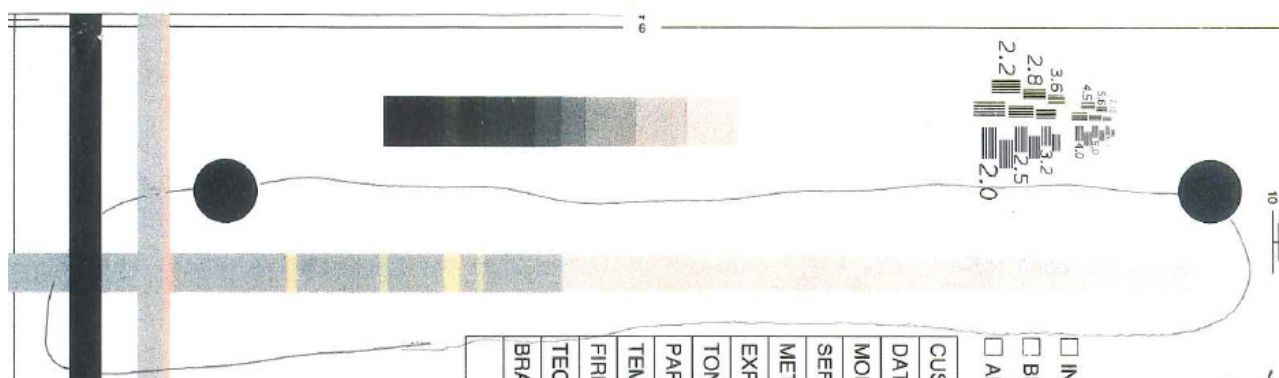
White or colored stripes may appear on copies.

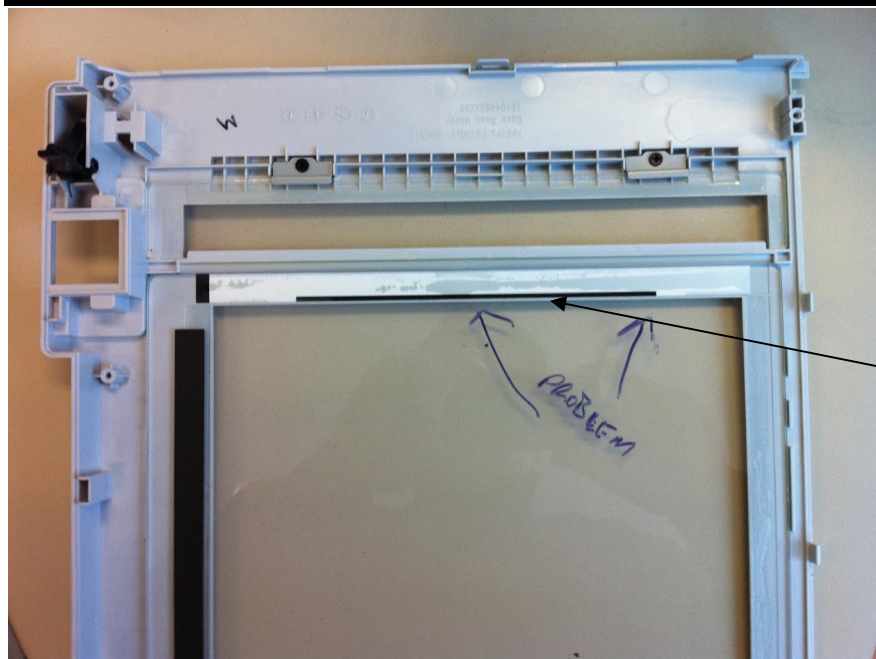
Glue melted
