Model: MD – P1	Date: 21-Jan-09	No.: RM040001f
----------------	-----------------	----------------

Subject: Firmware Release Note: Engine		Prepared by: H.K.	
From: 2nd Overseas Tech Support Sec. 2nd PQM Dept			
Classification:	<input type="checkbox"/> Troubleshooting	<input type="checkbox"/> Part information	<input type="checkbox"/> Action required
	<input type="checkbox"/> Mechanical	<input type="checkbox"/> Electrical	<input type="checkbox"/> Service manual revision
	<input type="checkbox"/> Paper path	<input type="checkbox"/> Transmit/receive	<input type="checkbox"/> Retrofit information
	<input type="checkbox"/> Product Safety	<input checked="" type="checkbox"/> Other (Firmware)	<input checked="" type="checkbox"/> Tier 2

Model: Model MD-P1		Date: 15-May-09	No.: RM040003
Subject: SPACER		Prepared by: H.K.	
From: 1st Tech. Support Sec. Service Support Dept.			
Classification:	<input type="checkbox"/> Troubleshooting <input checked="" type="checkbox"/> Part information <input type="checkbox"/> Action required <input type="checkbox"/> Mechanical <input type="checkbox"/> Electrical <input type="checkbox"/> Service manual revision <input type="checkbox"/> Paper path <input type="che

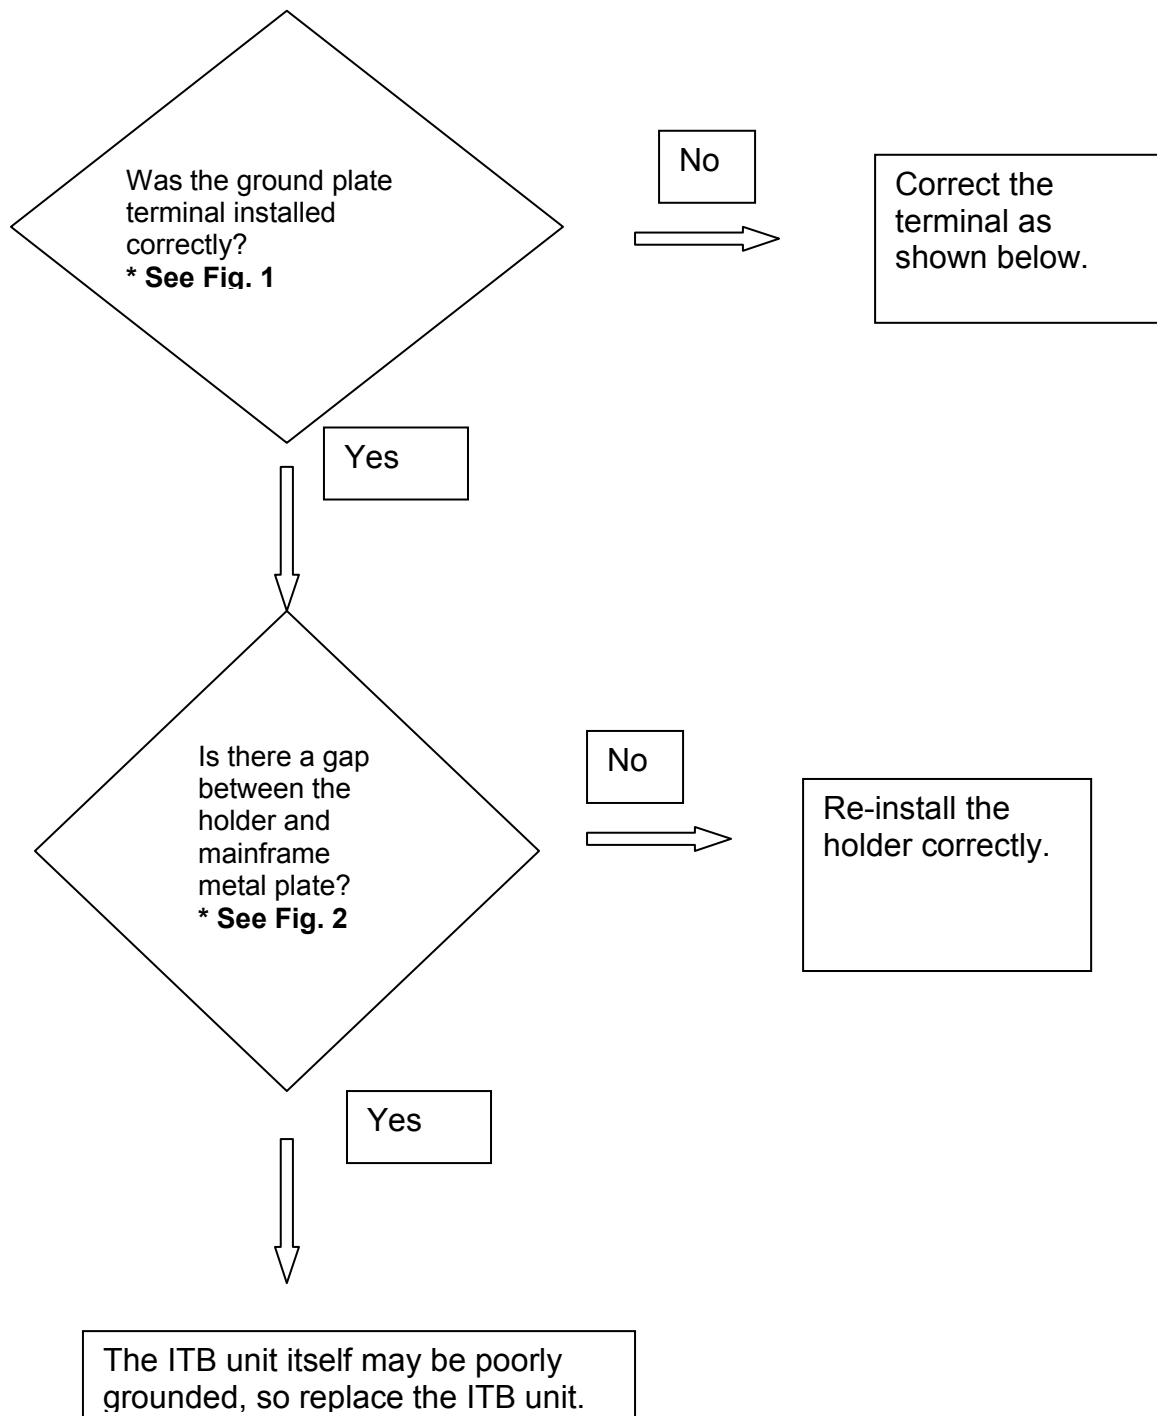
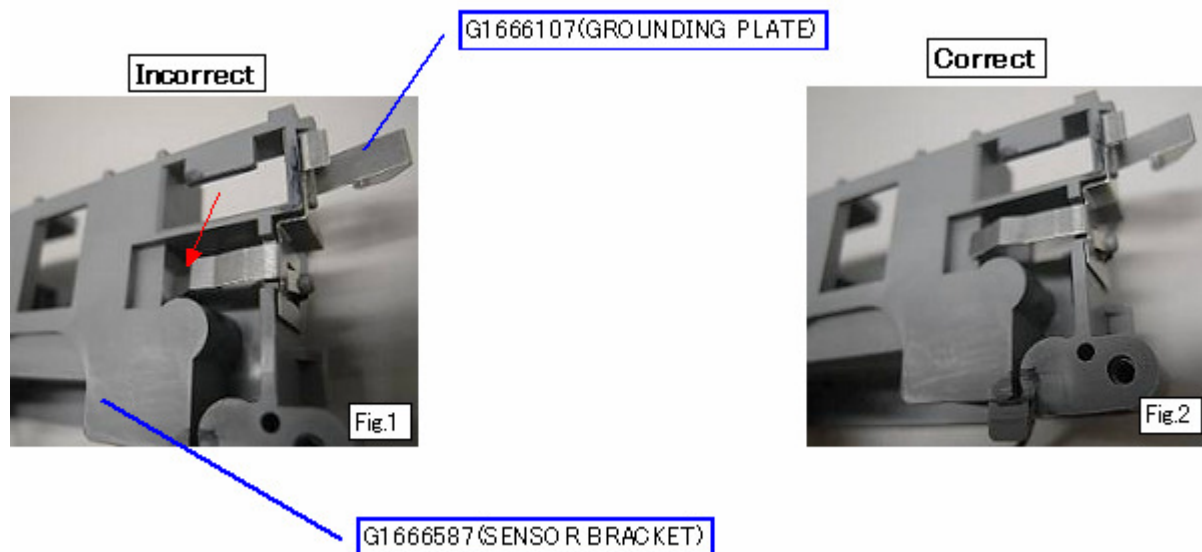
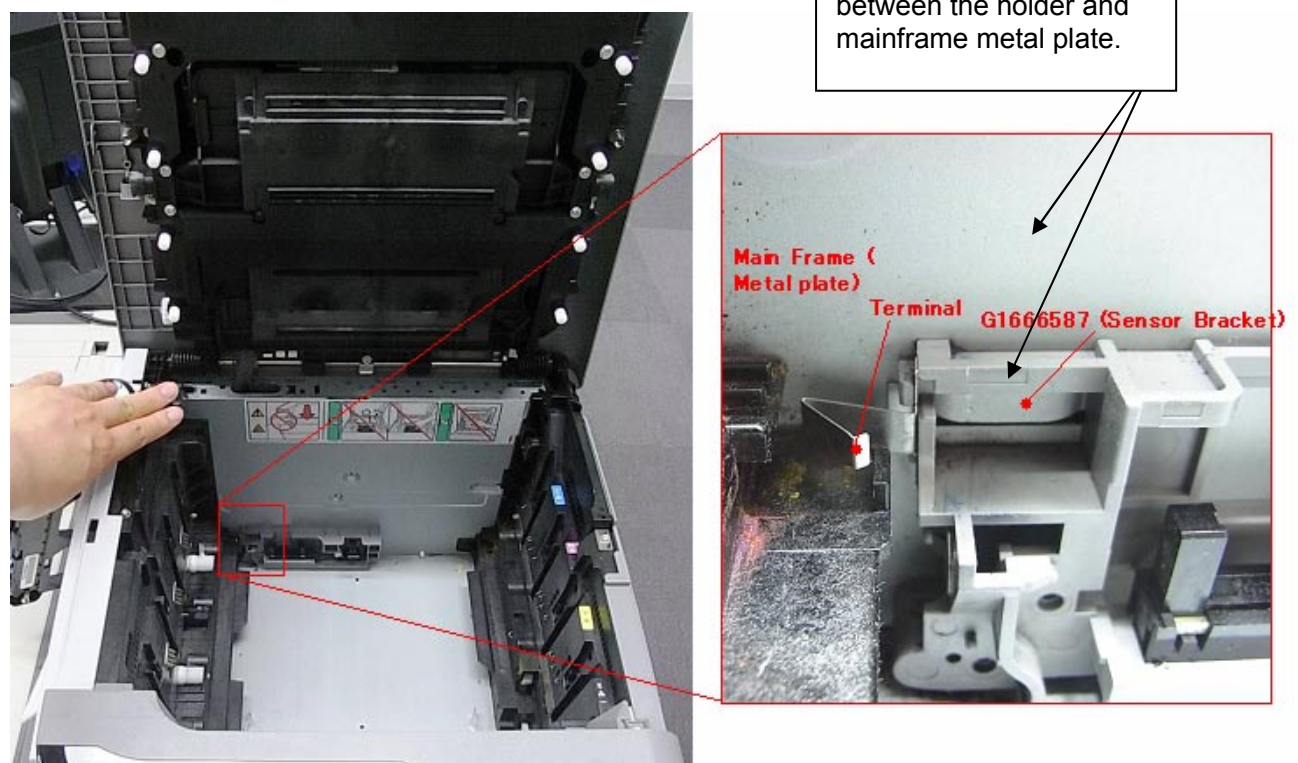
Figure 1

The alert message, "Reset the (random color/s) print cartridge" is displayed, but the cartridges in question do not need to be reset. If this occurs during printing, the paper jam alert message is also displayed.

Poor grounding of the ITB (image transfer belt)

1. Remove all AIO cartridges.
2. Remove the transfer unit.
3. Remove the lower fusing entrance guide (1 hook).
4. Remove the waste toner bottle.

5. Follow the flowchart below to check the ground plate terminal and sensor bracket:

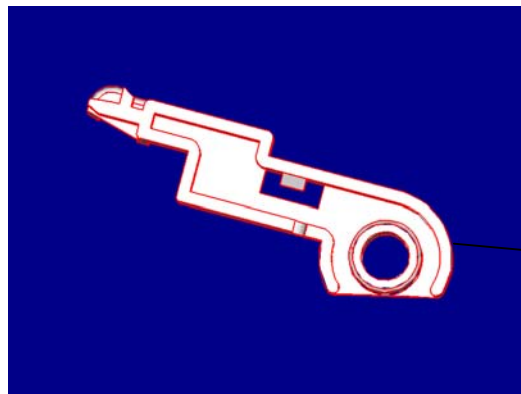
Interlock switch arm

The interlock switch arm (G1665747) breaks, which causes the torsion spring to open up too far. As a result, the interlock switch lever cannot be shifted and the interlock switches are not released, preventing the machine from detecting the cover open condition.

Replace the interlock switch arm with a new one (G1665754).

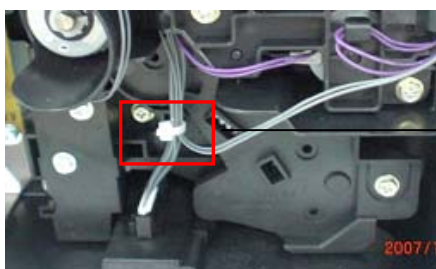
- 1) Cut the bind of the harness shown below. This is because the harness will be too short when the new parts are attached.**

Cut the bind.

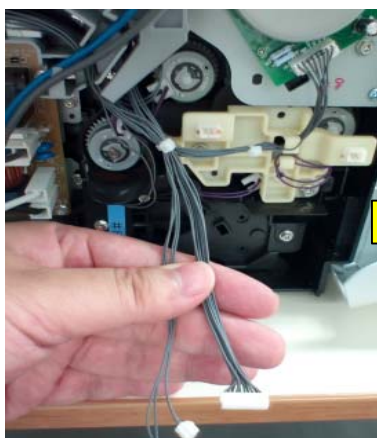
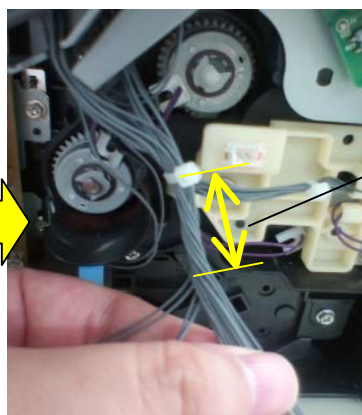
- 2) Twist the harness three or four times as shown below.**

Twist the harness 3 or 4 times as shown.

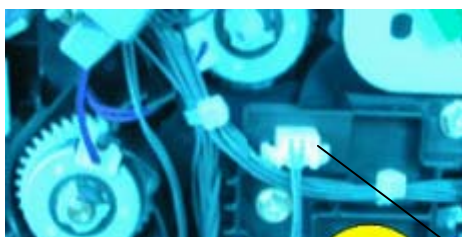
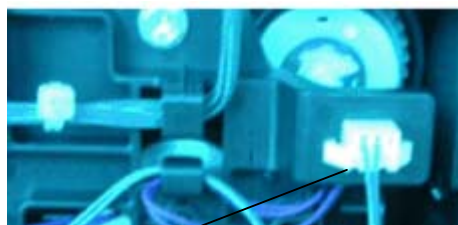
- 3) Connect the connectors as shown below.**

Connect the connectors.

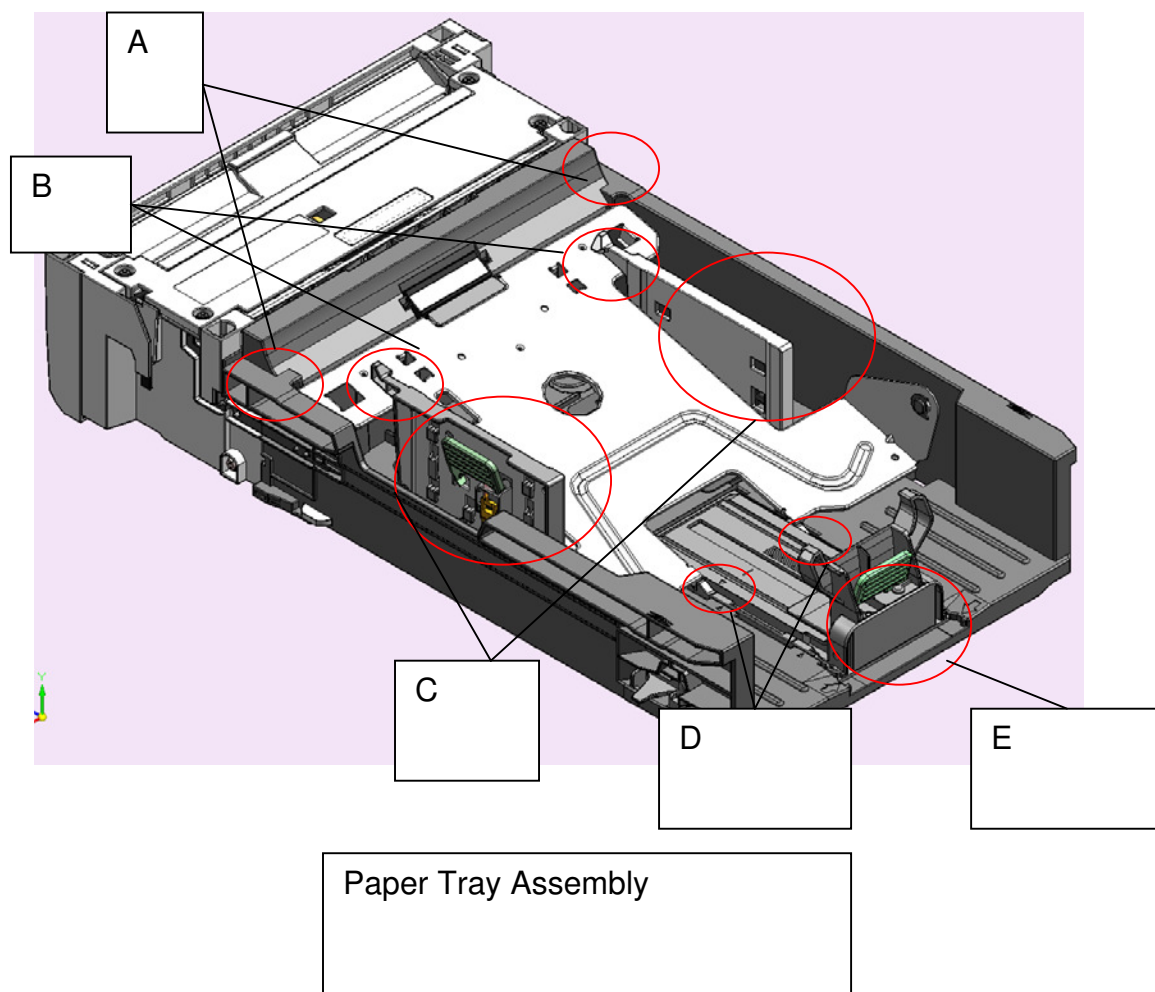
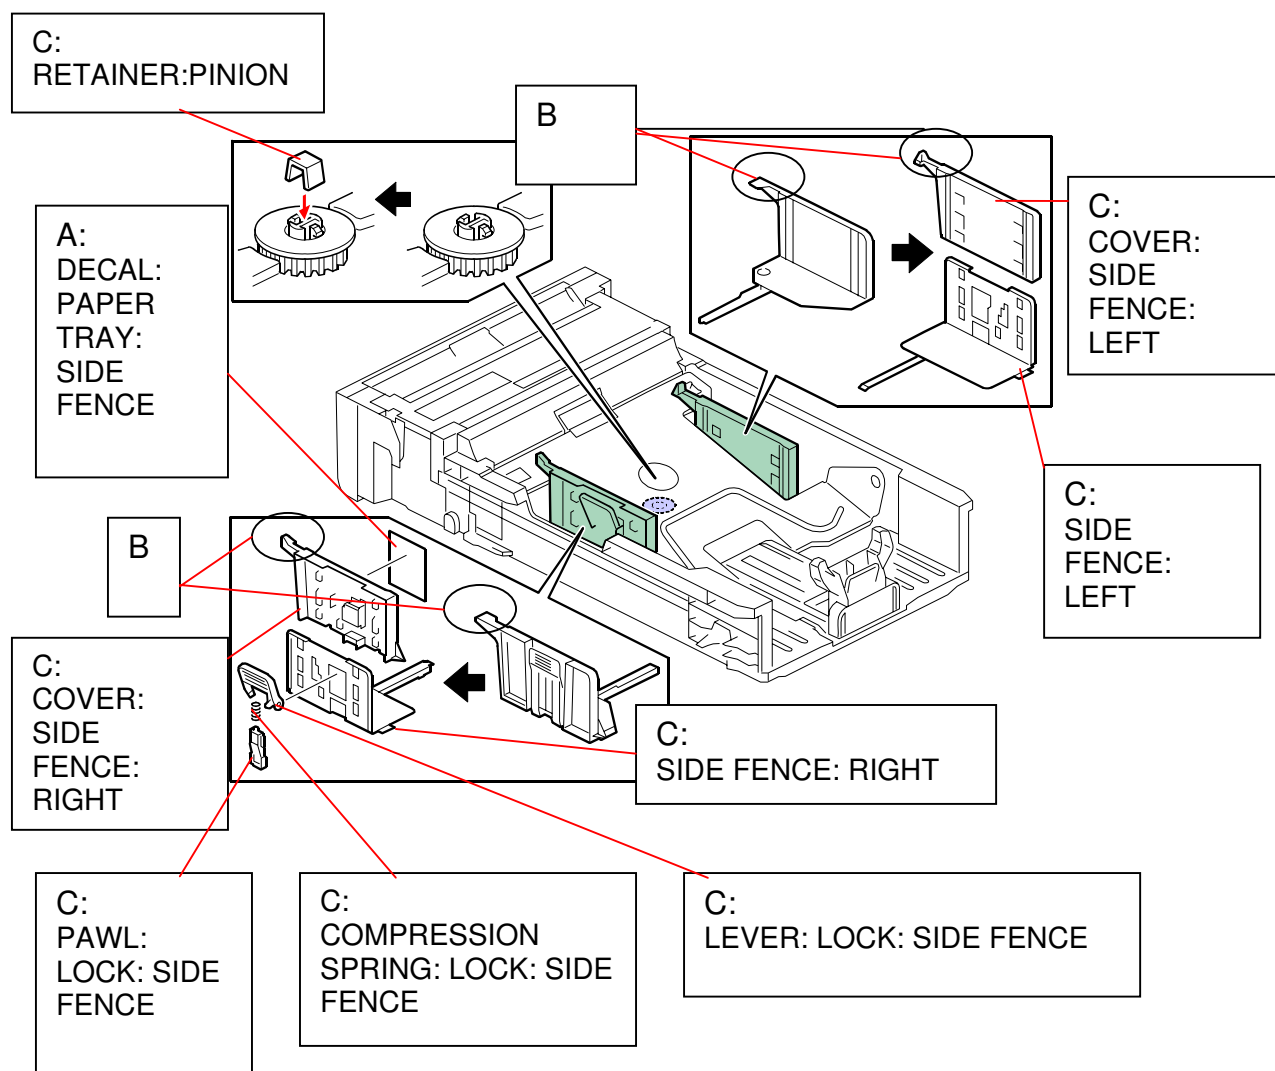
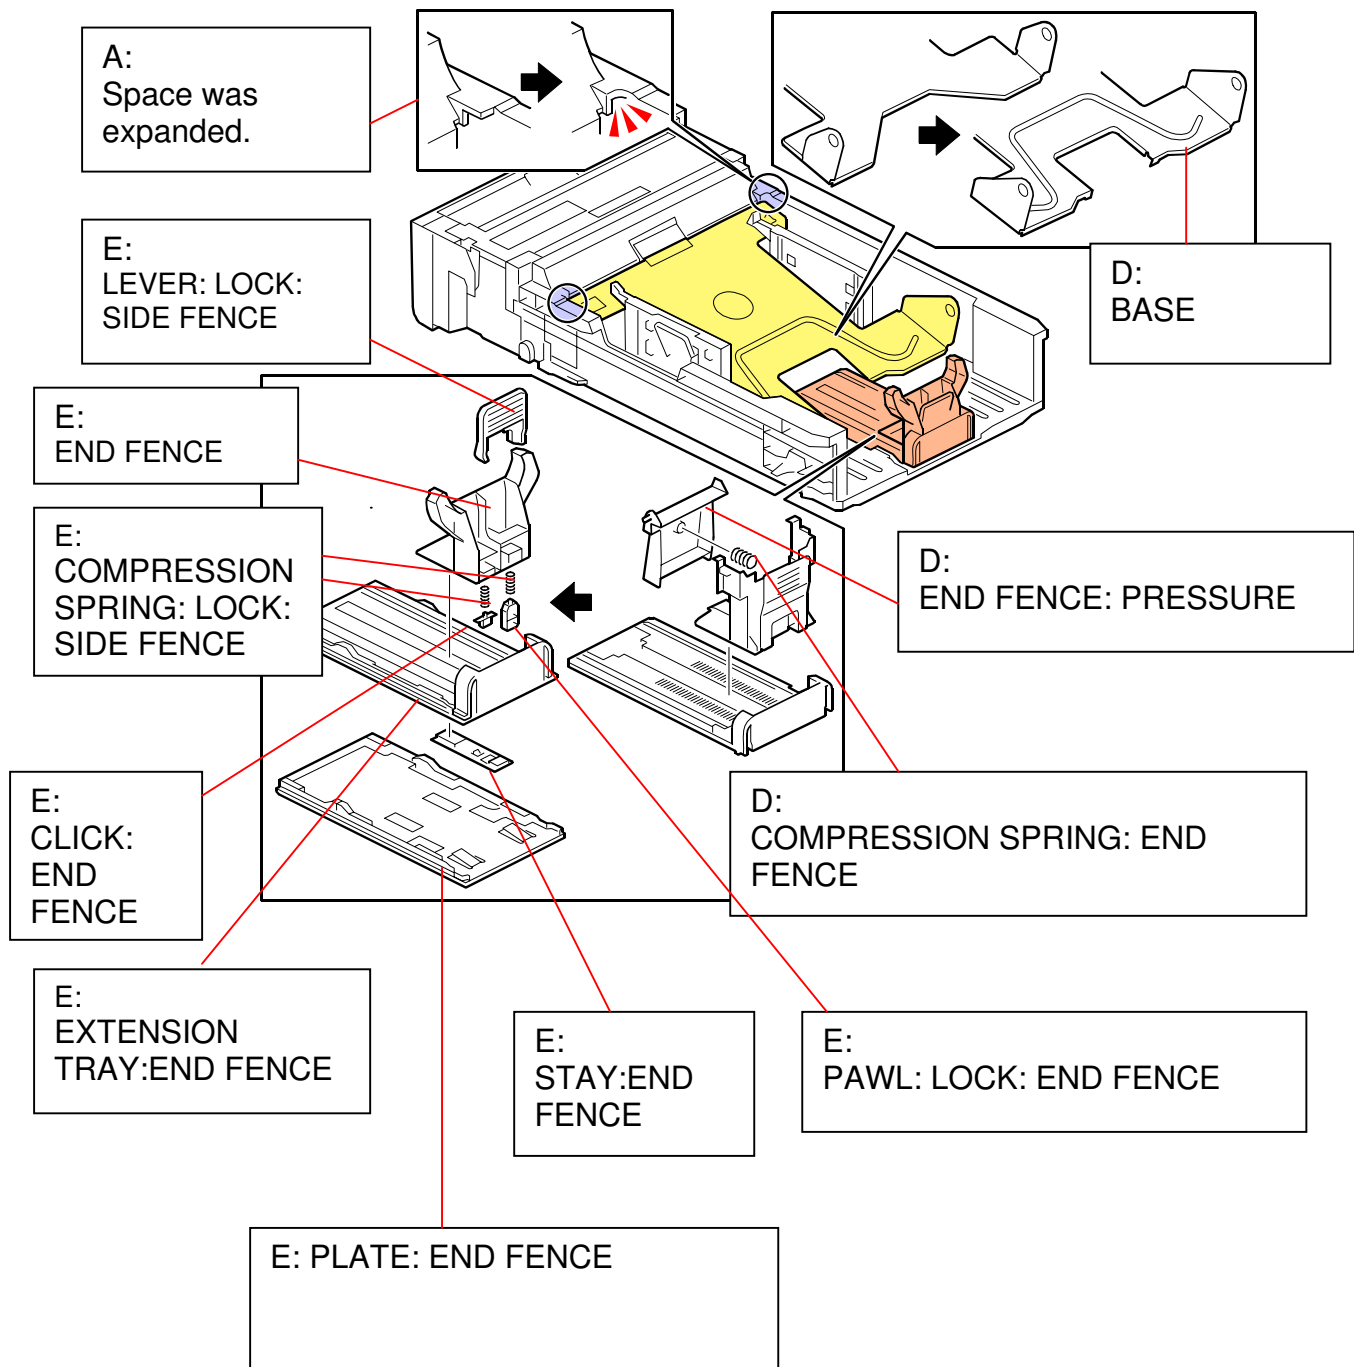
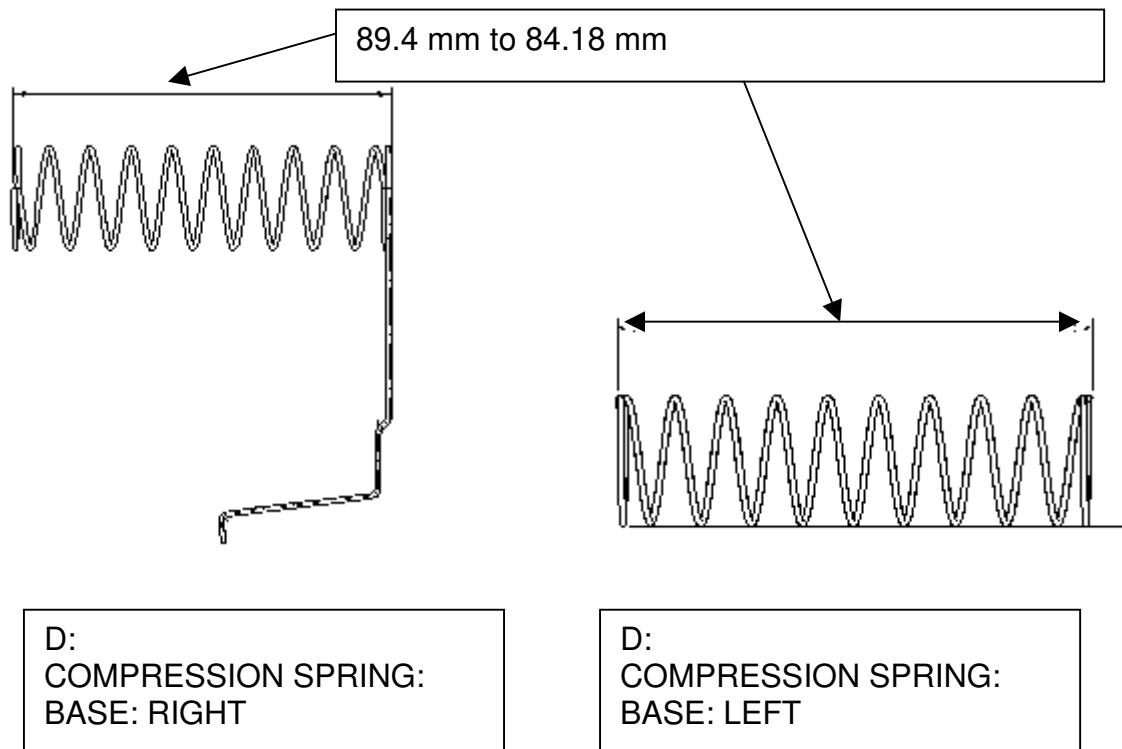
Change: The shapes of the paper tray components were changed.**Reason:**

The space for loading paper in the paper cassette assembly was expanded. Also, a decal was added to the right fence (lever side).

The shapes of the tips of the side fences were changed.

The lever for controlling the side fence movement was changed to the metal spring loaded lever. Also, the material of the side fences was changed from a resin to a metal. Lastly, a pinion retainer was added (to improve the movement of the pinion gear).

The pressure plate for the end fence was deleted. (The end fence will apply pressure to the paper stack when the bottom plate is lifted up). The base compression springs were strengthened and lengthened from 89.4 mm to 84.18 mm.

The shape of the end fence was changed (so that it stops at the positions for standard sizes more easily).

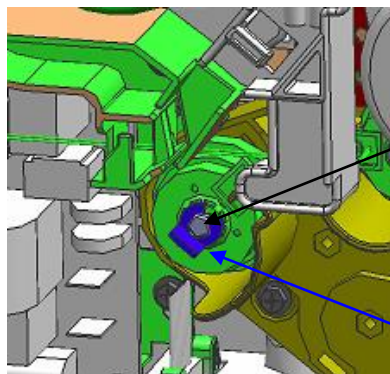
New

M1982580 Paper Feed Roller Shaft

H5213355 C-ring

08050089 → H5213355
