Model: MD-P2	Date: 18-Nov-2010	No.: RM075001i
--------------	-------------------	----------------

Subject: Firmware Release Note: Engine		Prepared by: H.Kobayashi	
From: 3rd Tech Service Sect., MFP/Printer Tech Service Dept.			
Classification:	<input type="checkbox"/> Troubleshooting <input type="checkbox"/> Mechanical <input type="checkbox"/> Paper path <input type="checkbox"/> Product Safety	<input type="checkbox"/> Part information <input type="checkbox"/> Electrical <input type="checkbox"/> Transmit/receive <input checked="" type="checkbox"/> Other (Firmware)	<input type="checkbox"/> Action required <input type="checkbox"/> Service manual revision <input type="checkbox"/> Retrofit information <input checked="" type="checkbox"/> Tier 2

Model: MD-P2		Date: 01-Apr-11	No.: RM075013
Subject: Horizontal white lines after switch from color to B/W mode		Prepared by: H.K.	
From: 2nd Overseas Tech Support Sec. 2nd PQM Dept			
Classification:	<input checked="" type="checkbox"/> Troubleshooting <input type="checkbox"/> Mechanical <input type="checkbox"/> Paper path <input type="checkbox"/> Product Safety	<input type="checkbox"/> Part information <input type="checkbox"/> Electrical <input

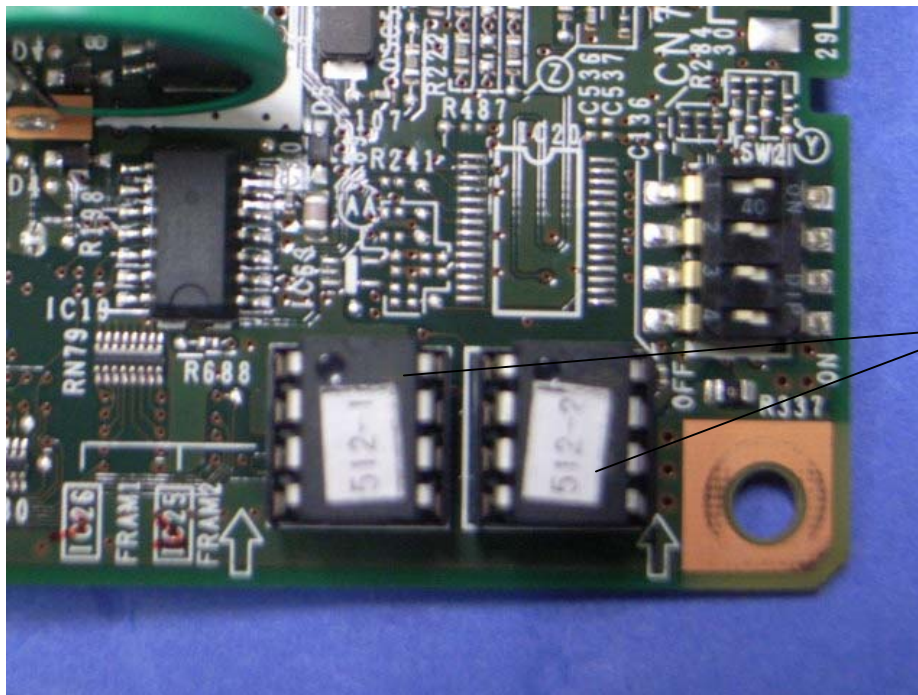
NV-RAM - ZERO
COUNTER

Change/Reason: This part was missing from the parts catalogue.

(512-1 & 512-2)

Controller PCB

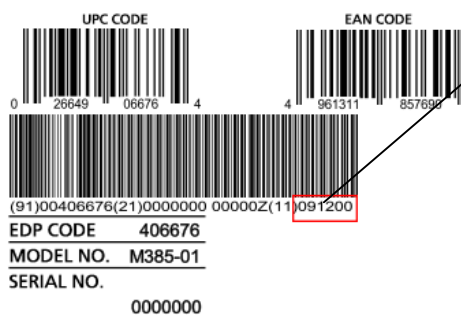
Camera Direct Print Card Type H

- **Supported version** (contains v1.09.04):

YYMM = **1011xx, 1012xx, 11mmxx**
(Nov. 2010 production onward)
- **Unsupported version** (contains v1.09.03):

YYMM = **1003xx to 1010xx**
(March to Oct. 2010 production)

Camera Direct Print v1.09.**04** was installed in SD cards from November 2010 production.

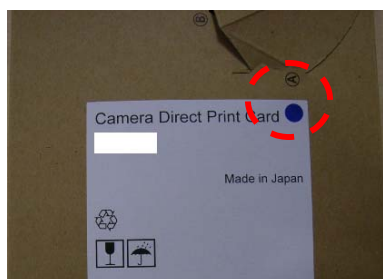
Some SD cards produced before November 2010 were reworked (v1.09.**04** was installed) before being released to the field. There is a round label or a mark on the upper right-hand corner of the box.

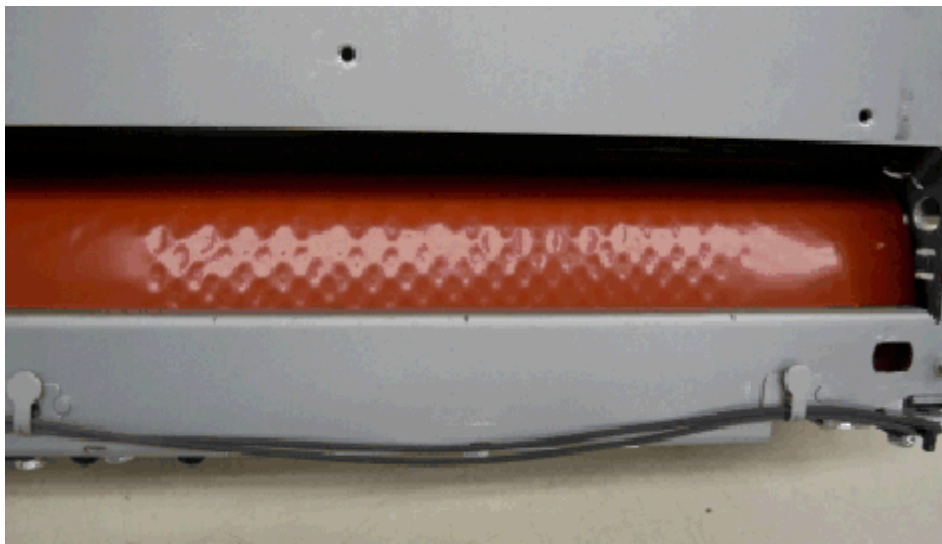
Note: In some cases, the fusing belt is deformed by high temperature, as shown below.

If SC543 occurs before you have the chance to update the firmware, **make a proactive visit** to the user site and **replace the fusing unit** with the one listed below (and update the firmware). This is because once SC543 occurs, the output of the thermistor may

change and cause the SC to be triggered again. This is true even if the firmware is updated, which makes it necessary to replace the fusing unit.

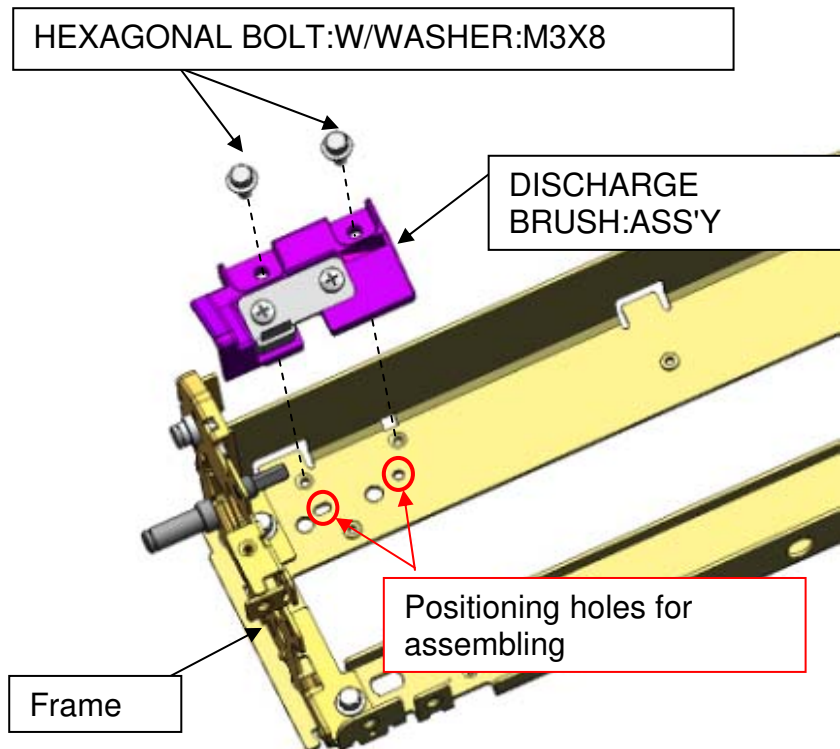
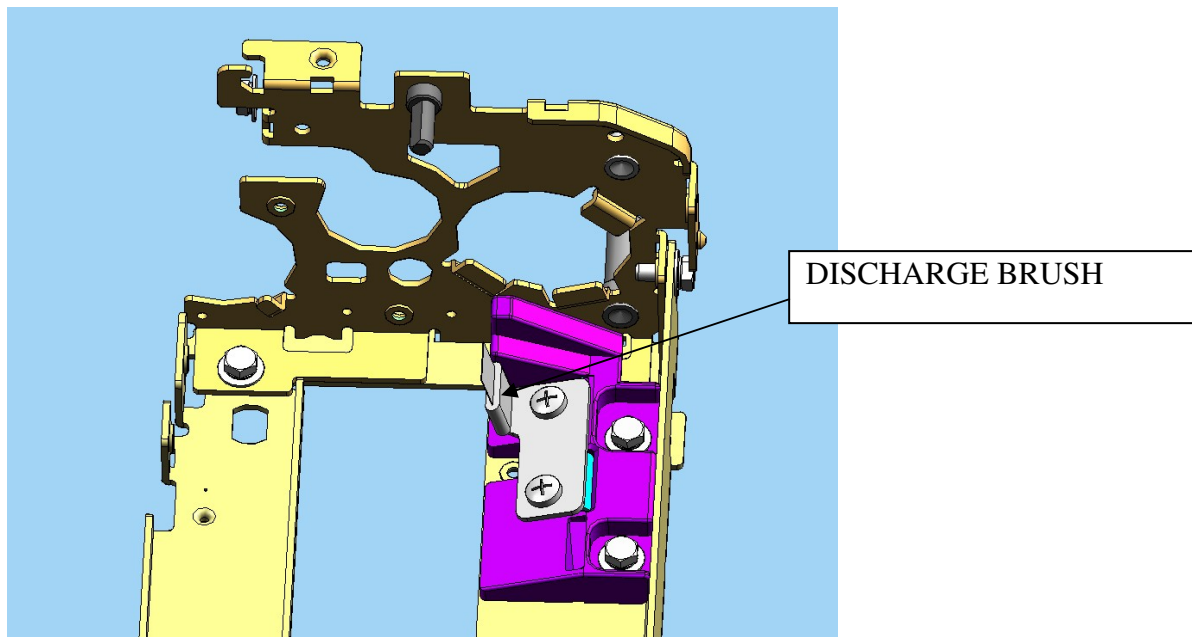
- This is done by removing the static electric charge on the pressure roller.
- Discharge Brush Ass'y is attached directly to the fusing unit frame. To facilitate this change, two positioning holes and two bolt holes were cut in the frame.

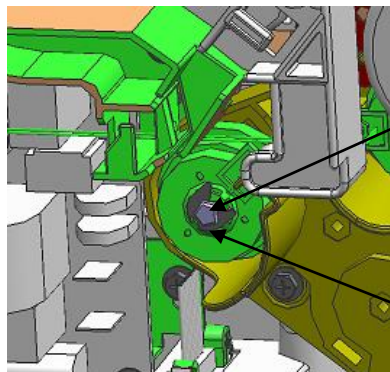
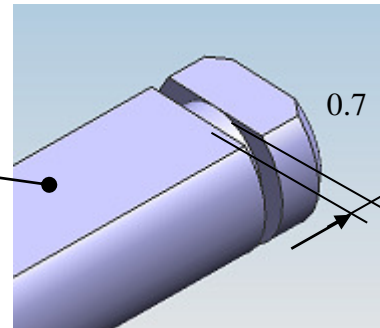
Old

G1662580 Paper Feed Roller Shaft

08050089 E-ring

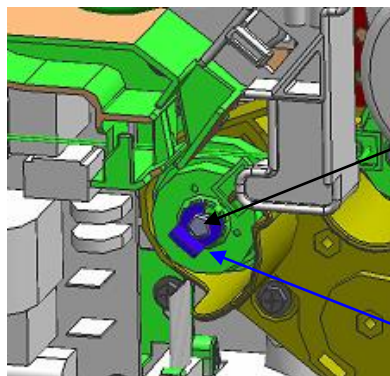
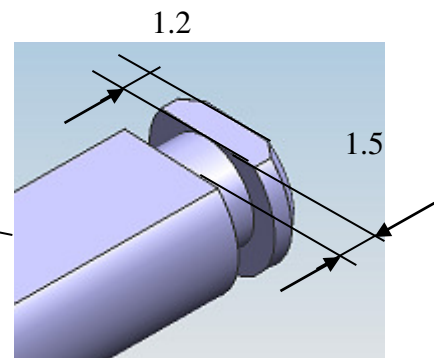
New

M1982580 Paper Feed Roller Shaft

H5213355 C-ring

08050089 → H5213355

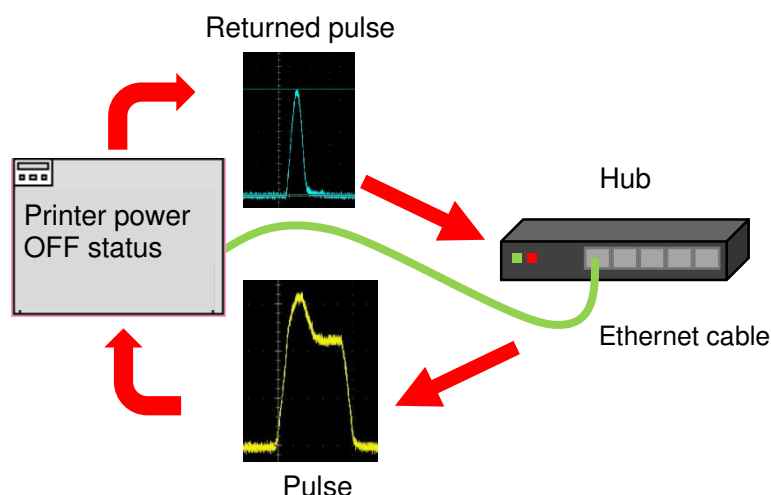
Pulses generated from hubs are transmitted to the printer while the printer is switched OFF (or unplugged). After being transmitted to the printer, they return to the hub, causing interference in network communication.

A circuit on the Controller Board was modified.

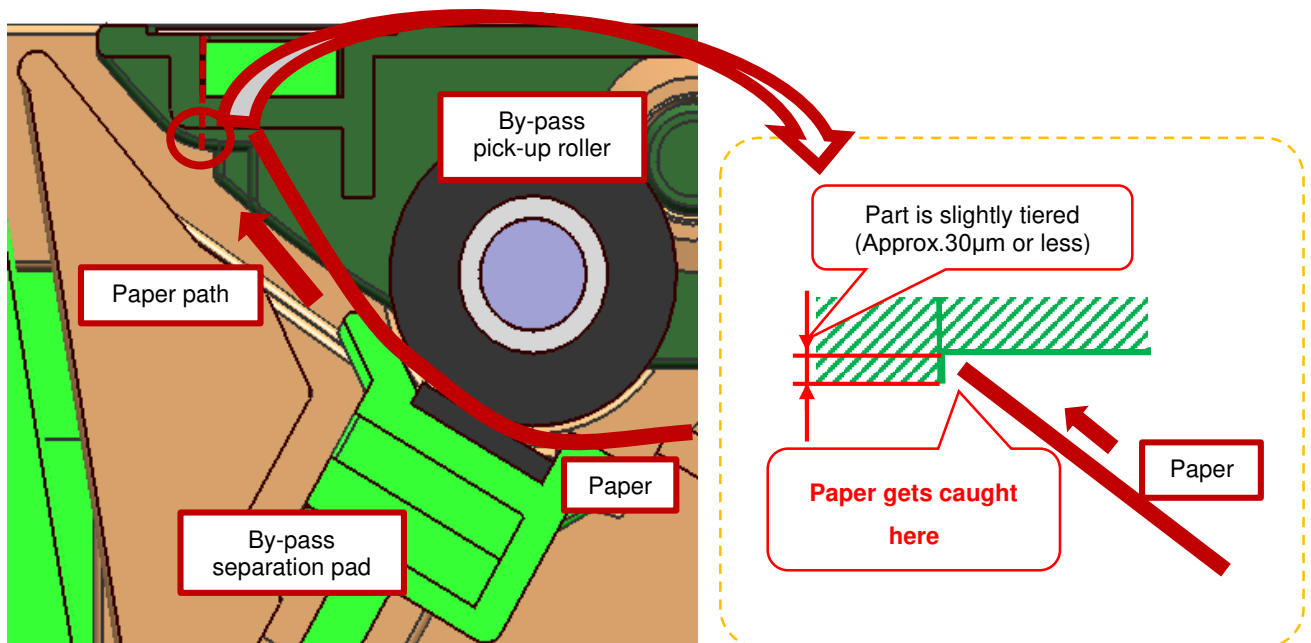
An old tool was used on the production line to produce the part shown below. As a result, the part was produced with a slightly tiered section (see diagram), and the paper may get caught here.
