Model: G-P3	Date: 12-Mar-08	No.: RG190001e
-------------	-----------------	----------------

Subject: Firmware Release Note: Engine		Prepared by: Y. Suzuki	
From: 3rd Tech Service Sect., MFP/Printer Tech Service Dept.			
Classification:	<input type="checkbox"/> Troubleshooting	<input type="checkbox"/> Part information	<input type="checkbox"/> Action required
	<input type="checkbox"/> Mechanical	<input type="checkbox"/> Electrical	<input type="checkbox"/> Service manual revision
	<input type="checkbox"/> Paper path	<input type="checkbox"/> Transmit/receive	<input type="checkbox"/> Retrofit information
	<input checked="" type="checkbox"/> Other ()

Model: Model G-P3		Date: 4-Apr-08	No.: RG190011
Subject: Service Manual Correction		Prepared by: K. Moriizumi	
From: 1st Tech. Support Sec. Service Support Dept.			
Classification:	<input type="checkbox"/> Troubleshooting	<input type="checkbox"/> Part information	<input type="checkbox"/> Action required
	<input type="checkbox"/> Mechanical	<input type="checkbox"/> Electrical	<input checked="" type="checkbox"/> Service manual revision
	<input type="checkbox"/> Paper path	<input type="checkbox"/> Transmit/receive	<input type="checkbox"/> Ret

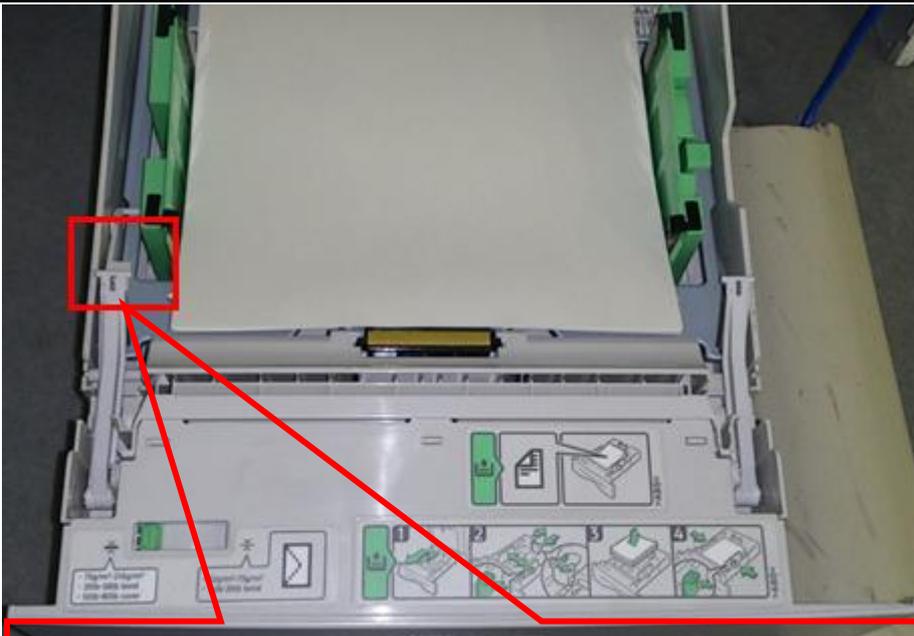
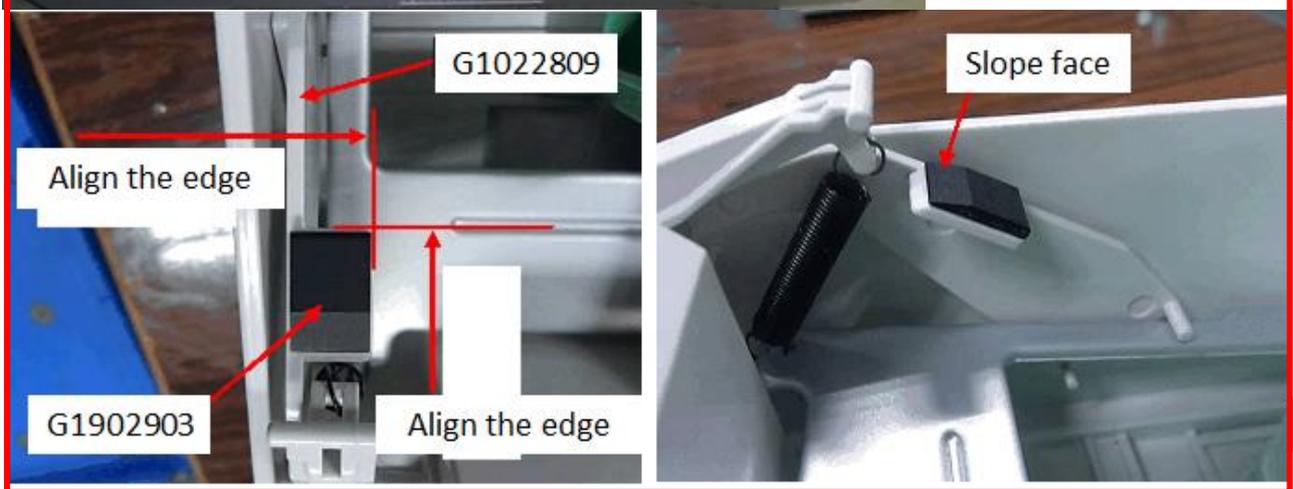
CAUSE

Add a spacer (G1902903) to the BASE PAPER VOLUME SENSOR BOARD (G1022809) or install the new part(s) shown below.

Old part number	New part number	Description	Q'ty	Int	Page	Index	Note
G1592527	G1592528	PAPER TRAY:ASS'Y	1 - 1	X/O	7	*	Spacer added
G1022809	G1902904	PAPER VOLUME SENSOR BOARD:BASE:ADHESION	1 - 1	X/O	7	15	Spacer added
	G1902903	SPACER:PAPER VOLUME SENSOR	0 - 1		7		Add

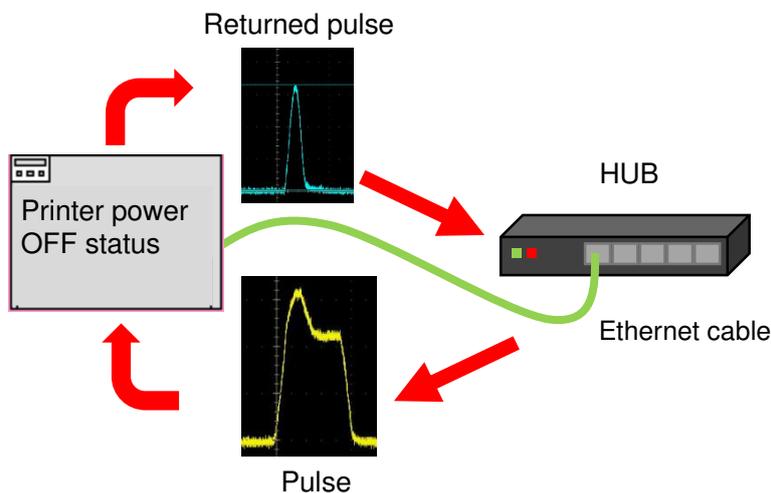
A pulse generated from a hub is transmitted to the printer while the printer is switched OFF (or unplugged). After transmitted to the printer, it then returns to the hub, causing interference in network communication.

A circuit on the Controller Board was modified.
