Model: Ti-P1		Date: 21-May-13	No.: RM109001
Subject: IEEE802.11 Interface Unit Type O Notification		Prepared by: Y. Suzuki	
From: 3rd Tech Service Sect.,MFP/P Tech Service Dept.			
Classification:	<input checked="" type="checkbox"/> Troubleshooting <input type="checkbox"/> Mechanical <input type="checkbox"/> Paper path <input type="checkbox"/> Product Safety	<input type="checkbox"/> Part information <input type="checkbox"/> Electrical <input type="checkbox"/> Transmit/receive <input type="checkbox"/> Other ()	<input type="checkbox"/> Action required <input type="checkbox"/> Service manual revision <input type="checkbox"/> Retrofit information <input checked="" type="checkbox"/> Tier 2

Subject: Firmware Release Note: Engine		Prepared by: H. Kobayashi	
From: 2nd Tech Service Sect., MFP/Printer Tech Service Dept.			
Classification:	<input type="checkbox"/> Troubleshooting <input type="checkbox"/> Mechanical <input type="checkbox"/> Paper path <input type="checkbox"/> Product Safety	<input type="checkbox"/> Part information <input type="checkbox"/> Electrical <input type="checkbox"/> Transmit/receive <input checked="" type="checkbox"/> Other (Firmware)	<input type="checkbox"/> Action

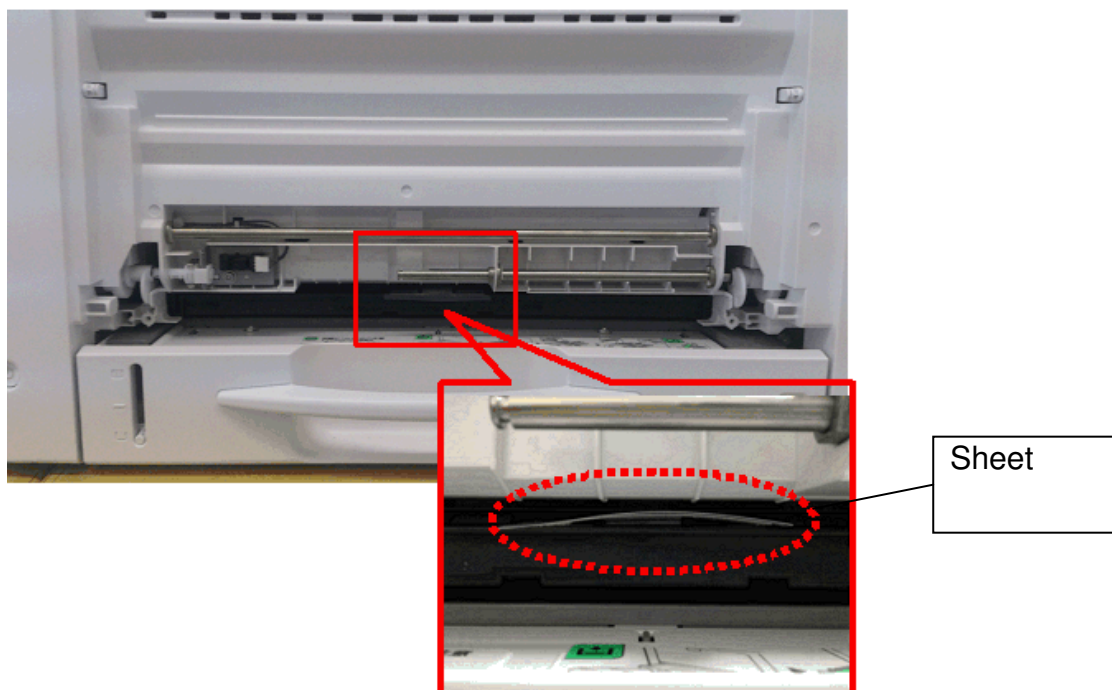
CAUSE

The sheet attached to the lower transport guide may partially peel off.

Note: The above photo was taken after the bypass feed table, bypass feed roller cover, bypass feed roller, and bypass feed friction were all removed.

The sheet was removed and the shape of the lower transport guide was changed. The portion that was extended (circled below) performs the same function as the sheet.

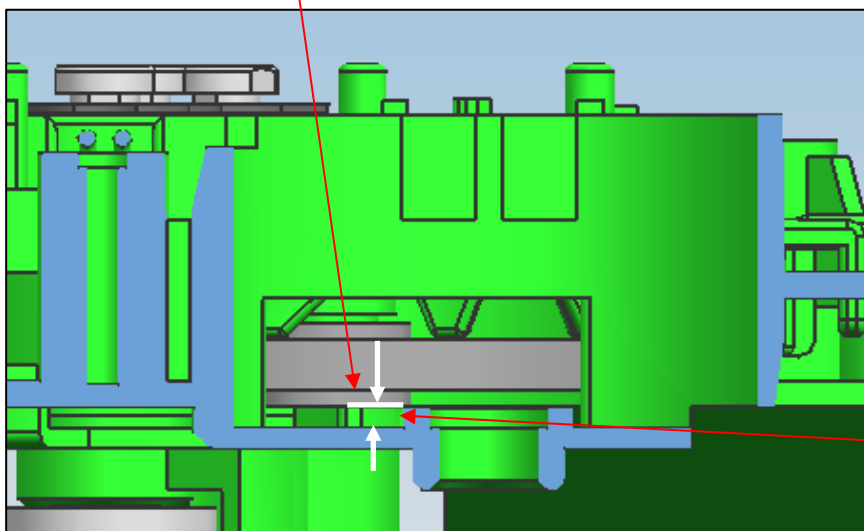
Height of rib on toner
supply drive bracket
increased:
 $0.85 \pm 0.1 \rightarrow 1.15 \pm 0.1$

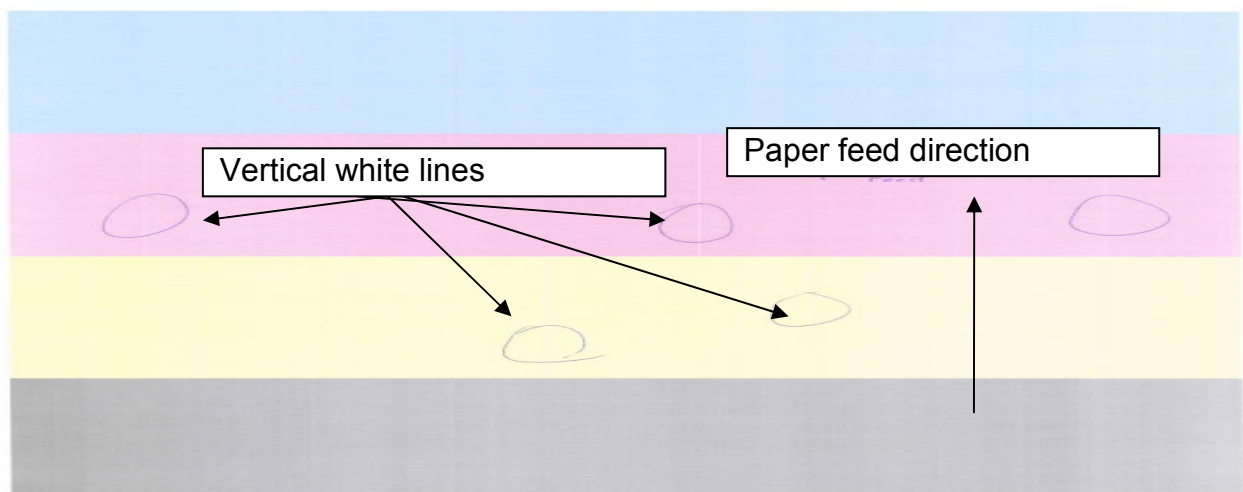
Conditions:

- The lines appear shortly after a new PCDDU is installed
- The average image coverage ratio is 2% or lower

CAUSE

A small amount of toner softens and gets caught in clumps between the development blade and development roller.

2. Update the Engine firmware to **Ver1.60:16** or newer and the System firmware to **Ver.1.08** or newer. Replace the PCDUs on which the symptom occurs.

3. If the problem is not solved, set **SP2500-012** (Data UC2) to a value of **1**. With this setting, the machine will consume more toner than with the default setting. Advise customers that the toner and waste toner bottle will need to be replaced earlier with this setting.

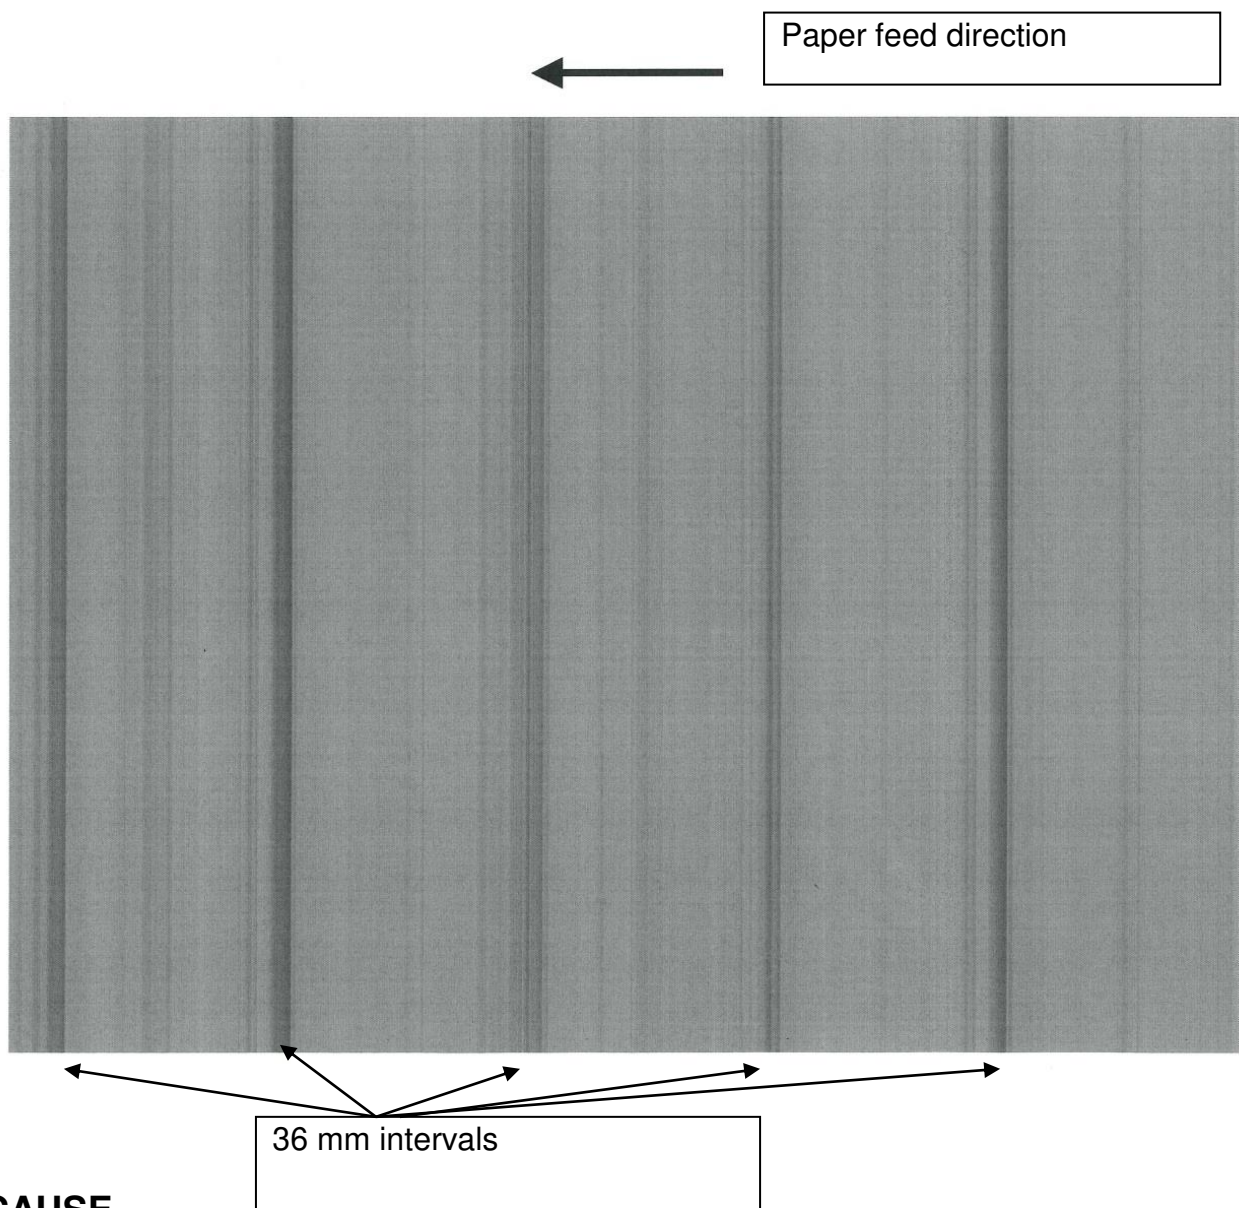
Lines appear on the image at 36mm intervals or at random.

CAUSE

The development bias may not be applied correctly to the development roller.

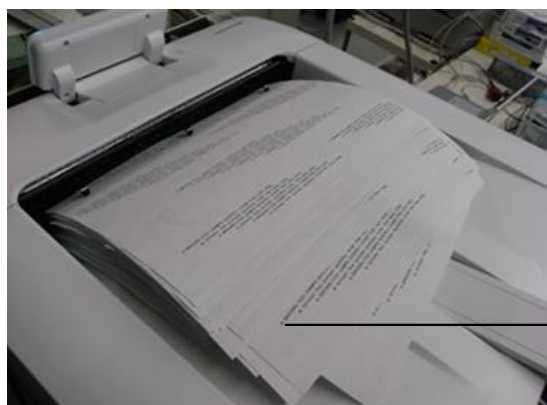
Poor stacking
(348 sheets)

Poor stacking or a paper jam occurs at the exit tray when making duplex prints.

CAUSE

Curled sheets of paper push the paper stacked in the exit tray after the stack has reached 200 sheets. As a result, the detection of the tray full condition is delayed.

Change: The shape of the feeler was changed so that the full condition is detected earlier.

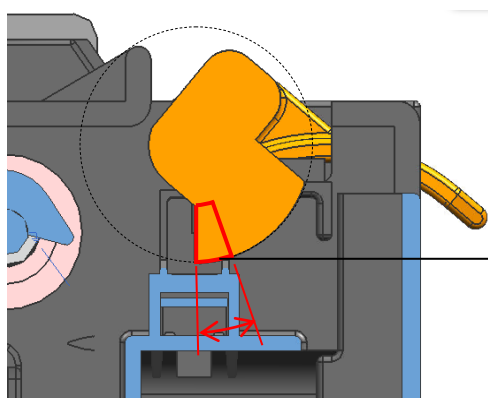
A portion of the overflow sensor
feeler was removed.

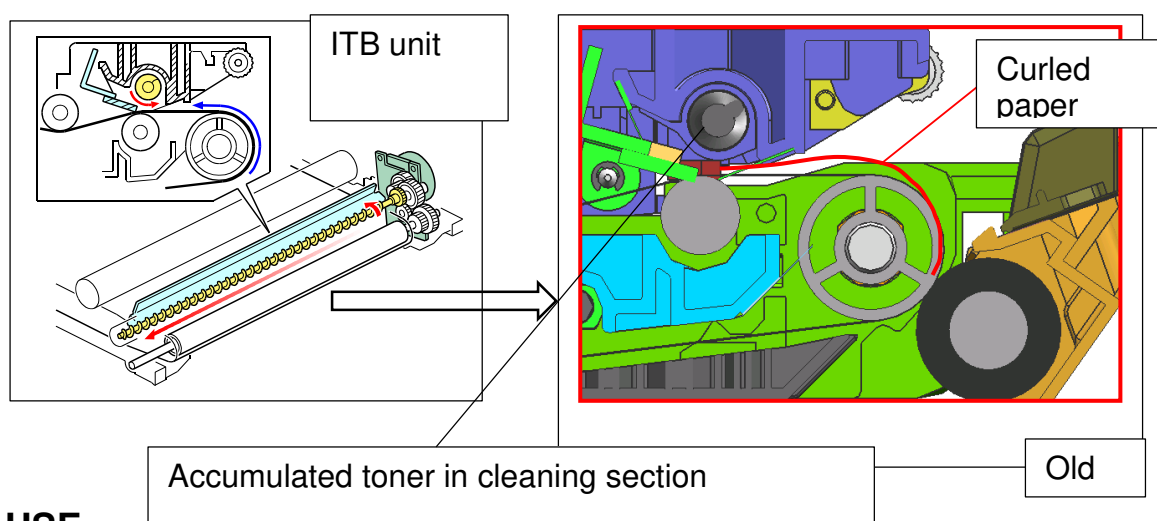
Toner in the cleaning section of the ITB unit may leak out when the user removes paper that had curled and then jammed in the unit.

CAUSE

Part of the paper gets stuck inside the ITB unit.

The shape the Paper Guide Holder was changed so as to block curled paper from entering the ITB unit.

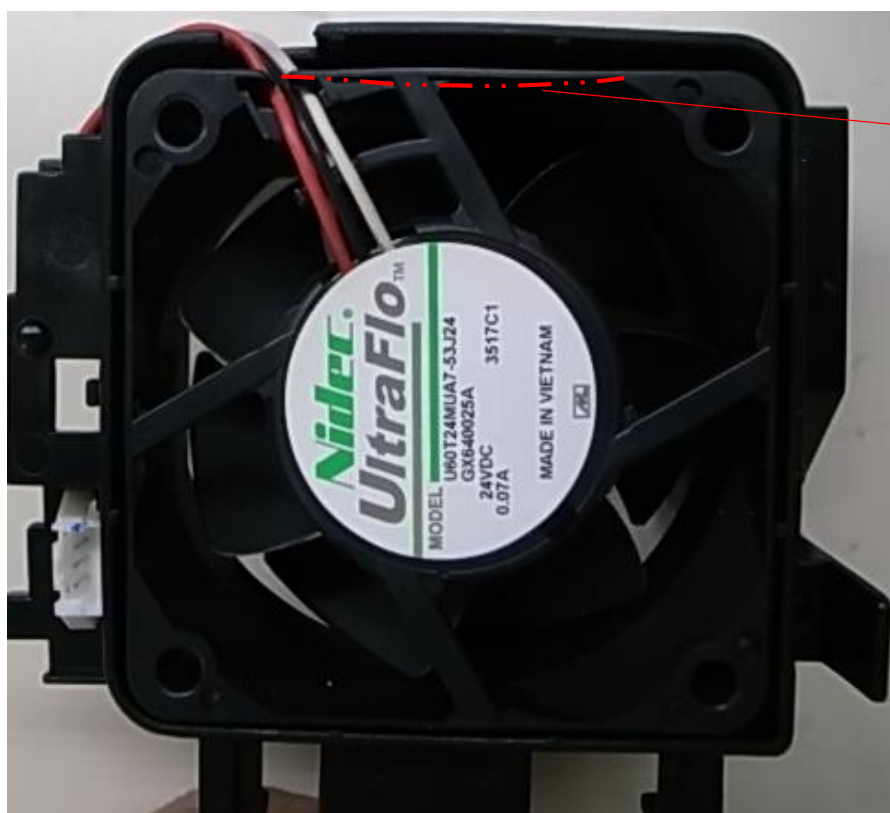
Bent
Fusing Fan Motor and
Fusing Fan Duct

Note: The Fusing Fan Duct tended to be bent inward when the fusing fan was installed. This sometimes caused the fusing fan blade to touch the Fusing Fan Duct.
