Model: Model AP-P1	Date: 29-Sep-06	No.: RG133001k
--------------------	-----------------	----------------

Subject: Firmware Release Note: System		Prepared by: M.Kumagai	
From: 1st Overseas Tech Support Sec., 1st PQM Dept.			
Classification:	<input type="checkbox"/> Troubleshooting	<input type="checkbox"/> Part information	<input type="checkbox"/> Action required
	<input type="checkbox"/> Mechanical	<input type="checkbox"/> Electrical	<input type="checkbox"/> Service manual revision
	<input type="checkbox"/> Paper path	<input type="checkbox"/> Transmit/receive	<input type="checkbox"/> Retrofit information
	<input checked="" type="checkbox"/> Other ()

Model: AP-P1		Date: 5-Dec-06	No.: RG133008
Subject: Unparallel horizontal lines		Prepared by: K. Moriizumi	
From: 1st Tech. Support Sec. Service Support Dept.			
Classification:	<input checked="" type="checkbox"/> Troubleshooting <input type="checkbox"/> Mechanical <input type="checkbox"/> Paper path <input type="checkbox"/> Product Safety	<input type="checkbox"/> Part information <input type="checkbox"/> Electrical <input type="checkbox"/> Transmit/receive <input type="checkbox"/> Other ()	<input type="checkbox"/> Action required <in

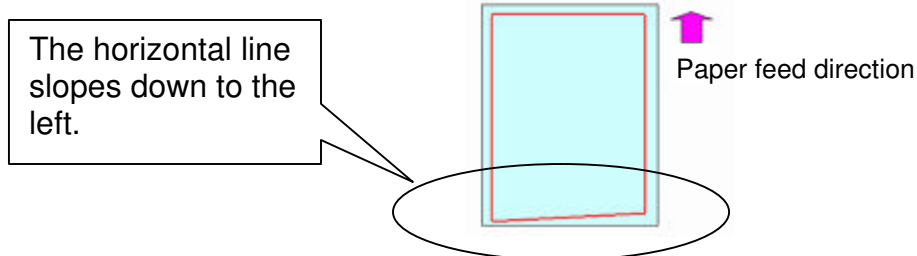
Parallel horizontal lines on the original are not parallel on the printout (they are separated by more than 2.5mm),

Sometimes, the paper is not transported between the transport roller and fusing roller perfectly straight.

Attach a spring to one of the stud pins (**see the procedure below**).

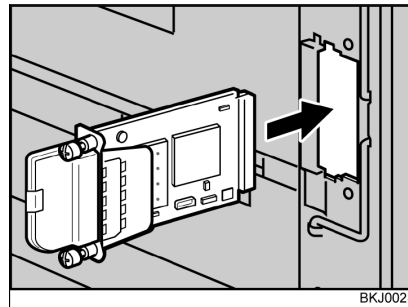
New Type (IEEE802.11b
Interface Unit Type N):
Pre-assembled

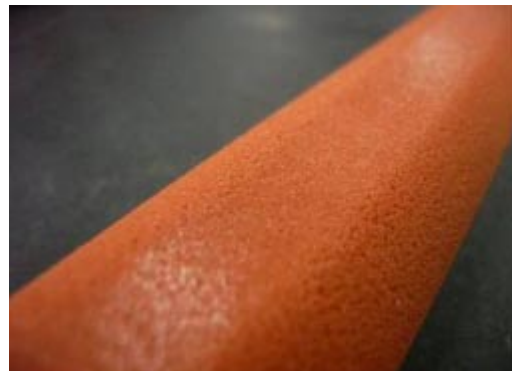
The machine is used under the following conditions, which minimizes the frequency at which the fusing roller is rotated/idled. Also, the idling home position is constant. As a result, the same area of the fusing roller surface is exposed to the heating roller for long periods of time, which flattens out this area.

- Energy save mode is set to OFF
- The actual PV is very low (1000 prints/month or less)

1. Replace the fusing roller.
2. Change **SP1115-002** from a setting of 0.7s to **0.9s**.
