Model: AP-P2	Date: 11-Dec-08	No.: RG188001e
---------------------	-----------------	----------------

Subject: Firmware Release Note: Engine		Prepared by: M. Kumagai	
From: 1st Overseas Tech Support Sec., 1st PQM Dept.			
Classification:	<input type="checkbox"/> Troubleshooting	<input type="checkbox"/> Part information	<input type="checkbox"/> Action required
	<input type="checkbox"/> Mechanical	<input type="checkbox"/> Electrical	<input type="checkbox"/> Service manual revision
	<input type="checkbox"/> Paper path	<input type="checkbox"/> Transmit/receive	<input type="checkbox"/> Retrofit information
	<input checked="" type="checkbox"/> Other ()

Model: Ap-P2		Date: 4-Sep-09	No.: RG188018
Subject: Duplex jam or Z-fold jam		Prepared by: M. Kumagai	
From: 2nd Tech Support Sec. Service Support Dept.			
Classification:	<input checked="" type="checkbox"/> Troubleshooting	<input type="checkbox"/> Part information	<input type="checkbox"/> Action required
	<input type="checkbox"/> Mechanical	<input type="checkbox"/> Electrical	<input type="checkbox"/> Service manual revision
	<input type="checkbox"/> Paper path	<input type="checkbox"/> Transmit/receive	<input type="checkbox"/> Retrofit in

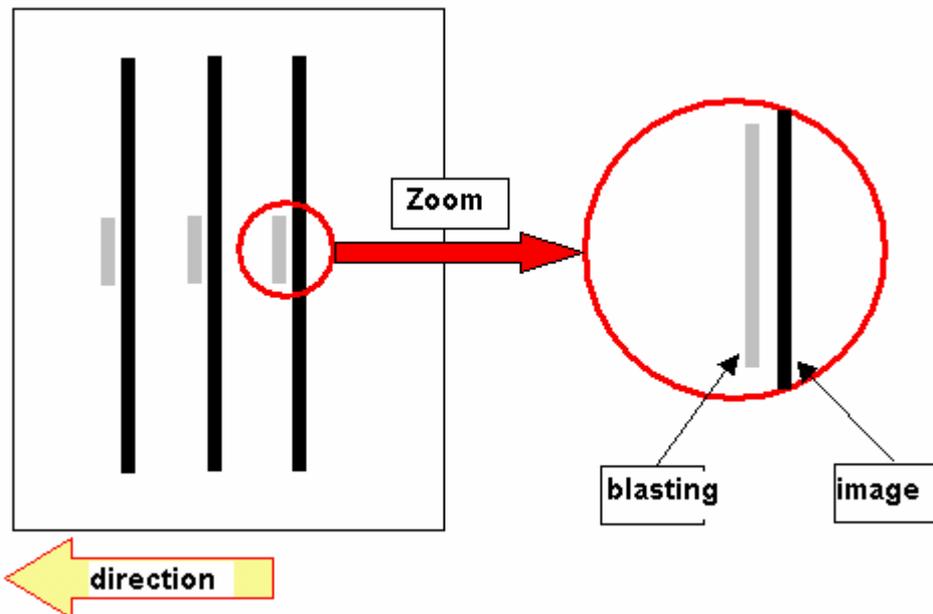
- Location of toner blasting -

Toner blasting appears just ahead of the image along the paper feed direction.

- Occurs only with black and white printing
- Occurs mainly at the center of the image but sometimes at the side edges.

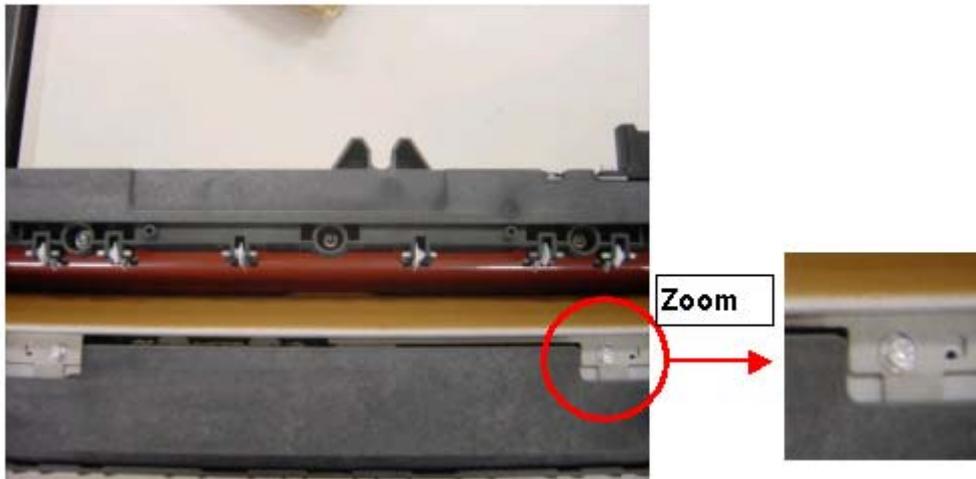
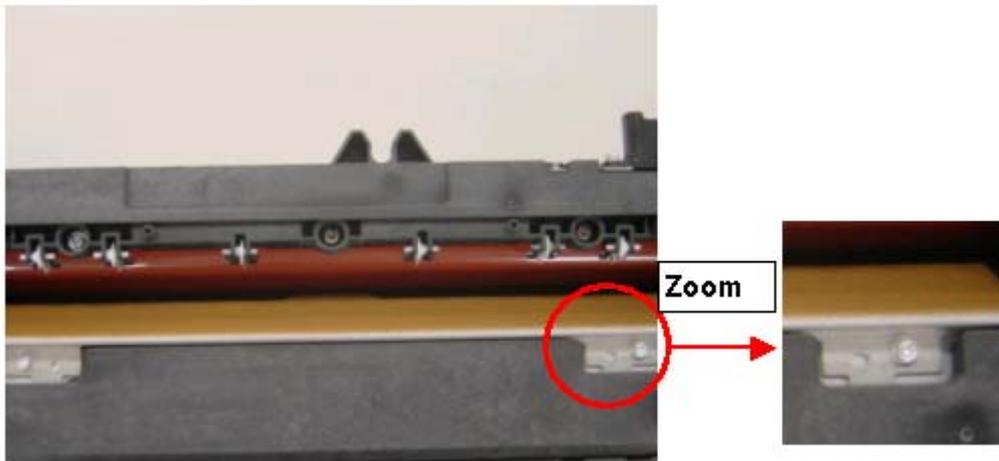
After this screw position is changed, in some cases, mimizu ('earth worms', slight wrinkling) may occur with the first print made of the day.

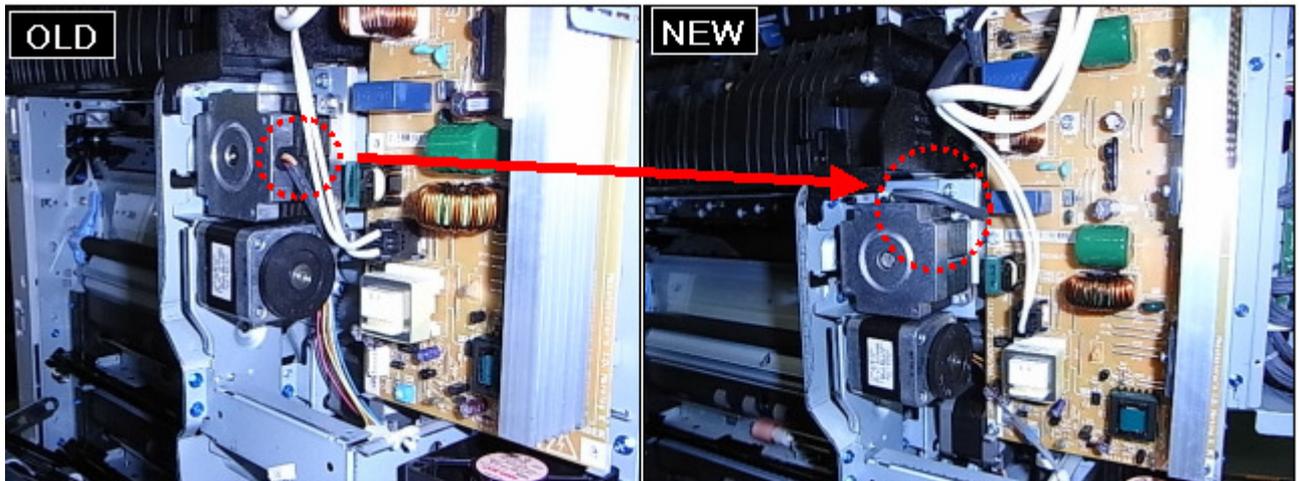
Important: Make sure that the opening in the pressure contact motor for the harness is **facing up** (and not right). This is to prevent the harness from touching the wheel of the duplex bypass motor.

13. Attach the pressure roller contact motor [I] (screw x 4) in the “NEW” orientation shown below.

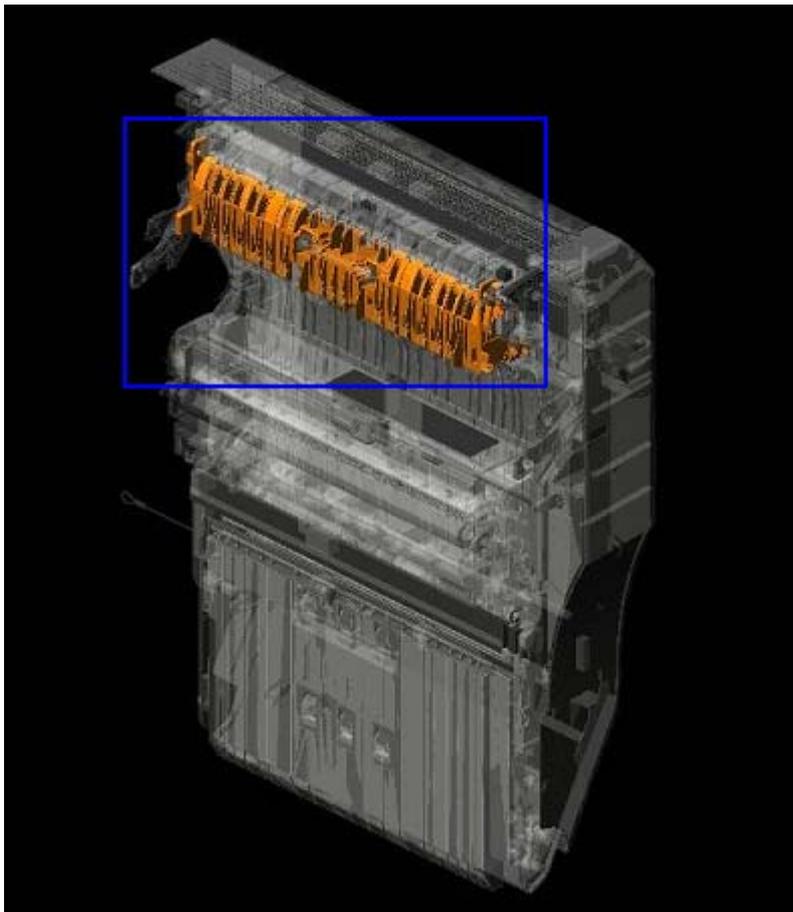
High temperature and a mechanical load cause the fusing entrance guide plate to bend.

Replace the guide plate with the new part shown below.

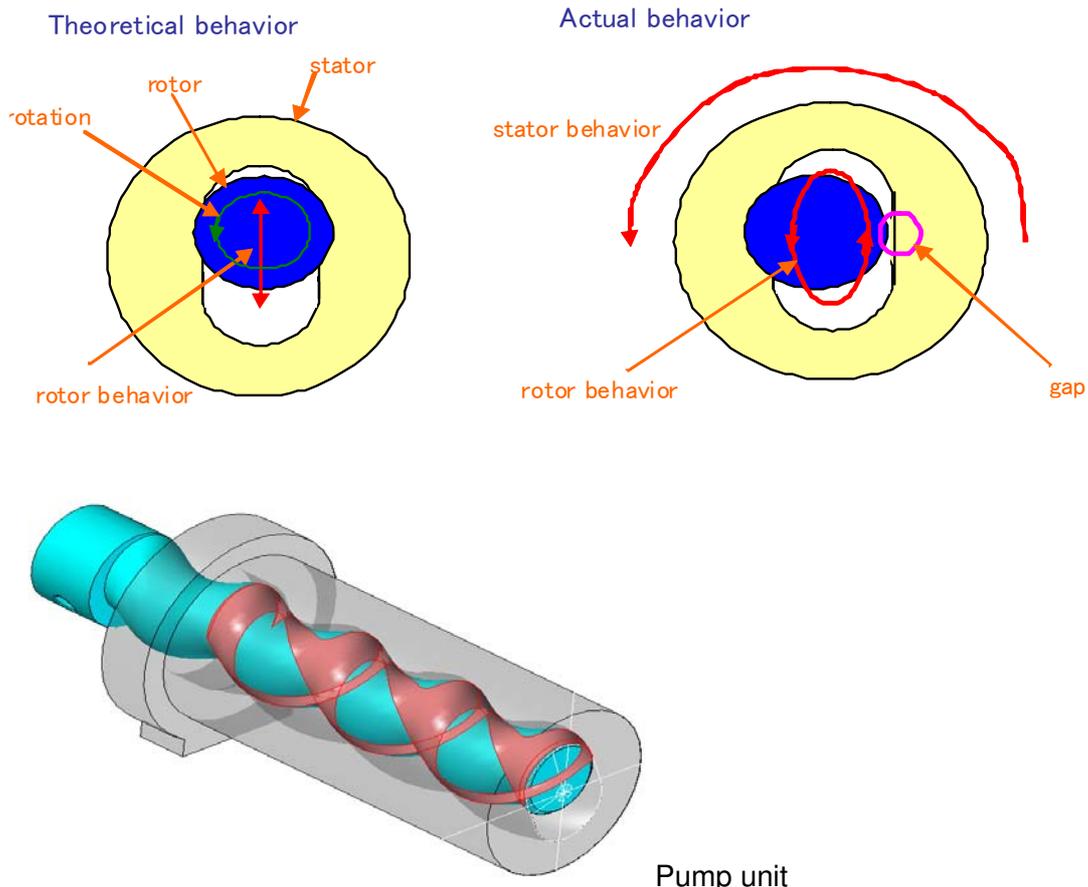
The “Toner End” display is not cleared when the toner bottle is replaced.

The rotor inside the pump unit moves in an elliptical pattern (instead of straight up and down), as shown in the illustration on the right below. This causes a gap to form between the rotor and stator. As a result, toner is not supplied correctly from the toner bottle to the development unit, and the machine incorrectly detects the Toner End condition.

Follow the flow chart on the next page and take the recommended action.

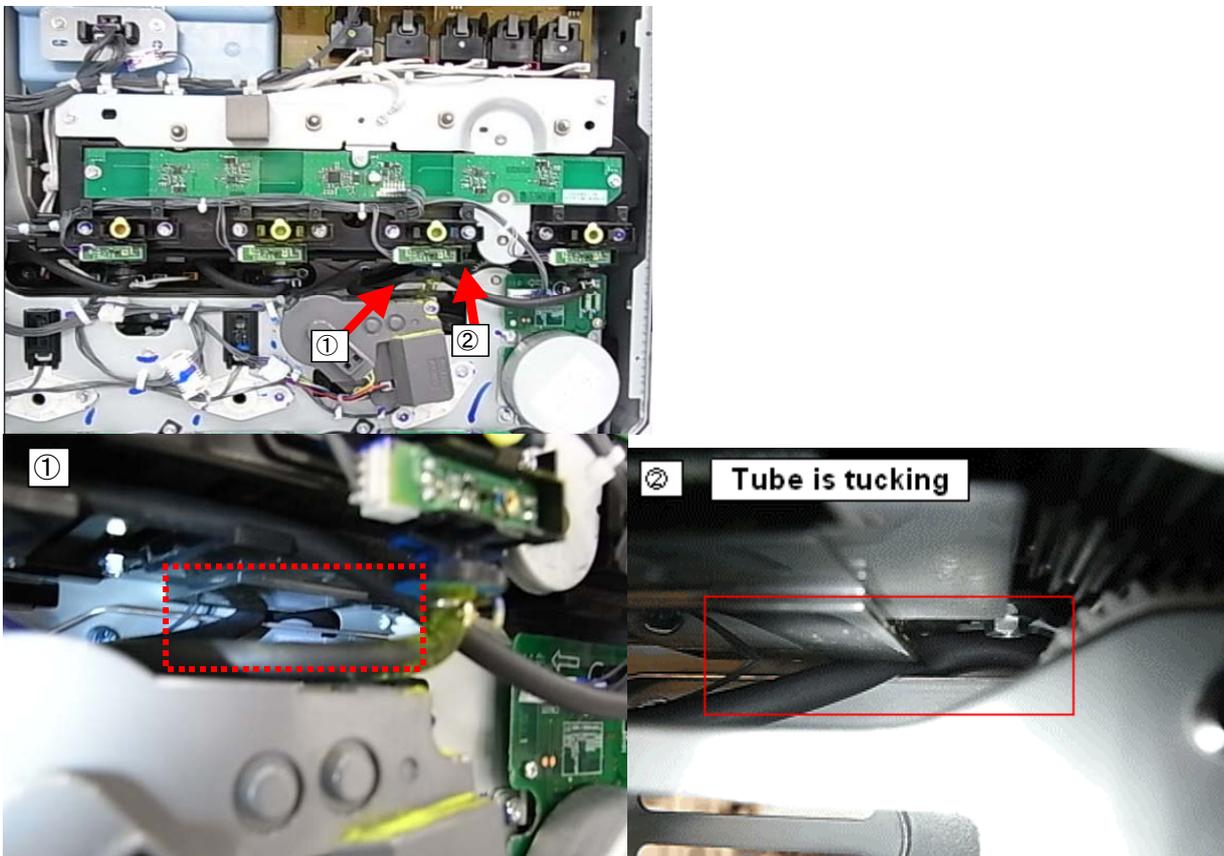
- This occurs when the machine is installed, when the value of the FC counter is under 1000.
- This condition does not clear when the Y toner bottle is replaced with a new one.

The toner supply unit was not attached correctly to the machine at the factory. As a result, the Y toner supply tube is tucked between the frame of the machine and the toner supply unit (see the picture below). Toner gets clogged inside the tube over time, eventually triggering the Toner End condition.

Check the condition of the Y toner supply tube. Replace the Y pump unit assembly if the tube is tucked between the machine frame and the toner supply unit.

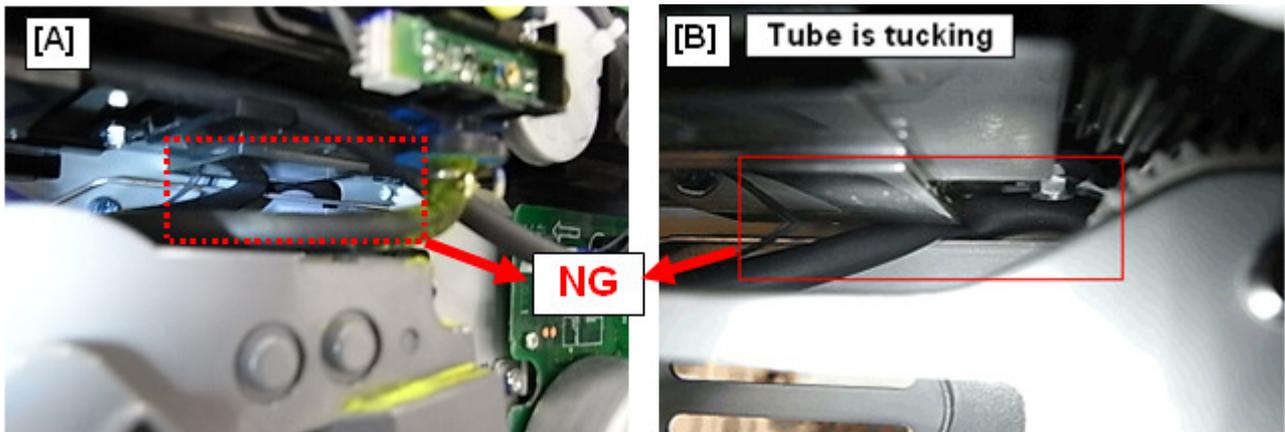
5. If the Y toner supply tube is tucked between the toner supply unit and the machine frame, shown in the photo below with [A] or [B], replace the Y pump unit (including the toner supply tube).

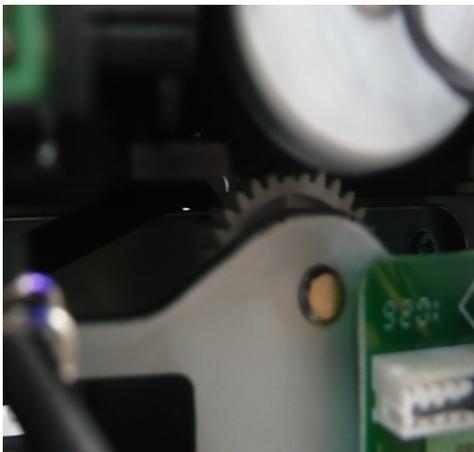
Important: Make sure that the tube is not tucked or folded. Also, make sure that the gear does not touch the tube.

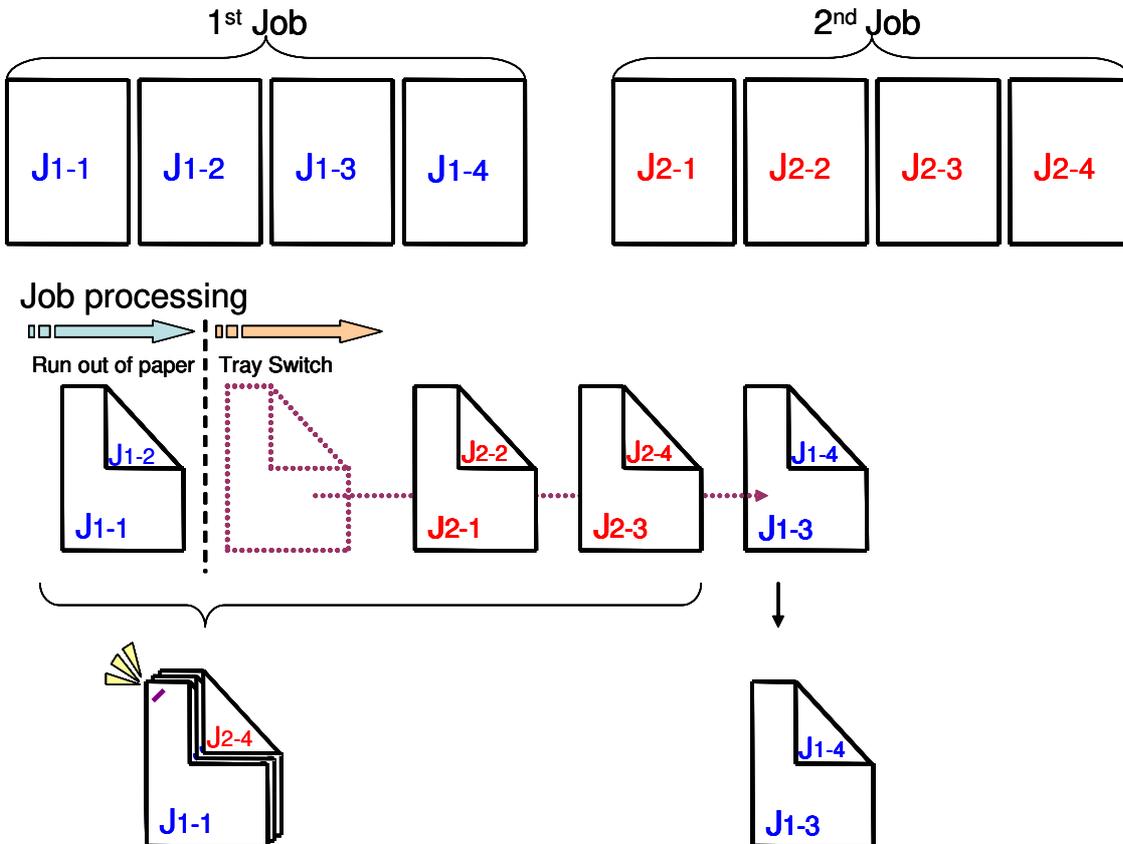
Conditions:

- Both jobs are duplex print jobs
- Both jobs are set for Stapling
- Paper runs out during the first job, just before the last duplex sheet is printed out
- At that time, the machine switches to another paper tray via Auto Tray Switch
