Model: <b>AP-P3</b>	Date: 28-Sep-12	No.: RM125001e
---------------------	-----------------	----------------

Subject: Firmware Release Note: Engine		Prepared by: Y. Urushihara	
From: 1st Tech Service Sect., MFP/Printer Tech Service Dept.			
Classification:	<input type="checkbox"/> Troubleshooting <input type="checkbox"/> Mechanical <input type="checkbox"/> Paper path <input type="checkbox"/> Product Safety	<input type="checkbox"/> Part information <input type="checkbox"/> Electrical <input type="checkbox"/> Transmit/receive <input checked="" type="checkbox"/> Other (Firmware)	<input type="checkbox"/> Action required <input type="checkbox"/> Service manual revision <input type="checkbox"/> Retrofit information <input checked="" type="checkbox"/> Tier 2

This RTB has been issued to announce the firmware release information for the **Engine**.

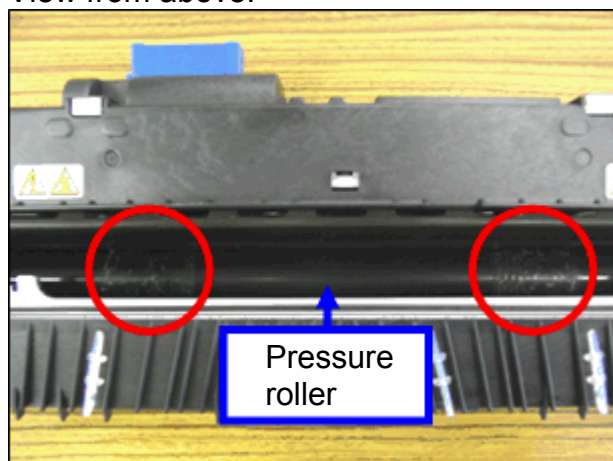
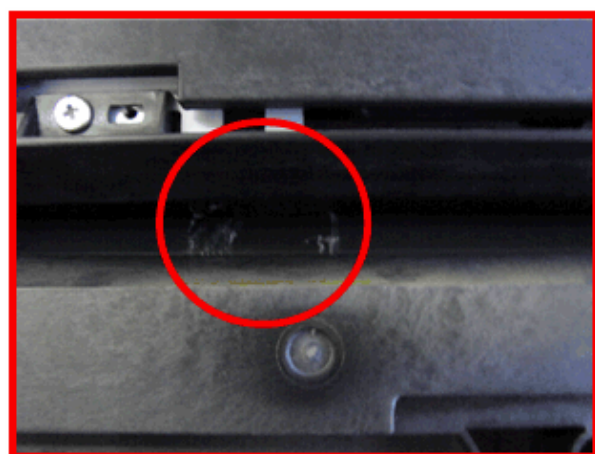
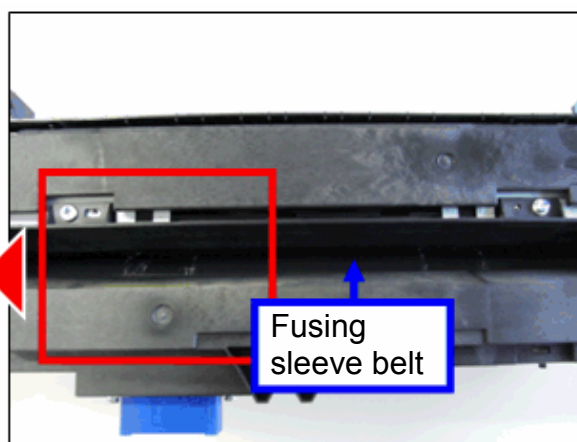
Conditions:

- The width of the paper is 206mm or less, or
- The paper size setting is different from the size of the paper loaded in the tray

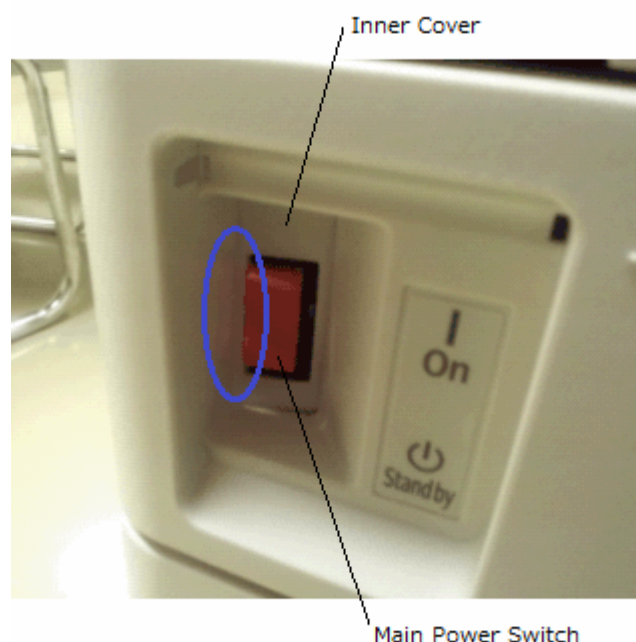
The gap between the inner cover and main power switch is too narrow, due to combined margins of error in the surrounding parts. As a result, when the ECO Night Sensor is enabled, the solenoid cannot turn off the main power switch and the controller logs SC819 (shut down count over). After this, SC672-10 (connection error) is displayed.

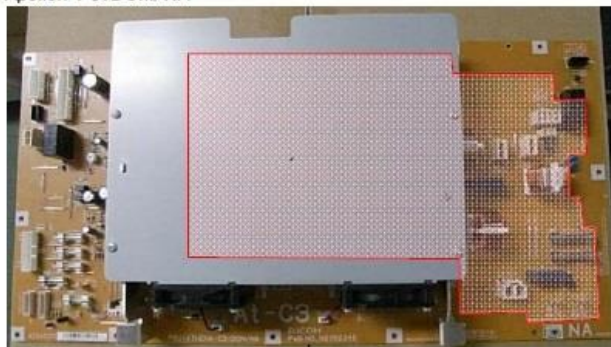
Apollon-P3:DOM/NA

**NEVER touch** the areas outlined in red in the photos below to prevent electric shock caused by residual charge.

Residual charge of about 100V-400V remains on the PSU board for several months even when the board has been removed from the machine after turning off the machine power and unplugging the power cord.

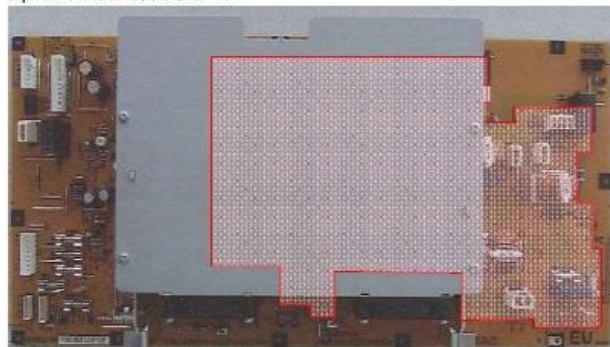
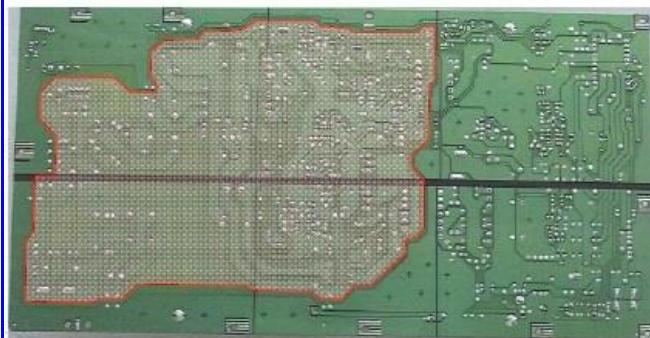
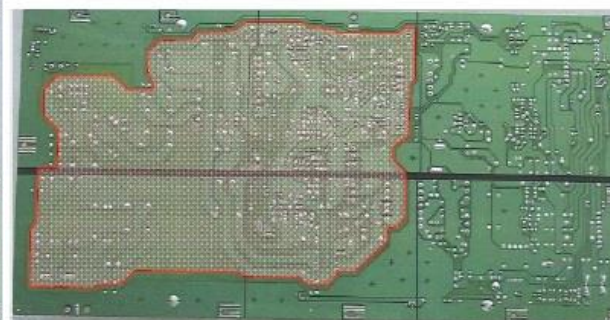
Apollon-P3:EU/AA/CHN

The areas outlined in red on the bracket mean the residual charge of about 100V-400V remains on the PSU board under the bracket.
