Model: MET-P2	Date: 21-Oct-16	No.: RM0AL004a
---------------	-----------------	----------------

Subject: Firmware Release Note: NetworkDocBox		Prepared by: Y. Ino	
From: 1st Tech Service Sect., MFP/Printer Tech Service Dept.			
Classification:	<input type="checkbox"/> Troubleshooting	<input type="checkbox"/> Part information	<input type="checkbox"/> Action required
	<input type="checkbox"/> Mechanical	<input type="checkbox"/> Electrical	<input type="checkbox"/> Service manual revision
	<input type="checkbox"/> Paper path	<input type="checkbox"/> Transmit/receive	<input type="checkbox"/> Retrofit information
	<input type="checkbox"/> Product Safety	<input checked="" type="checkbox"/> Other (Firmware)	<input checked="" type="checkbox"/> Tier 2

This RTB has been issued to announce the firmware release information for the **NetworkDocBox**.

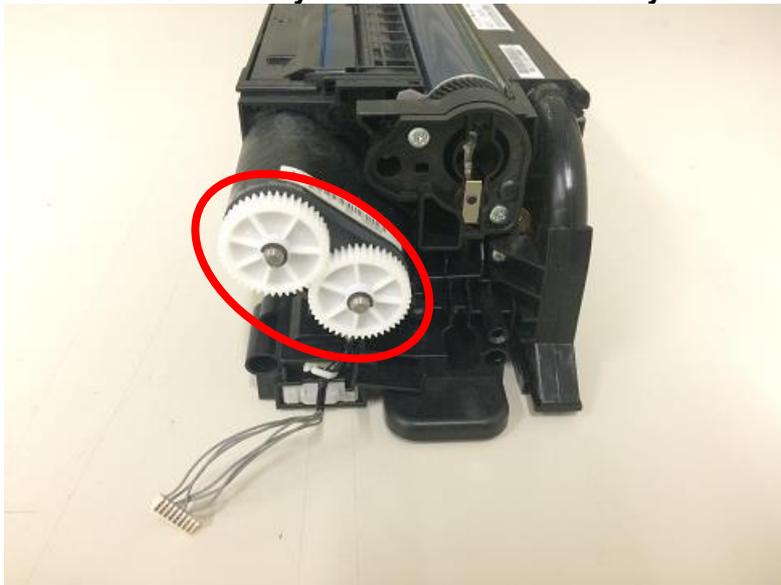
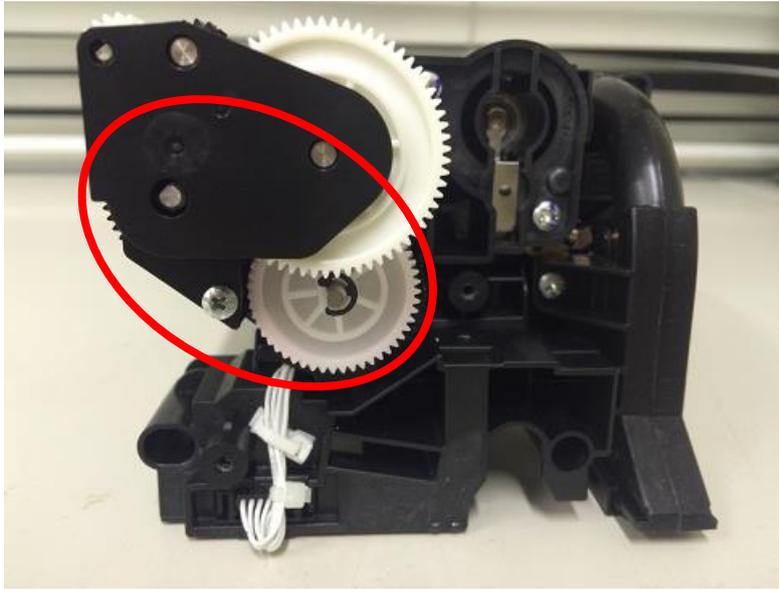
As one of the reasons that cause this symptom, the development unit was stored/transported in a position prior to its installation. This causes developer to accumulate on the gears at either end of the unit, disabling proper rotation of the development roller.

Note: For Metis-P2ce, the PCDU front cover needs to be released before rotating the gears.

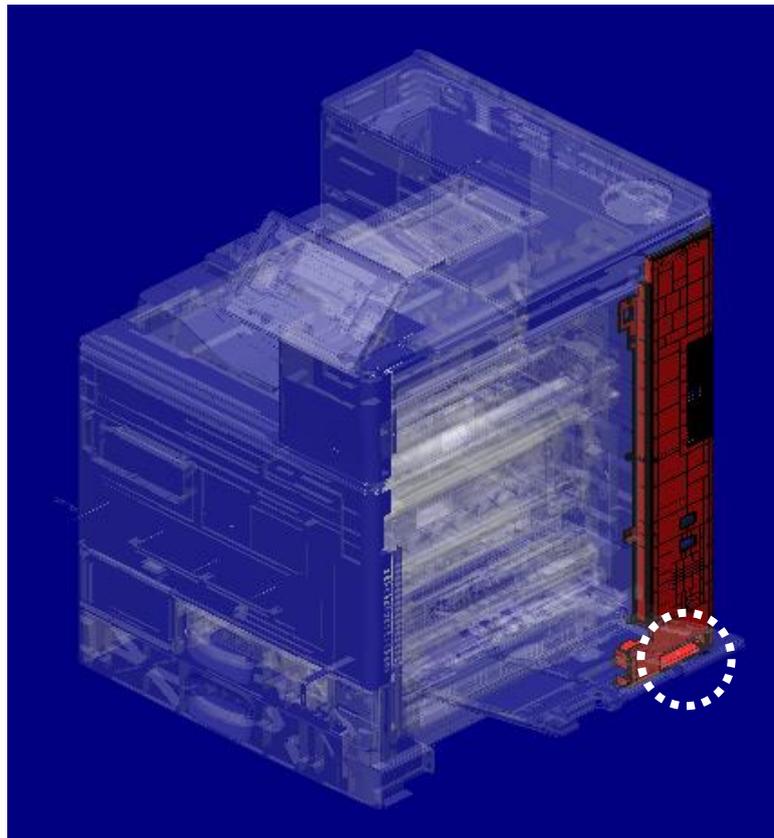
Figure1 right rear cover

- Make sure to do the following when installing the machine:
Hold the grip of the right rear cover as shown in **Fig. 2 (CORRECT)**.
Insert your fingers **all the way up and inside the grip**.
- If you do not, the right cover will break, as shown in Fig. 4.

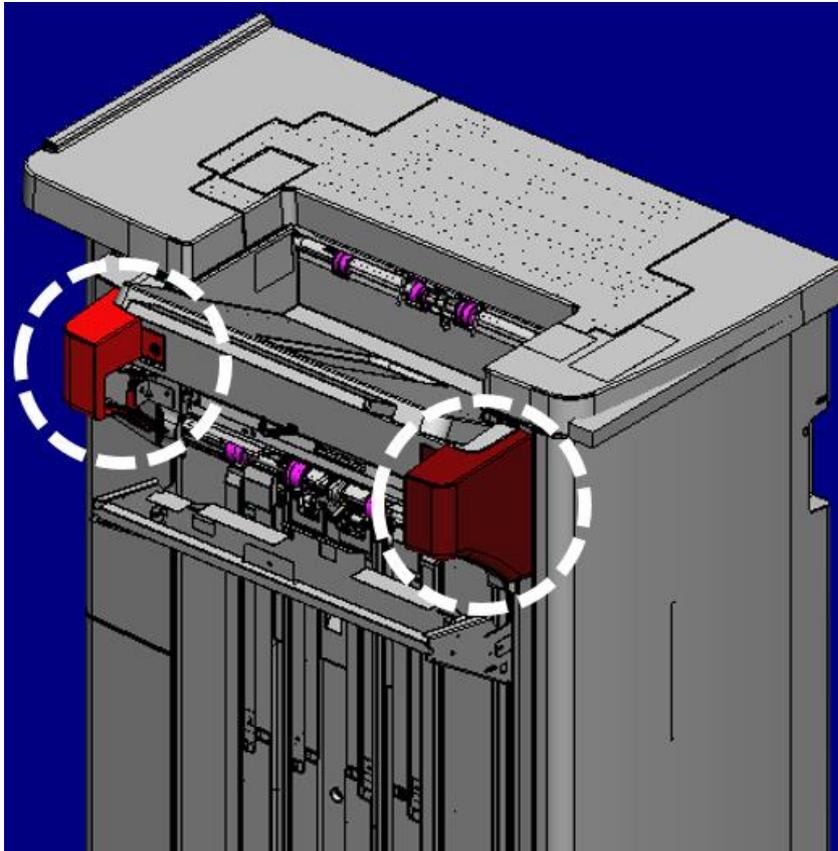
Do NOT hold the guide cover highlighted in RED when installing the finisher (SR3230/SR3240).

SC720-83 occurs due to breakage of the guide cover.

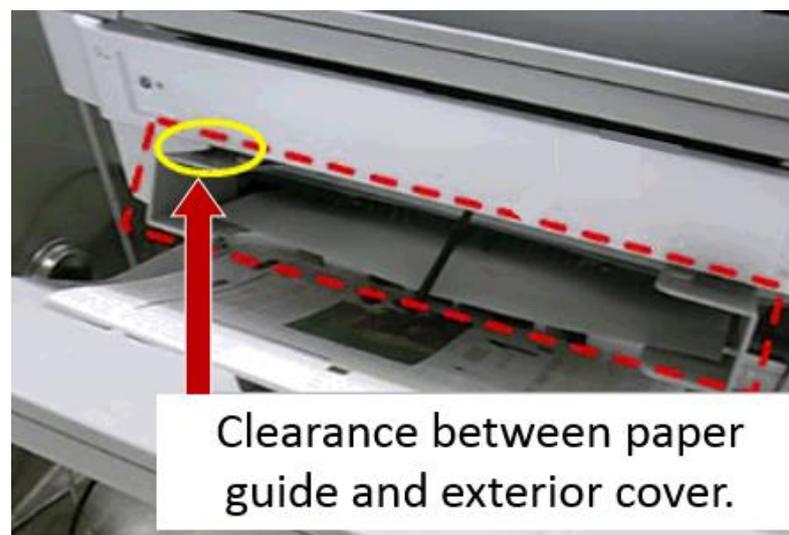
Fig.2

The broken piece drops into the clearance between the paper guide (GUIDE: PAPER: REAR: ASS'Y) and the exterior cover (COVER: PAPER: GUIDE) circled in YELLOW. (Fig.2)

This prevents the paper guide from returning to the home position.

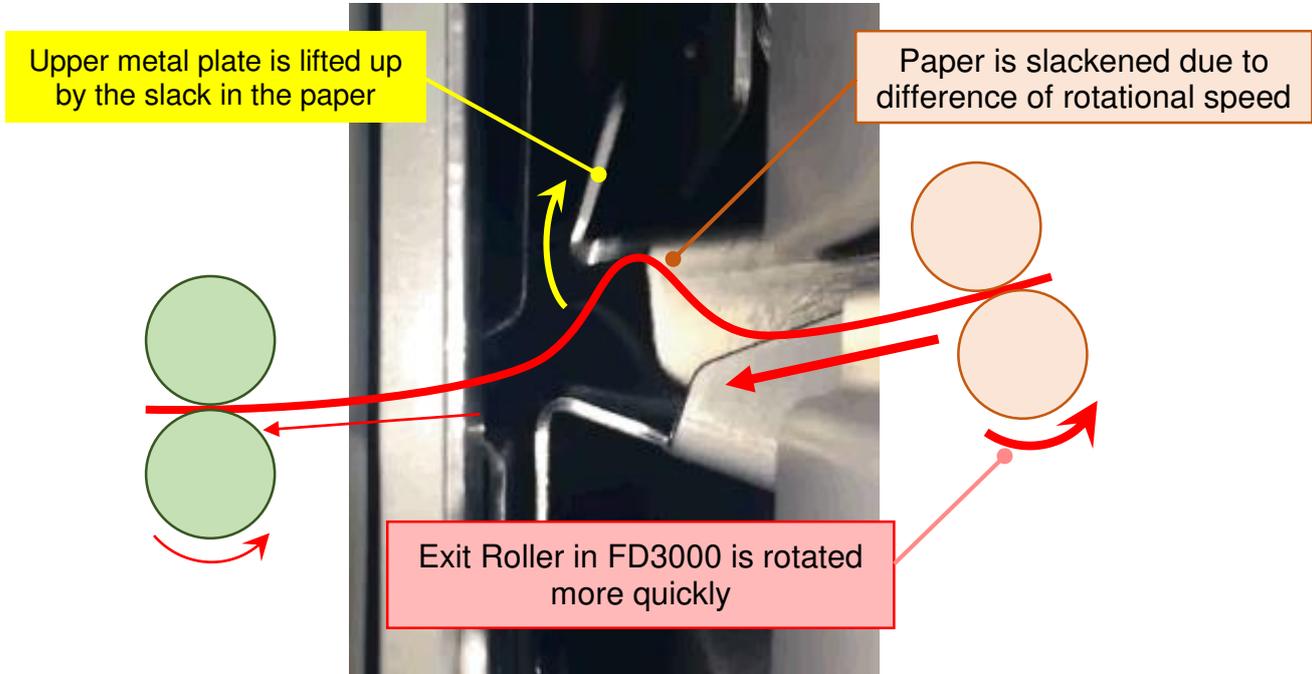
Due to the above error, the exit roller in the FD3000 is rotated at a higher speed than the entrance roller in the finisher (Normally, these speeds should be the same). This causes slack to develop in the paper, which then lifts up the upper metallic plate. As a result, the upper plate then drops onto the lower plate. Then a metallic “clinking” noise is produced.

INCORRECT paper transport between FD3000 and SR3210/3220

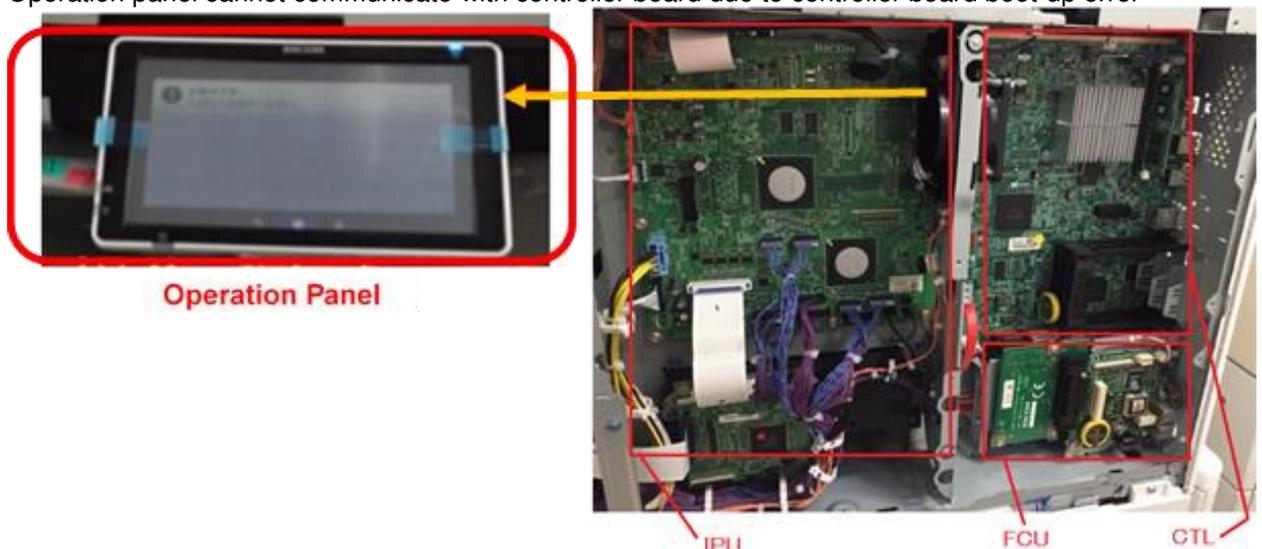
Figure 1: Operation panel, IPU and Controller / FCU

- USB communication path failure (USB cable, IPU)
- Controller board boot up error and/or operation panel boot up error due to abnormal break in operations of controller board.

- USB communication path failure (USB cable, IPU)
- Operation panel cannot communicate with controller board due to controller board boot-up error

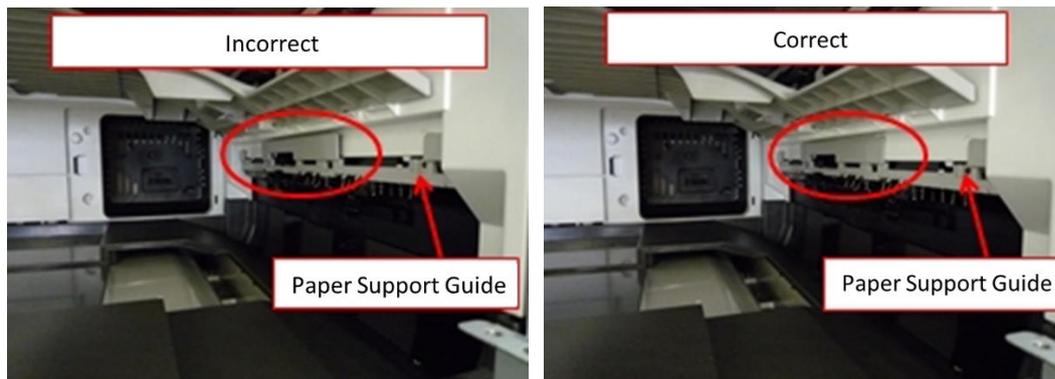
The paper support guide was incorrectly installed.

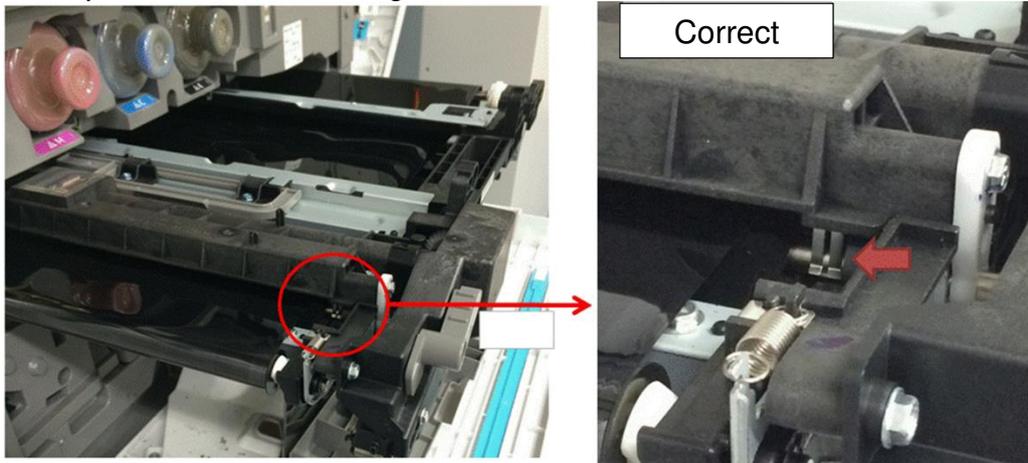
A grounding failure occurs with the belt cleaning unit in the ITB unit or paper transfer roller unit, either of which can generate electrical noise.

1. Check the grounding of the belt cleaning unit on the ITB unit.
2. Replace the belt cleaning unit.

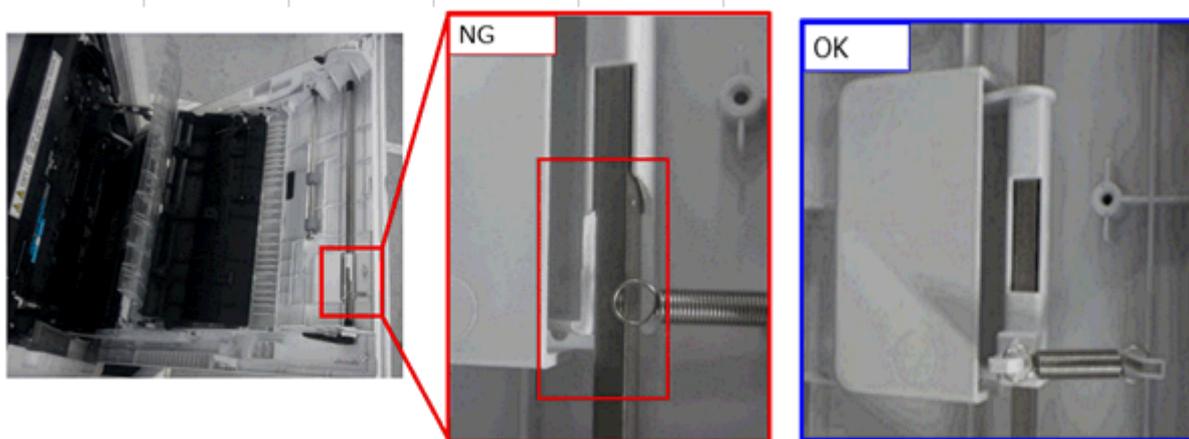
Lubricant contacts the shaft for the grip of the duplex unit, causing a chemical crack. As a result, the hook for the grip breaks and the spring detaches.
