Model: PD-D1	Date: 12-Apr-12	No.: RC279001c
--------------	-----------------	----------------

Subject: Firmware Release Note: Main(A3)		Prepared by: Y. Kuwabara	
From: 2nd Tech Service Sect., MFP/Printer Tech Service Dept.			
Classification:	<input type="checkbox"/> Troubleshooting	<input type="checkbox"/> Part information	<input type="checkbox"/> Action required
	<input type="checkbox"/> Mechanical	<input type="checkbox"/> Electrical	<input type="checkbox"/> Service manual revision
	<input type="checkbox"/> Paper path	<input type="checkbox"/> Transmit/receive	<input type="checkbox"/> Retrofit information
	<input type="checkbox"/> Product Safety	<input checked="" type="checkbox"/> Other (Firmware)	<input checked="" type="checkbox"/> Tier 2

Subject: Exit Pawl Timing Adjustment		Prepared by: K. Yamamoto	
From: 1st Tech Service Sect., MFP/Printer Tech Service Dept.			
Classification:	<input checked="" type="checkbox"/> Troubleshooting	<input type="checkbox"/> Part information	<input type="checkbox"/> Action required
	<input type="checkbox"/> Mechanical	<input type="checkbox"/> Electrical	<input type="checkbox"/> Service manual revision
	<input type="checkbox"/> Paper path	<input typ

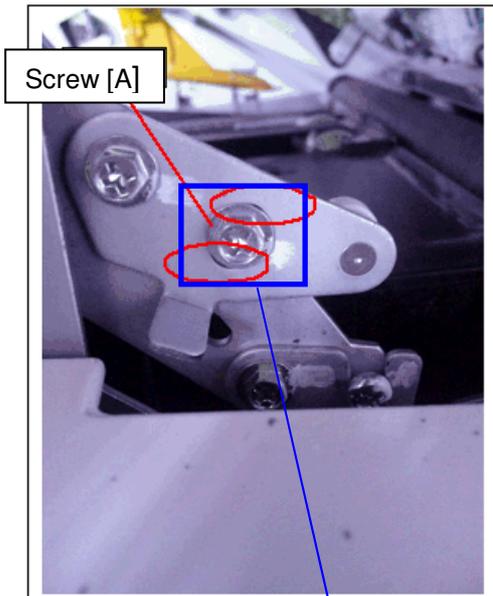
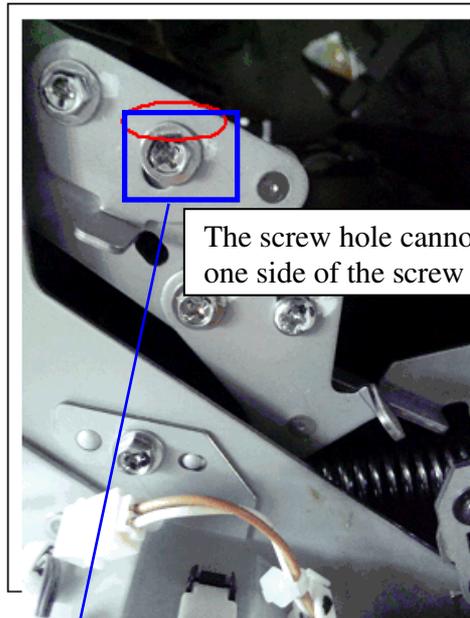
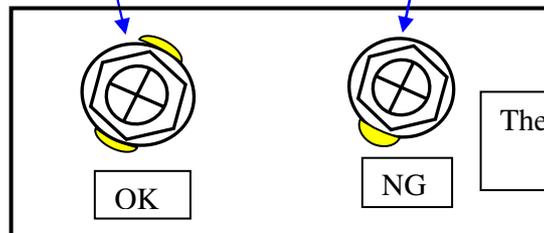
The Exit Pawl might be stuck to the drum during machine installation.

The exit pawl timing was not adjusted correctly at the factory.

1. Pull out the drum from the machine.
2. Check whether you can see the screw hole behind the screw [A].
 - If you **can** see any part of the screw hole, even if only a very small part (shown in yellow in the diagrams below), you **do not need** to do the “Adjusting the exit pawl timing” procedure below.
 - If you cannot see any part of the screw hole, do the procedure below.

The screw hole is shown in yellow

Check whether the exit pawl timing is correct (**Procedure I** below), and if it is not, adjust the pawl timing (**Procedure II** below).

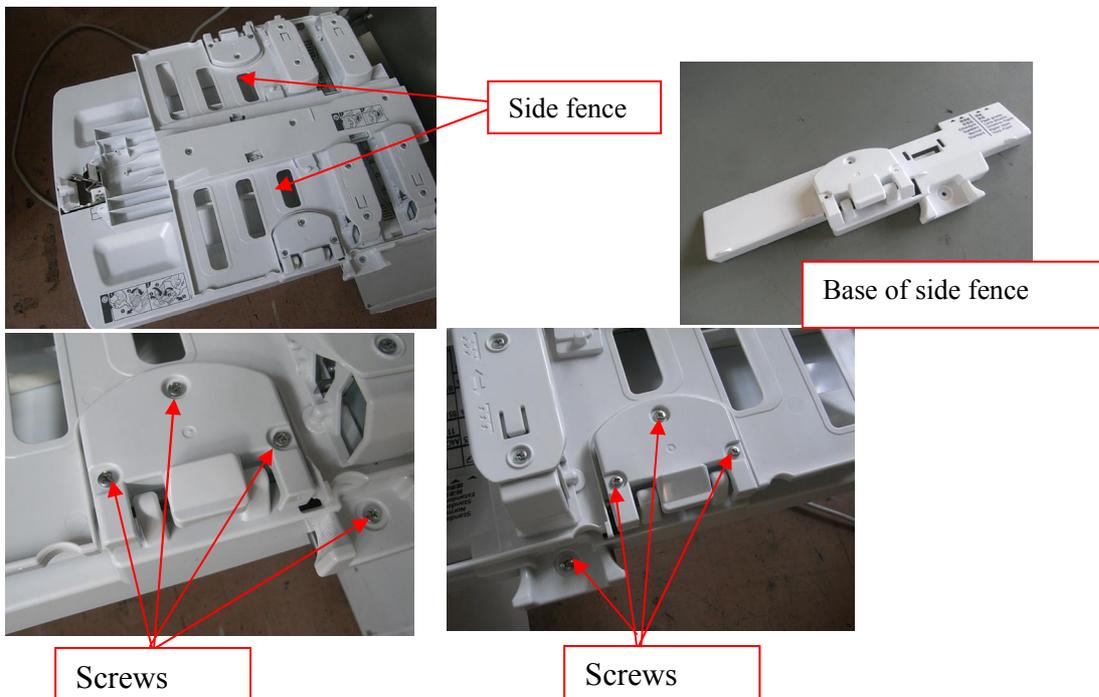
The base of the side fence for the paper exit table might break.

The oil on the shaft of the side fence base reduces the strength of the base (this oil should not be present on the shaft).

Replace the bases of the side fences for the paper exit table (screw x4 front, x4 rear).

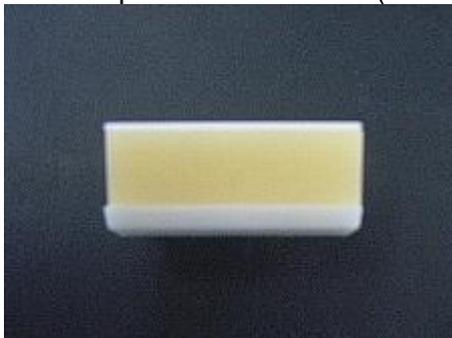
The paper is abraded after contacting the friction pad during paper feed.

The friction of the normal friction pad is too high or too low for some paper types.

Friction pad 2: **C2649001** (Coefficient of friction is **less than** that of the normal pad)

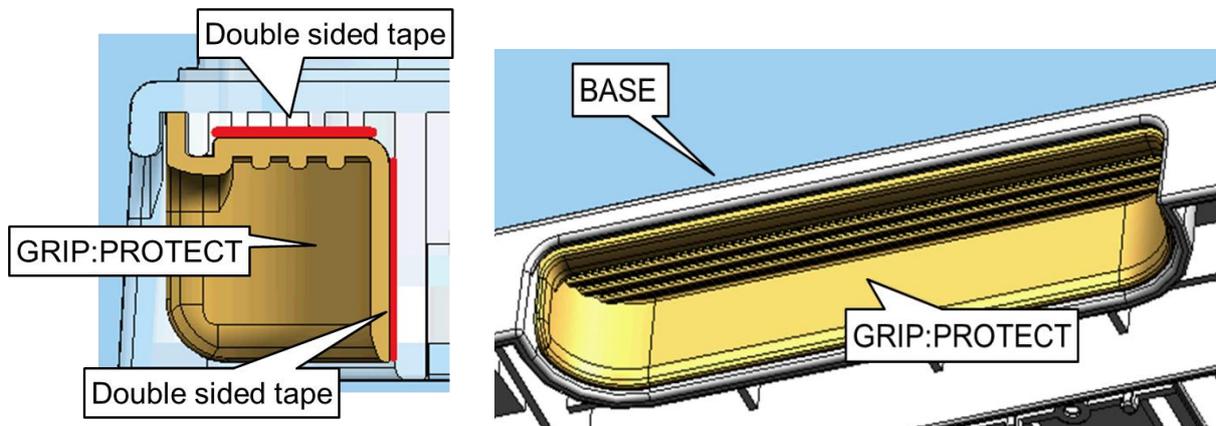
Reason: To increase the adhesive strength between the handgrip and DF base.

Note: The handgrip can be damaged when the DF is opened/closed repeatedly.

Important: Attach the grip to the base using double-sided tape.

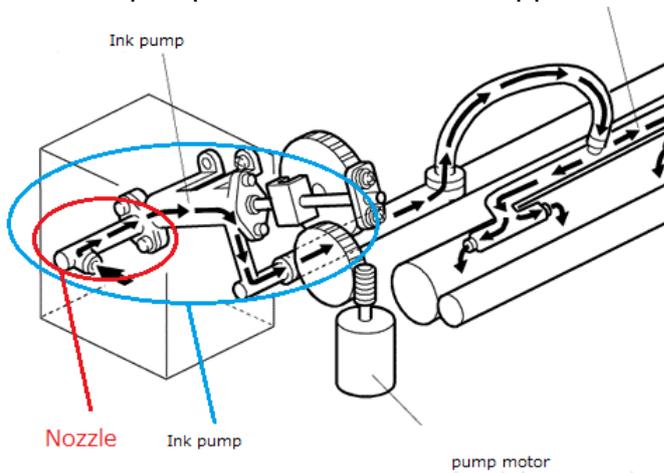
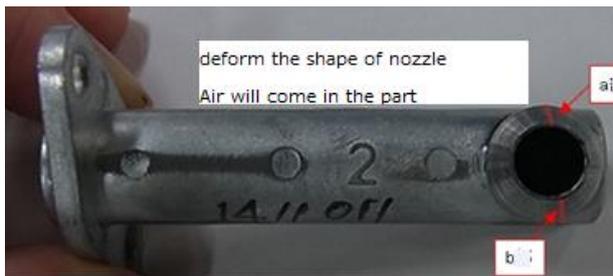
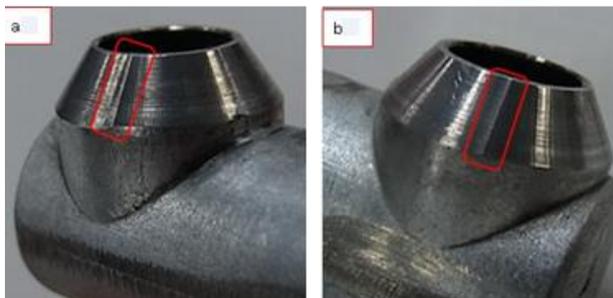
“No ink” is displayed while there is still ink remaining in the ink pack.

The ink nozzle is deformed, preventing a firm fit with the ink pack. As a result, air gets inside the pump and ink cannot be supplied to the machine correctly.

Replace ink nozzle (P/N C2799001).
