Technical Bulletin

Wodel. QO-D1			Date: 23 out 13	140110204000
Subject: Cloth scr	een of drum is torn	Prepar	ed by: K.Yamamoto	
From: Oversea Field				
Classification:	☐ Troubleshooting☐ Mechanical☐ Paper path☐ Product Safety	✓ Part informati✓ Electrical✓ Transmit/rece✓ Other (Firmw	Servi	n required ce manual revision fit information

Model: QU-D1			Date: 25-Jul-19		No.: RC284004	
Subject: Image problem due to shift (Slip out position) cloth screen					Prepared by: K.Yamamoto	
From: Oversea Field Sect., OP Product Quality Dept.						
Classification:	☐ Troubleshooting☐ Mechanical☐ Paper path☐ Product Safety	☐ Part informati☐ Electrical☐ Transmit/rece☐ Other (Firmw	eive		equired manual revision nformation

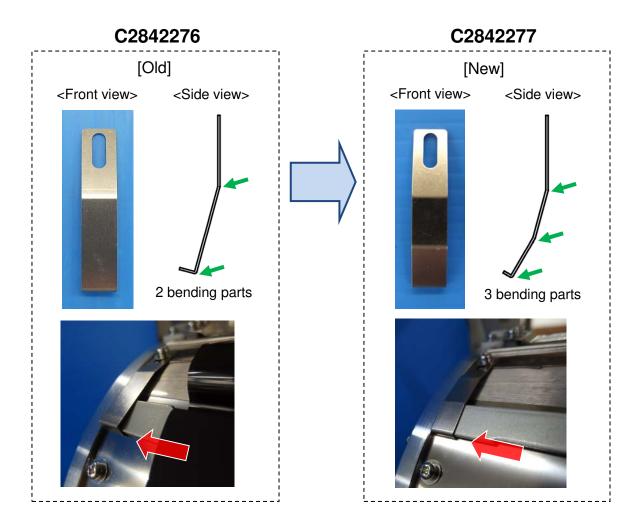
- The master slips out of place.
- The cloth screen slips from the cloth screen bar.
- The hook of the cloth screen bar does not catch the bar firmly.

- The new hook features a corrected angle, as shown.

Replace the following with the new parts, which have improved reliability.

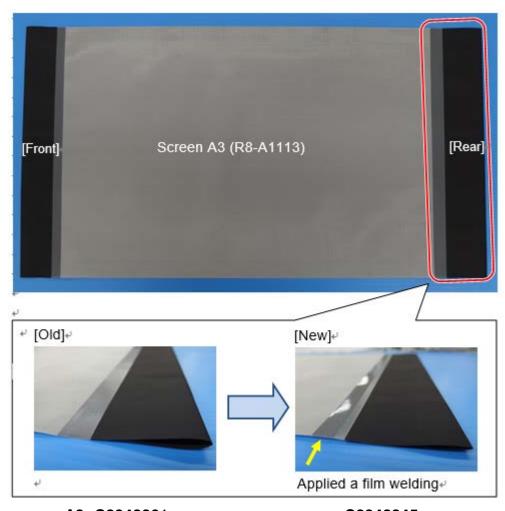
A3: C2842261 C2842245 B4: C2832261 C2832245

The edge of the cloth screen contacts the drum guide during printing, causing it to tear.

Replace the cloth screen with the new part.
