Model: PRIPORT Platinum/Platinum P/Platinum2		Date: 3-Sep-08	No: R-C267-001e
Subject: Firmware Modification History		Prepared by: K. Yamamoto, Priport Service Planning Section	
Classification:	<input type="checkbox"/> Troubleshooting <input type="checkbox"/> Part information <input type="checkbox"/> Action required <input type="checkbox"/> Mechanical <input type="checkbox"/> Electrical <input type="checkbox"/> Service manual revision <input type="checkbox"/> Paper path <input type="checkbox"/> Transmit/receive <input type="checkbox"/> Retrofit information <input checked="" type="checkbox"/> Other ()		
Model Name: Platinum: Ricoh DX3340/DX3440C/DX3240, Gestetner CP6146/DX3440/CP6300C/DX3240, Savin 3180DNP, Lanier LDD120, RexRotary DX3440/DX3240, nashuatec DX3440/DX3240, Standard SD360 Platinum P (China only): Ricoh DX3440CP, Gestetner CP6300P Platinum 2: Ricoh DX3442/DX3442C/DX3242, Gestetner DX3442/CP6301C/DX3242, Rotary DX3442/DX3242, nashuatec DX3442/DX3242

Model: PRIPORT Platinum/Platinum P		Date: 23-Oct-06	No: R-C267-002
Subject: Durability of the cloth screen is not enough		Prepared by: K. Yamamoto, Priport Service Planning Section	
Classification:	<input checked="" type="che

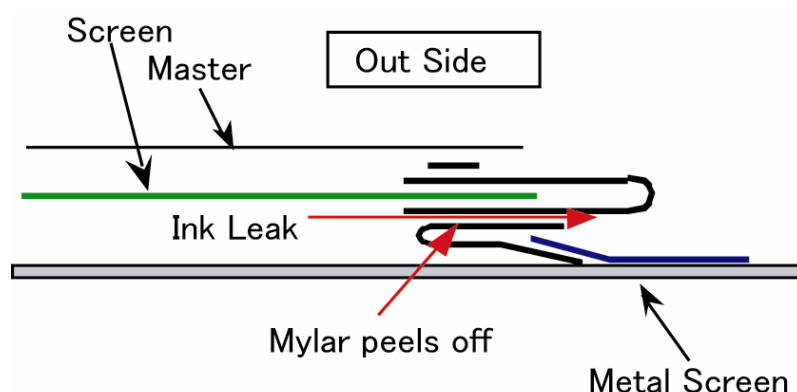
The ink leaks from the trailing edge of the cloth screen on the black drum.

The Mylar peels off the cloth screen during printing, causing the ink to leak from between the Mylar and cloth screen.

The cloth screen for the black drum was changed to the one that is used on optional drums.

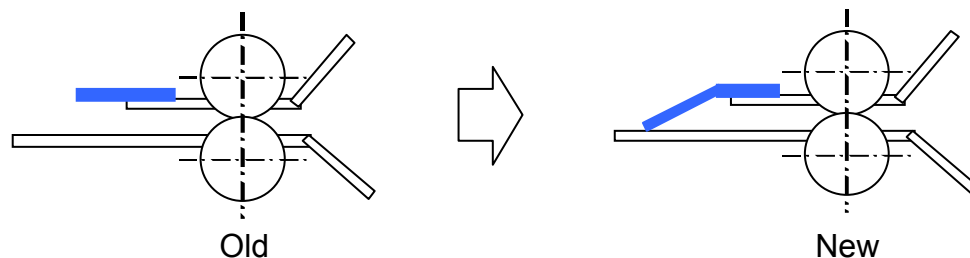
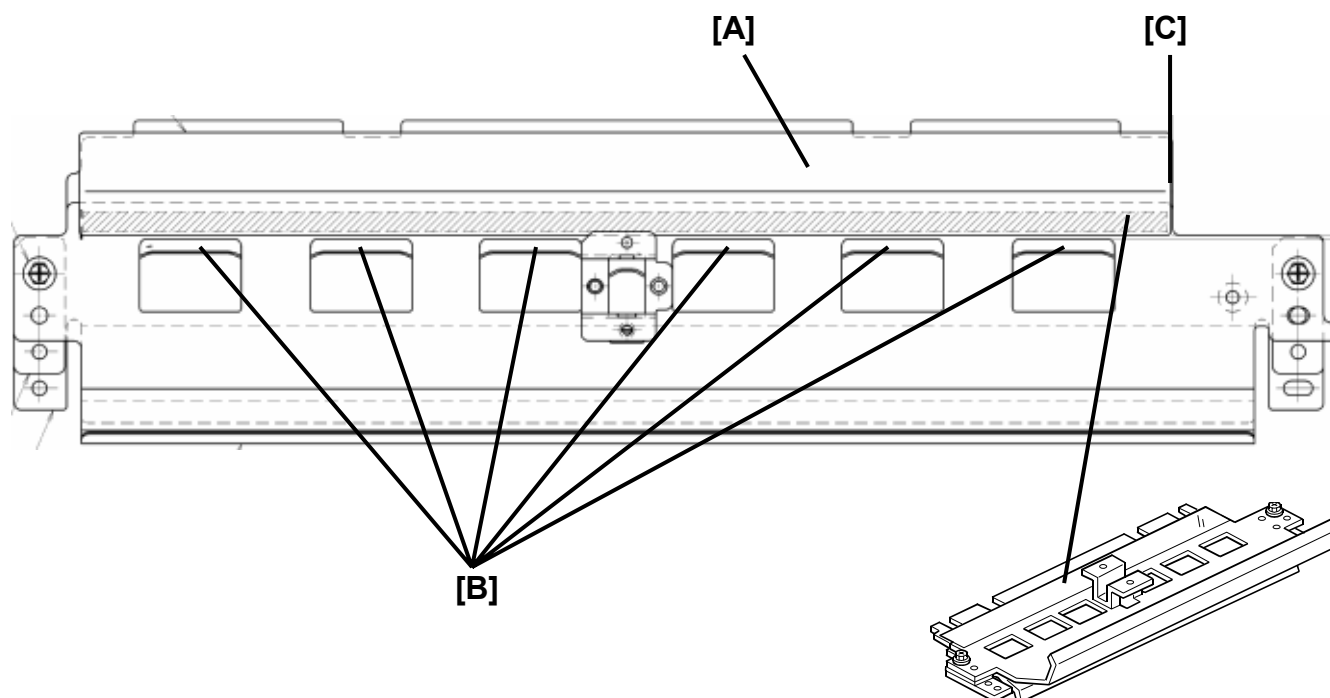
Difference

Paper wrinkles occur when using thin paper.

The paper is thinner than specification, or the print speed is too high for the type of paper used.

1. Remove the drum.
2. Open the master eject unit carefully.
3. Remove the old Mylar.
4. Clean the paper feed guide [A] and remove the glue.

1. Align the edge of the Mylar with the bumps [B], as shown above.
2. Make sure that the edge of Mylar is aligned with the edge of the guide [C].
3. The attachment position is the same for both the old and new Mylars.

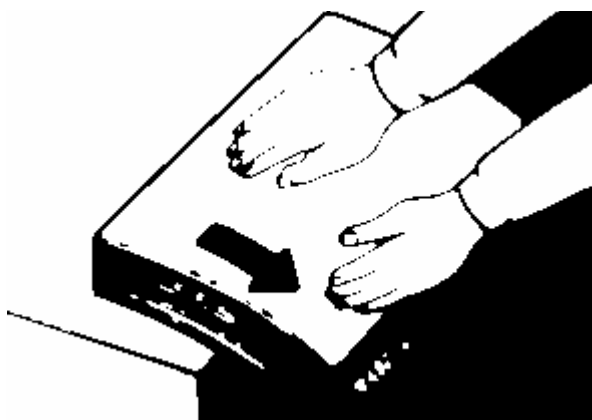
Sometimes when using thin paper, the paper wrinkles.

The paper is curled when loaded into the paper tray.

1. Make sure the paper is flat when loaded.
 - Store the paper in a low-humidity environment.
 - Do not open the paper ream until just before printing.
 - Make the paper flat.
See the picture below.

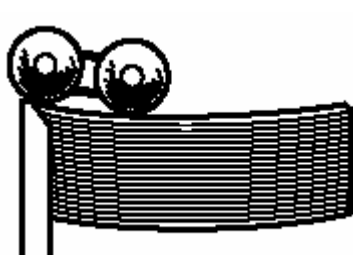
- If the paper is loaded when curling upward, it will minimize wrinkling, but there may be more paper jams.
- If the paper is loaded when curled downward, it will tend to form wrinkles, but there will be fewer paper jams.

- If the paper is already curled, try loading the paper upside-down in the tray.

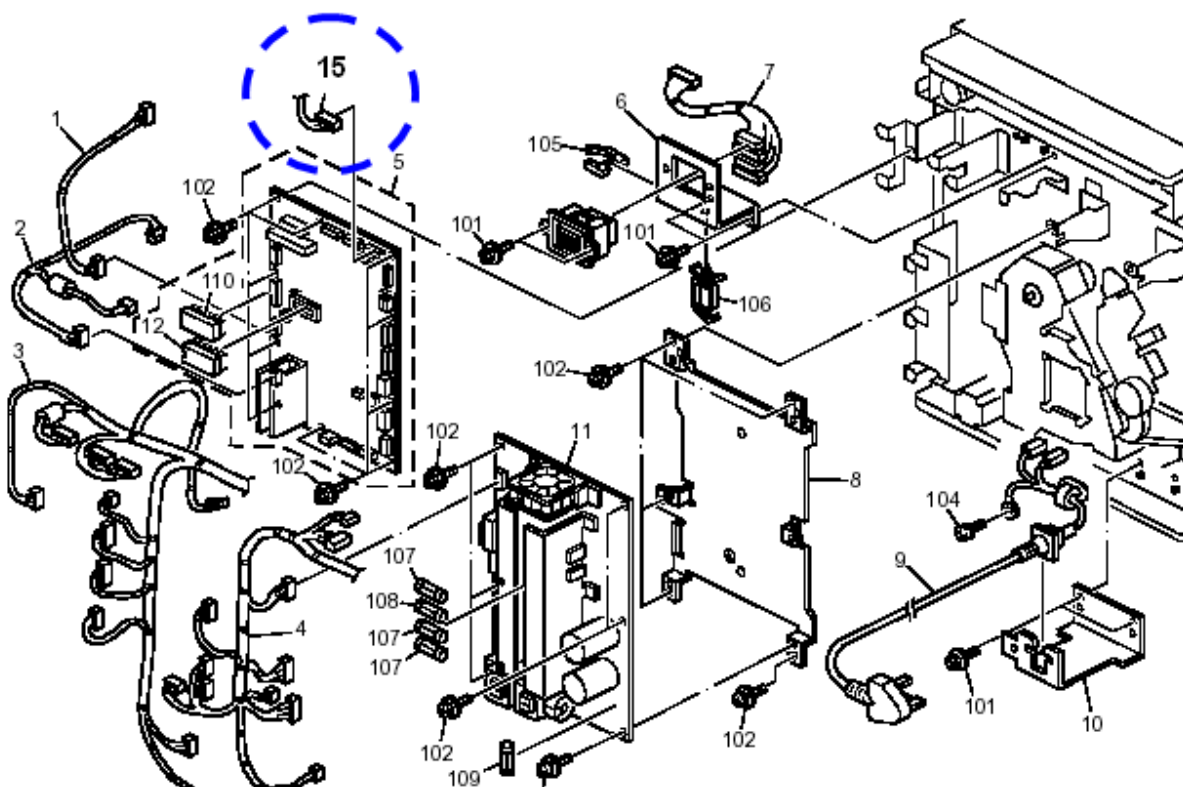
21.ELECTRICAL SECTION 1 (C267)

Change/Reason: The harness was missing from the Parts Catalog.
