Model: PRIPORT Cats-eye	Date: 29-Mar-07	No: R-C269-002a
Subject: Firmware Modification History	Prepared by: K. Yamamoto, Priport Service Planning Section	
Classification:	<input type="checkbox"/> Troubleshooting <input type="checkbox"/> Part information <input type="checkbox"/> Action required <input type="checkbox"/> Mechanical <input type="checkbox"/> Electrical <input type="checkbox"/> Service manual revision <input type="checkbox"/> Paper path <input type="checkbox"/> Transmit/receive <input type="checkbox"/> Retrofit information <input checked="" type="checkbox"/> Other ()	
Model Name:		
Cat's-eye: Ricoh DX4640PD, Gestetner CP6340D, Savin 3585DNP2, Standard SD462, Lanier LDD350d

This RTB contains the software release information for the Cat's-eye Operation Panel.

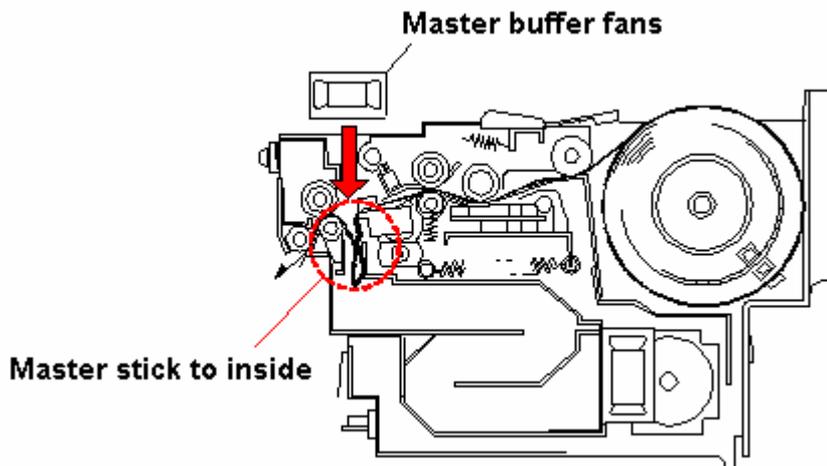
The master sticks to the inside of the master buffer duct.

The airflow of the master buffer fan is not strong enough.

Replace the master buffer fan.

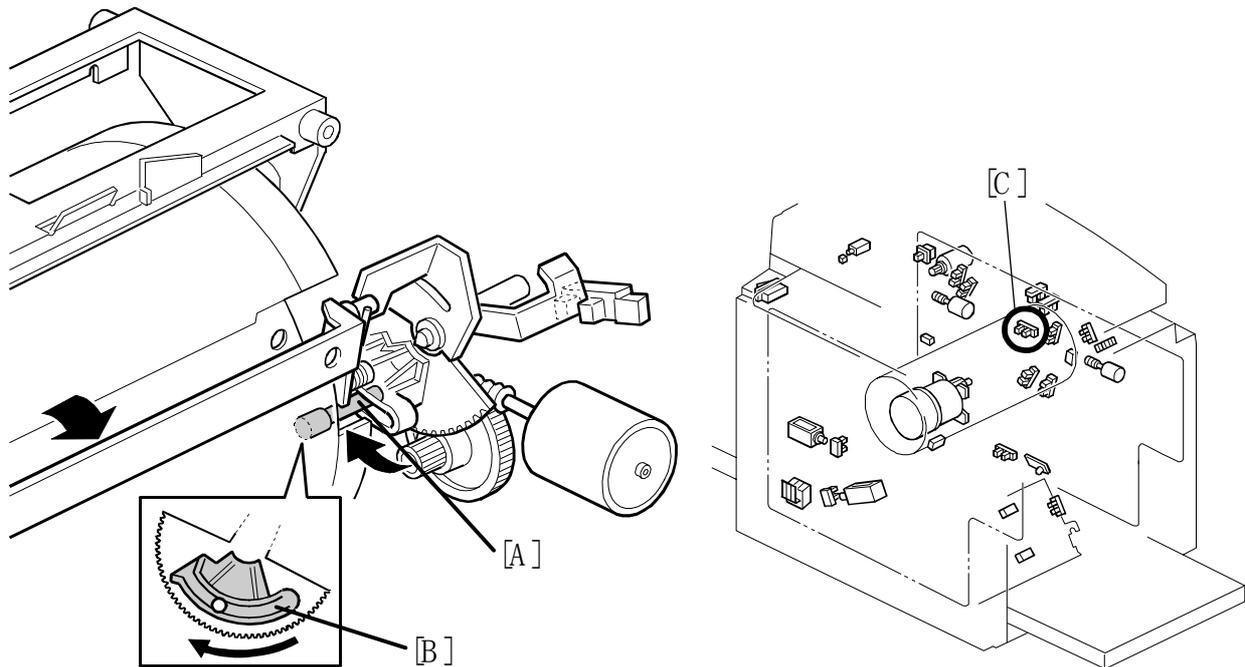
The drum does not stop at the master clamping position (2nd Drum Position Sensor [C]). As a result, the drum guide [A] cannot hold the drum stud [B].

If this symptom occurs on any of the following machines, replace the bracket for the 2nd drum position sensor (new P/N: **P/N C2699001**).

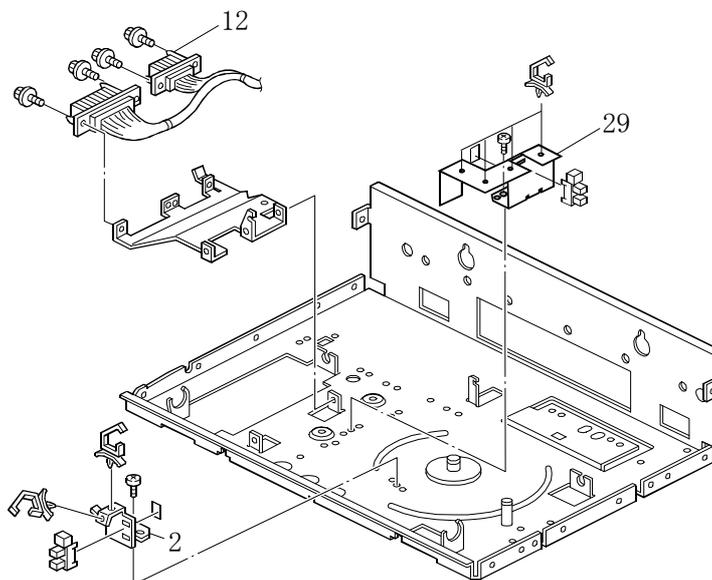
The edge of the duplex unit suction fan hits the harness and damages it.

Replace the harness [12] and sensor bracket [29] together as a set.

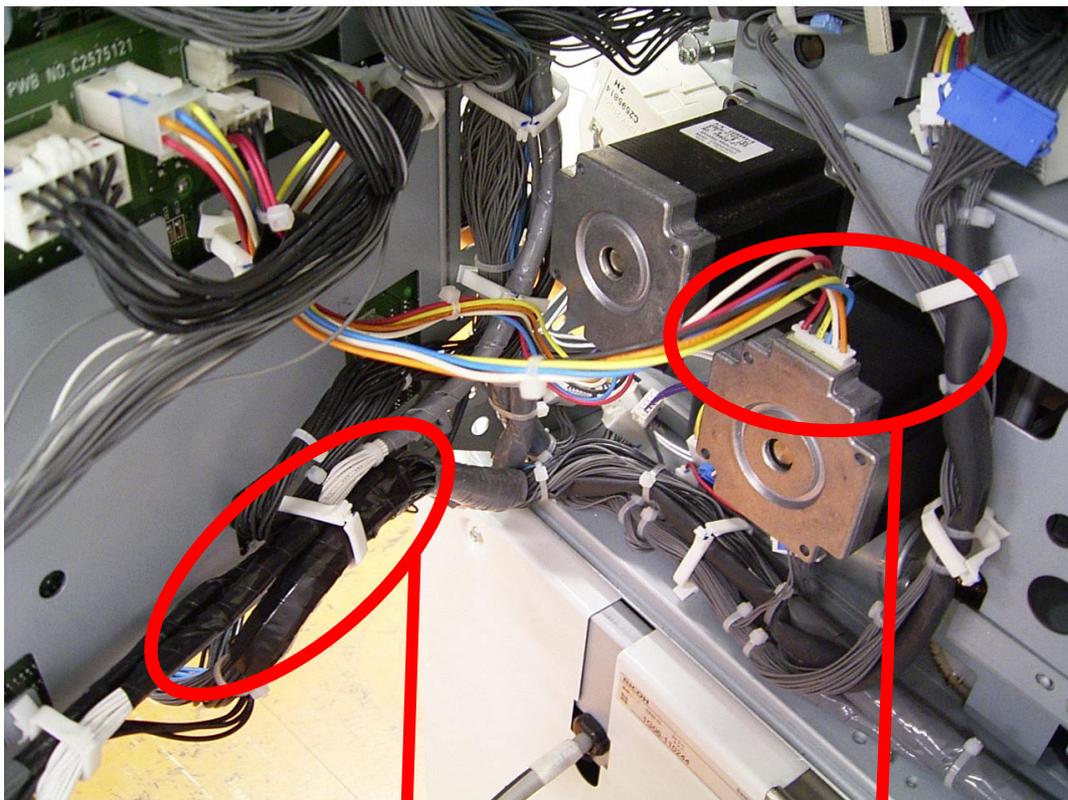
The covers of the harnesses around the registration motor are damaged, which triggers a short circuit.

Tape was added

Motor harness connector is now located on top

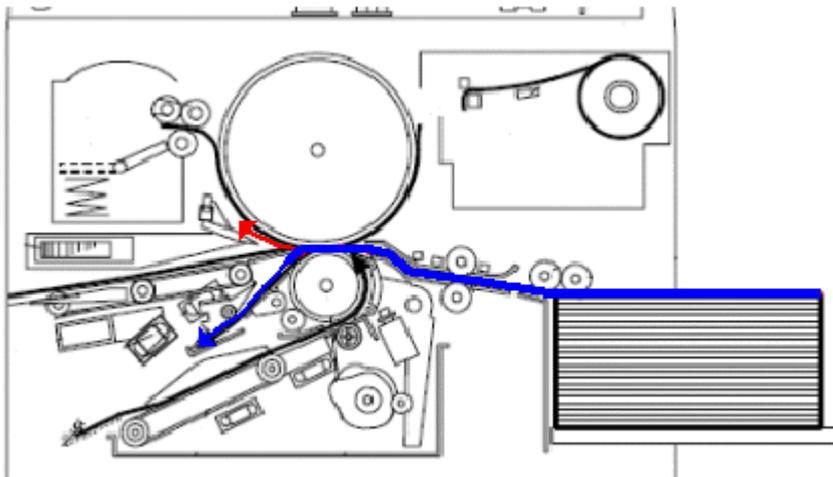
The solid image area along the leading edge sticks to the drum, preventing the paper from separating from the drum properly. (The paper follows the path shown by the red line in the photo below, when it should follow the path shown by the blue line).

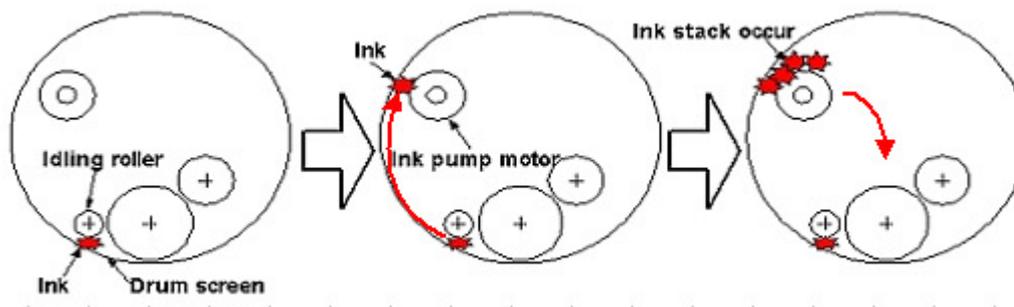
Lumps of ink build up on the ink pump motor and eventually drop onto the drum and stick to the drum surface.

- 1) Do the solution described in RTB #RC262017.
- 2) If the symptom still occurs, replace the following brackets as a set:

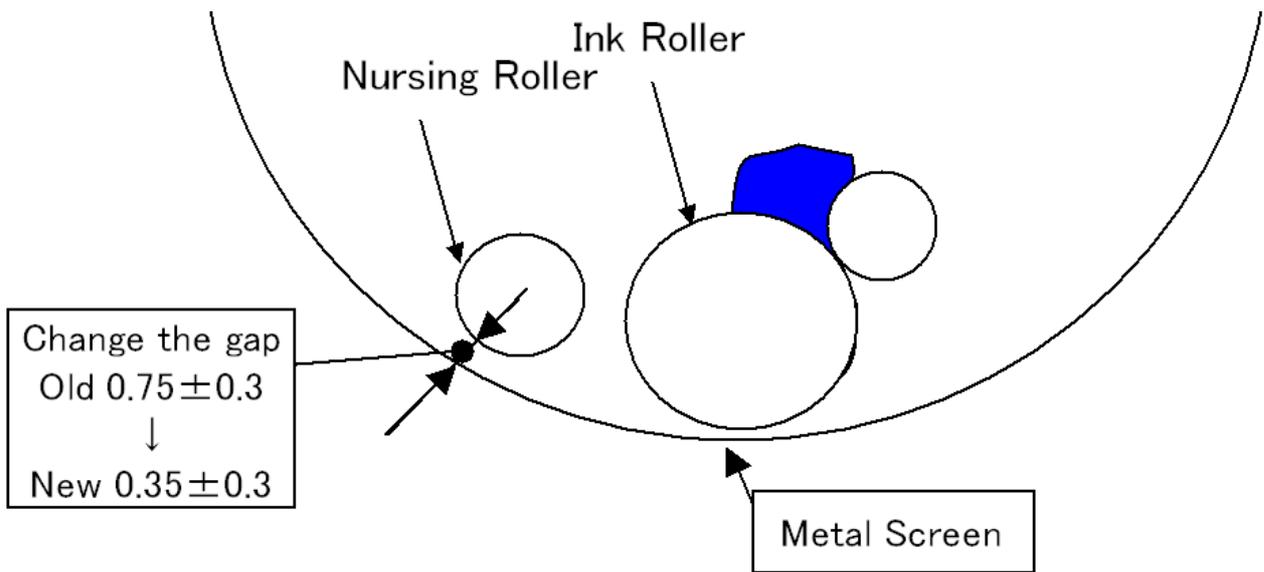
The shape of hole is changed

Change the gap
Old 0.75 ± 0.3
↓
New 0.35 ± 0.3
