Model: PRIORT EMERALD/TOPAZ		Date: 1-Dec-05	No: R-C262-001
Subject: Firmware Release History (ACU)		Prepared by: K. Yamamoto, Priort Service Planning Section	
Classification:	<input type="checkbox"/> Troubleshooting <input type="checkbox"/> Part information <input type="checkbox"/> Action required <input type="checkbox"/> Mechanical <input type="checkbox"/> Electrical <input type="checkbox"/> Service manual revision <input type="checkbox"/> Paper path <input type="checkbox"/> Transmit/receive <input type="checkbox"/> Retrofit information <input checked="" type="checkbox"/> Other ()		
Model Name: EMERALD: Ricoh HQ9000, Gestetner CP6346, RexRotary CP6346, nashuatec CP6346, Savin 3590DNP, Standard SD700, Lanier LDD280 TOPAZ: Ricoh HQ7000, Gestetner CP6334, RexRotary CP6334, nashuatec CP6334, Savin 3580DNP, Standard SD460, Lanier LDD250

Model: PRIPORT EMERALD/TOPAZ		Date: 27-Dec-05	No: R-C262-006
Subject: Firmware update during USB connecting		Prepared by: K. Yamamoto, Priport Service Planning Section	
Classification:	<input checked="" type="checkbox"/> Troubleshooting <input type="checkbox"/> Part information <input type="checkbox"/> Action required <input type="checkbox"/> Mechanica

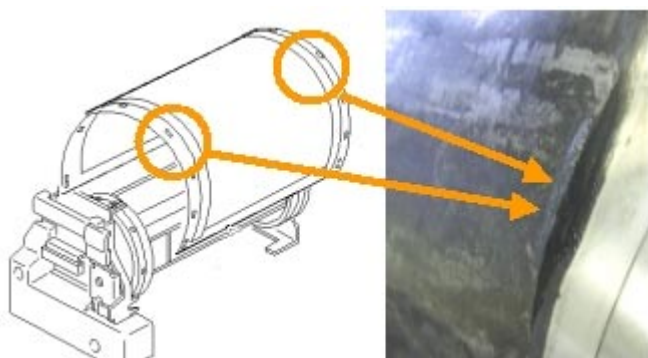
The edge of the metal screen breaks

The metal screen bumped into something on the floor when the user removed the drum from the machine.

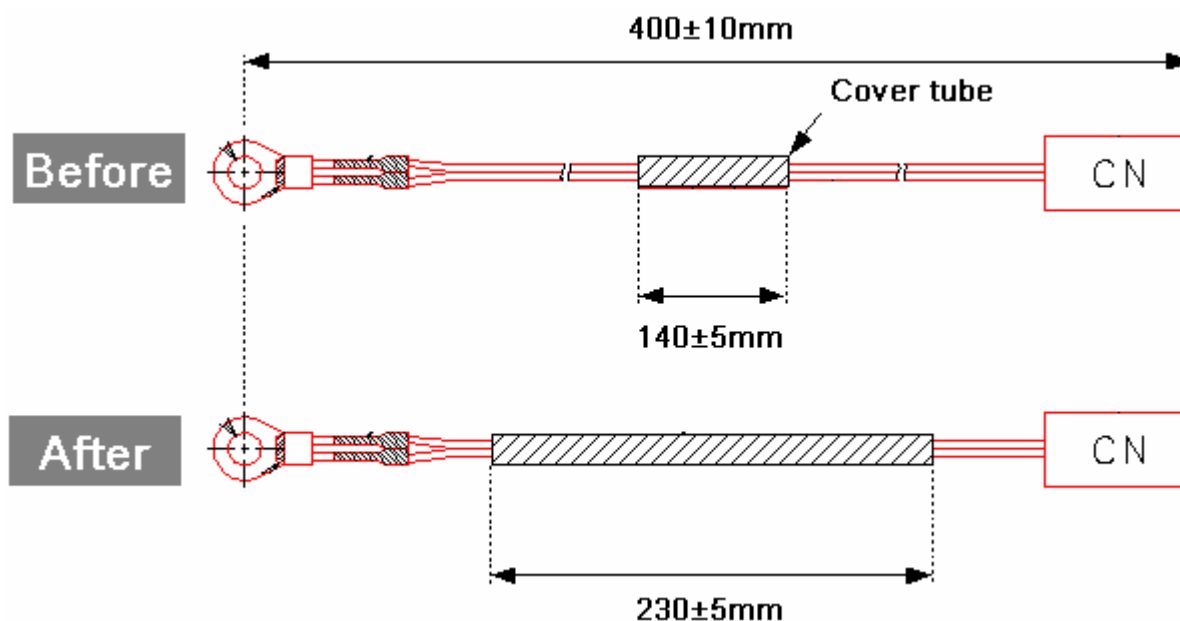
The thermistor hits the inside of the machine frame, causing damage to the cover tube. If a short-circuit occurs, SC307 is triggered.

The length of the cover tube was increased from 140mm to 230mm.

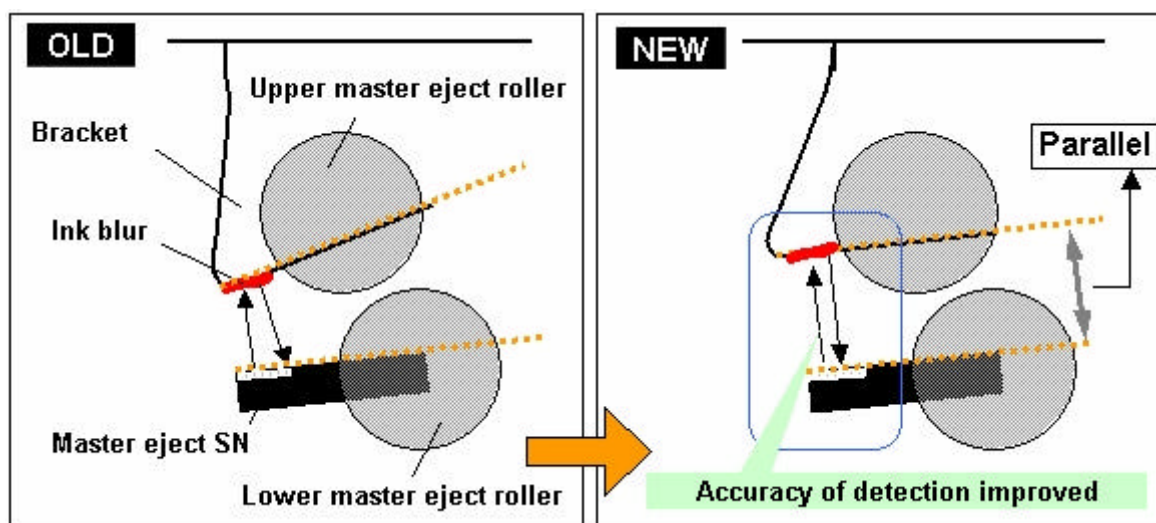
The shape of the bracket was changed to improve detection accuracy.

Replace the bracket for the master exit sensor.

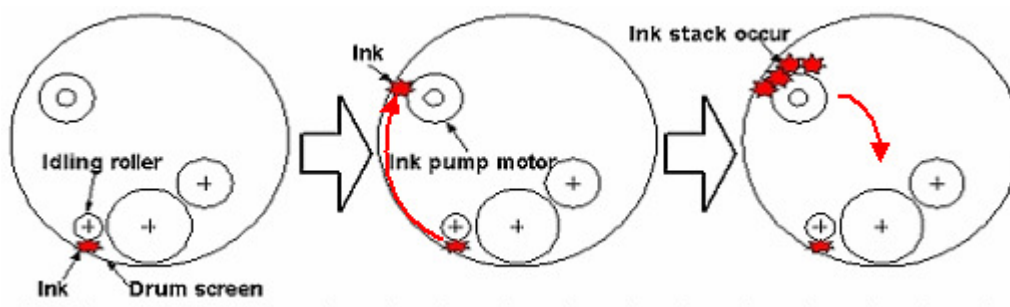
Lumps of ink build up on the ink pump motor, and eventually the ink begins dropping into the drum and sticks to the drum surface.

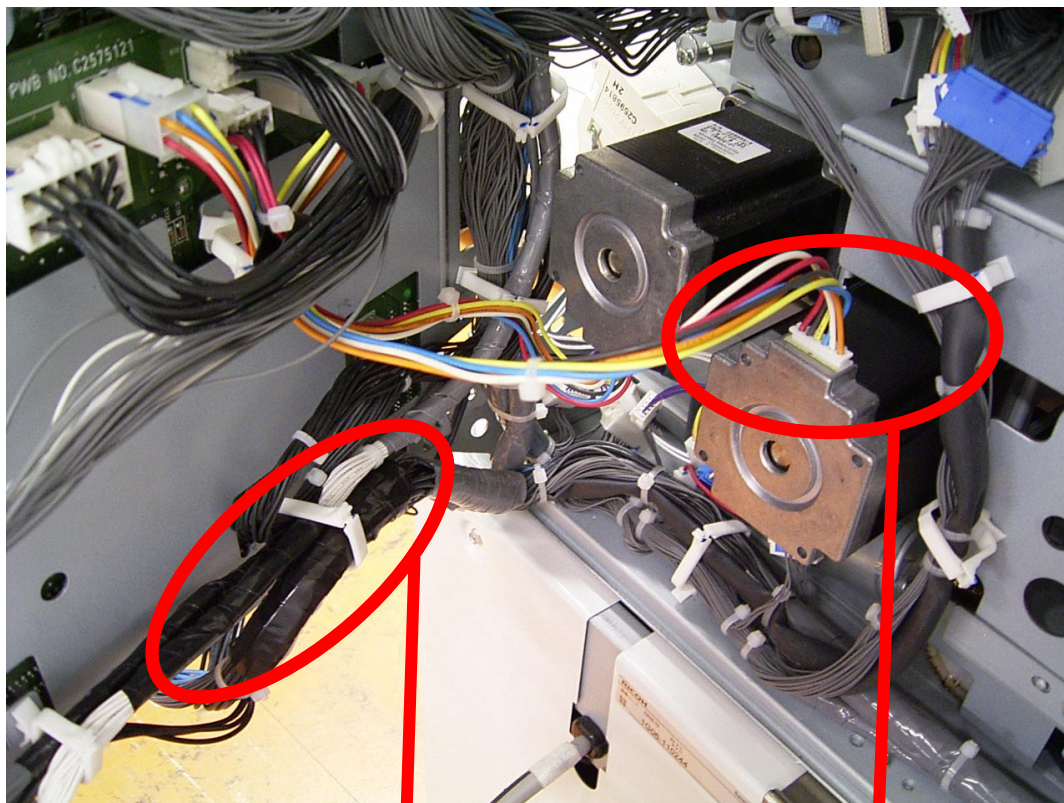
The covers of the harnesses around the registration motor are damaged, which triggers a short circuit.

- The registration motor is now attached in a different direction so that the harness connector is at the top (180 degrees from its current position).
- Tape was added to the harness to further protect the harness.

Tape was added

Motor harness connector is now located on top

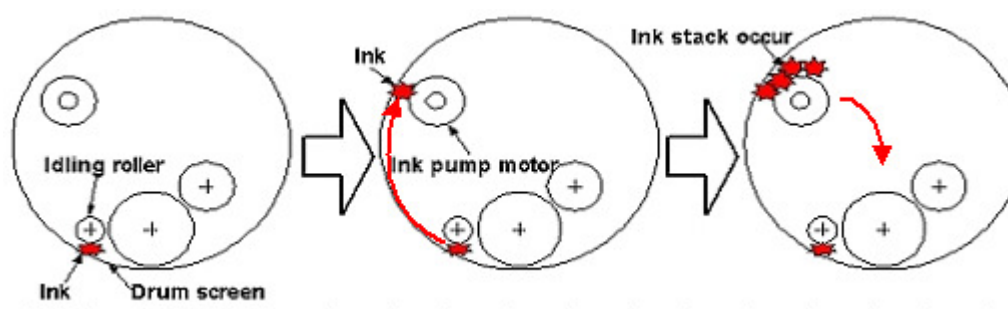
Lumps of ink build up on the ink pump motor and eventually drop onto the drum and stick to the drum surface.

- 1) Do the solution described in RTB #RC262017.
- 2) If the symptom still occurs, replace the following brackets as a set:
