Model: PRIPORT SILVER		Date: 31-Dec-98	No: 01
Subject: Firmware Modification History		Prepared by: H. Kokubo,

Model: PRIPORT SILVER		Date: 15-Apr-99	No: 02
Subject: Controller Connectivity Problem (Firmware Update Information)		Prepared by: H. Kokubo,

Model: PRIPORT SILVER		Date: 15-Jun-99	No: RC231003
Subject: Paper jam at the paper delivery section		Prepared by: H. Kokubo,

Model: PRIPORT SILVER		Date: 15-Jun-99	No: RC231004
Subject: E-01 Cutter Failure, Master Misfeed		Prepared by: H. Kokubo,

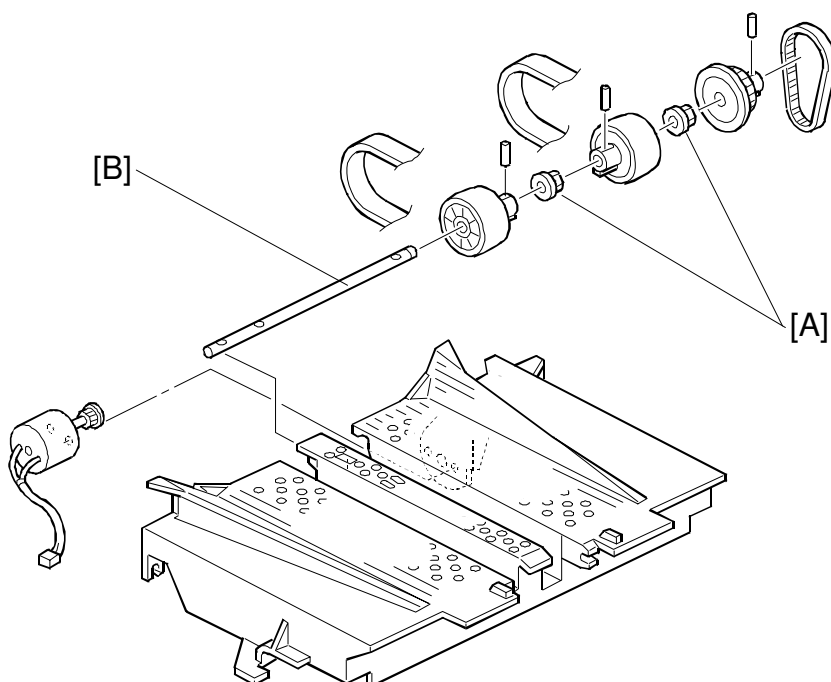
CAUSE

When this problem occurs, lubricate the shaft [B] where the bushings [A] contact.

On the production line, lubrication has been added from October '98.

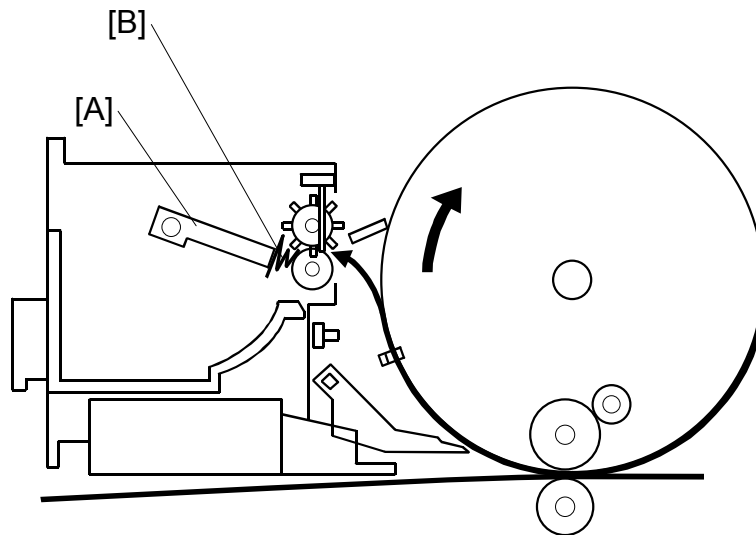
This is because the home position of the pressure plate [A] is wrong.

If the pressure plate position is slightly lower than normal, the pressure plate [A] will interfere with the ejected master [B] as shown above, causing a jam.

Make sure that the stop position for the pressure plate is correct.

The pressure plate HP adjustment process has been added from the November 1999 production.

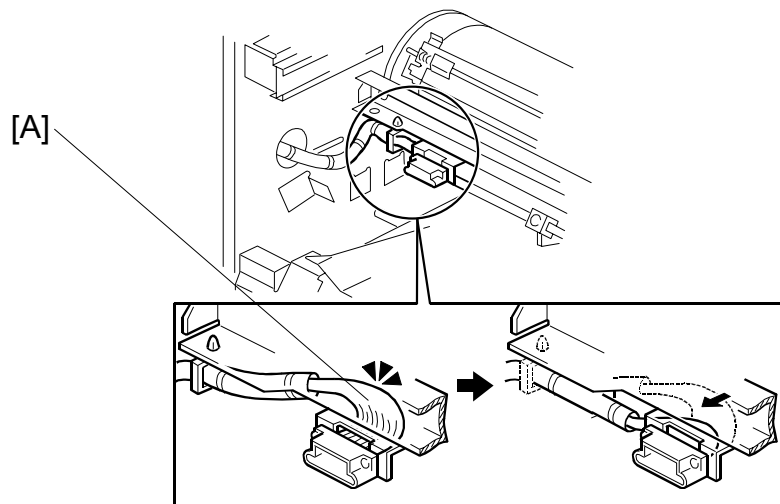
Damaged DC harness wires located inside the stay that hold the master eject unit can cause these problems.

The wires are damaged by the master clasper on the drum while the drum is turning. DC current (+ 5-volt going to the master eject sensor) grounded at a certain interval (synchronizing the drum rotation) during printing, causes these problems.

If the DC harness wires [A] are warped, adjust them as shown above.

Check if the harness (located as [A]) touches the master clasper when it comes close to the turning drum. If the harness touches the drum (and if it is already damaged), reroute the harness and firmly attach it with tape.

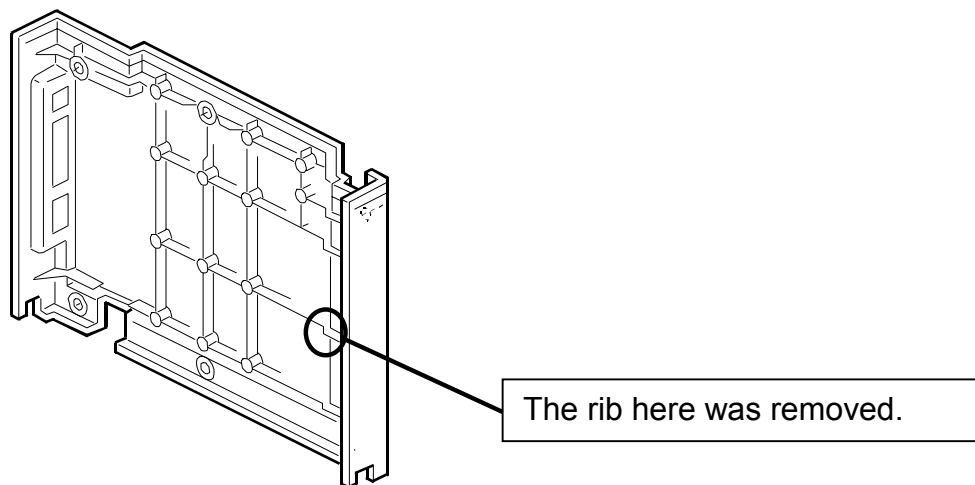
There is a short relay cable that goes to the paper end sensor (from the main dc harness). The relay cable tends to be caught by the rib on the reverse of the rear exterior cover (C2311362) when the cover is installed. This will damage the relay cable wires, causing the paper end sensor to malfunction.

To make the rear cover installation easier, the rear cover has been changed. The rib where the cable wires are caught was removed (see below). This modification was applied from January 1999 production.

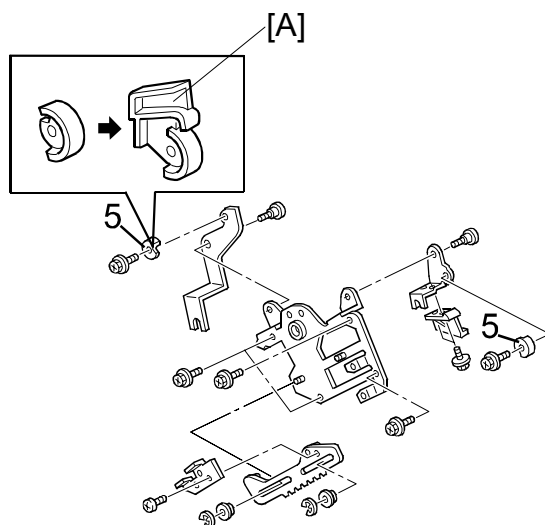
When a new drum guide (see MB #MC231007) was installed, it may be broken.

1. Grease is not applied to the drum guide service parts.
2. The drum position on the master making section is not correct.

Please lubricate area [A] of the drum guide as shown above.

NOTE: The part number of our recommend grease is 52039502.

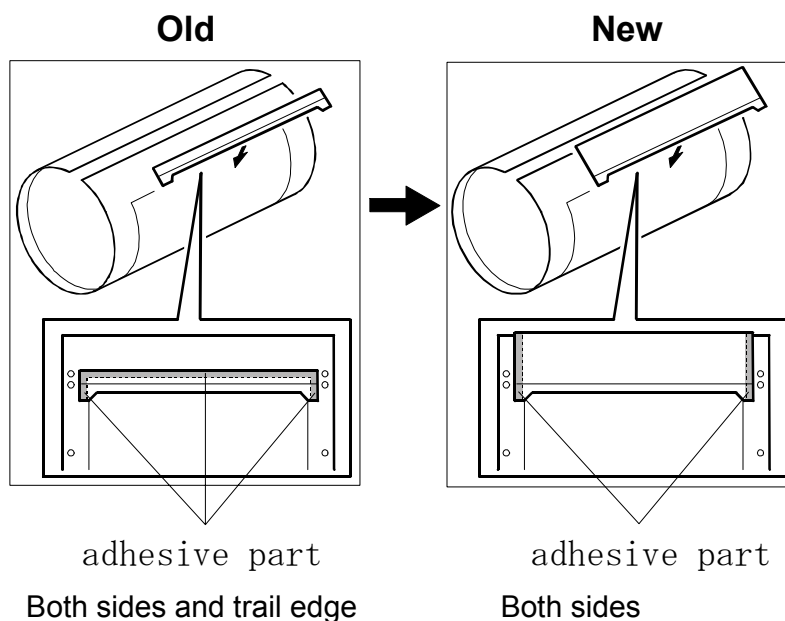
The adhesive of the mylar seal for metal and cloth screen is weak because the ink pressure affects the mylar seal. As the result, ink leaks from the trailing edge of the metal screen.

The adhesive parts are only at the sides of the mylar seal for the new metal screen (not at the trailing edge).

A new mechanism for the metal and the cloth screen has been developed. You must replace the metal and the cloth screen as a set.

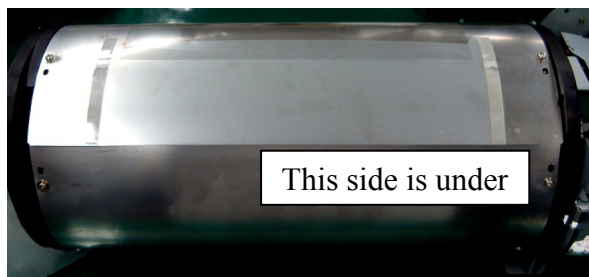
Incorrect:

The trailing edge (the side of the Mylar that is attached) of the metal screen was placed incorrectly at the factory (The trailing edge was placed above the leading edge of the metal screen).

The Mylar is placed above the leading edge of the metal screen.

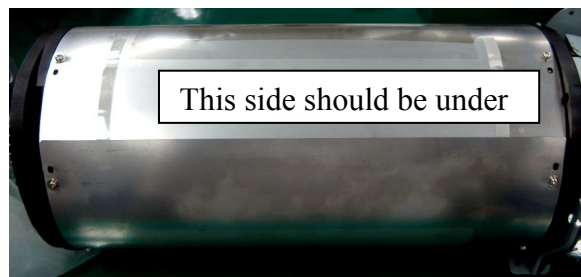
CORRECT:

The Mylar is placed **under** the leading edge of the metal screen.

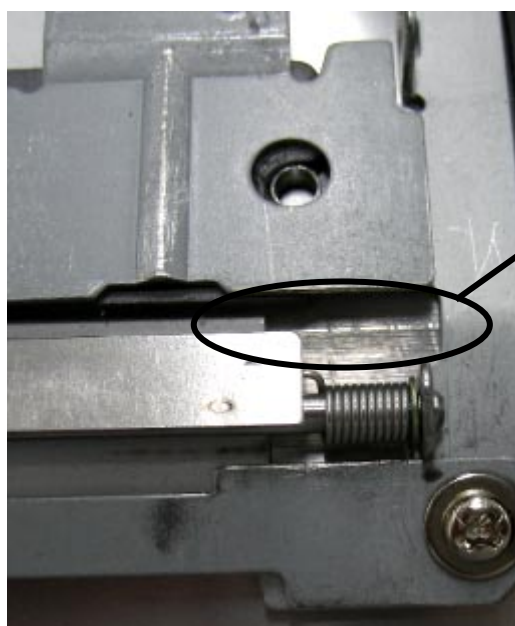
NG

You can see or feel a ridge/bump in area [A].

- If area [A] is completely flat, you do not need to do the action in this RTB.
- If you can see or feel a ridge in area [A], **do the procedure below.**

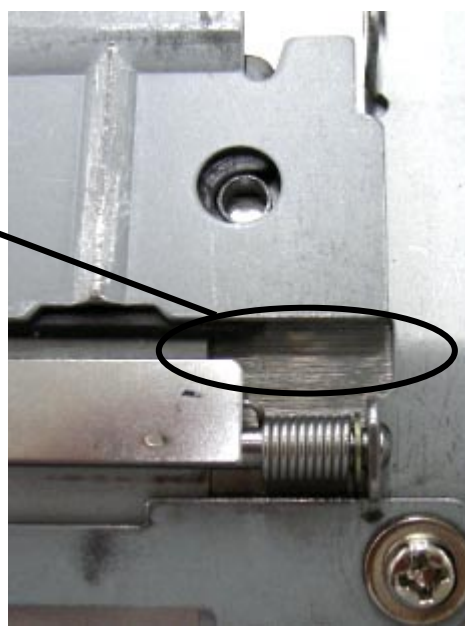
OK

The tape in area [A] is completely flat.
