Model: PRIORT PINKGOLD		Date: 20-May-02	No: R-C238-001
Subject: PINKGOLD firmware history		Prepared by: H. Onodera, Priort Service Planning Section	
Classification: <input type="checkbox"/> Troubleshooting <input checked="" type="checkbox"/> Part information <input type="checkbox"/> Action required <input type="checkbox"/> Mechanical <input type="checkbox"/> Electrical <input type="checkbox"/> Service manual revision <input type="checkbox"/> Paper path <input type="checkbox"/> Transmit/receive <input type="checkbox"/> Retrofit information <input type="checkbox"/> Other ()			
Model Name: Ricoh JP3000/JP3800, Gestetner 5430/5428C, RexRotary 1330, nashuatec CP430, Savin 3260DNP, Standard SD370

This bulletin is to inform you of the firmware modification history of Priort PINKGOLD.

FIRMWARE MODIFICATION HISTORY

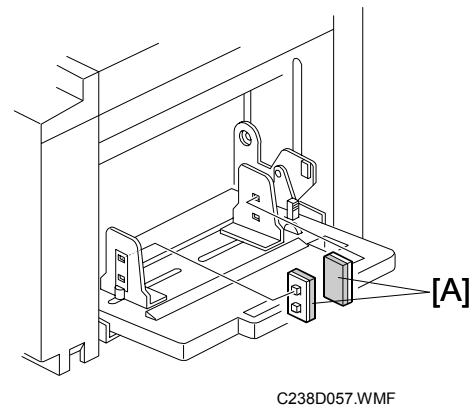
The image shifts approximately 7mm when the side fence friction pads [A] are used.

Note: As shown in Table 1 below, a shift may still occur when using suffix D with the old pads.

As stated above, the effective width of the paper + old pads is at or very near the upper limit of the suffix D detection range. Therefore, if pads need to be used, it is recommended to use the new pads together with the suffix D firmware.

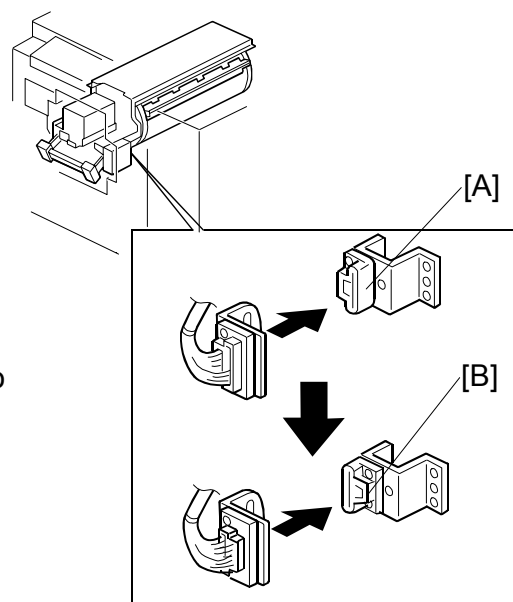
C238A085.WMF

Only B4 drums can be installed on the PG B4. The direction of the connector has been changed from [A] to [B] as shown, so that the A3/A4 drums used on the PINKGOLD cannot be installed on the PG B4.

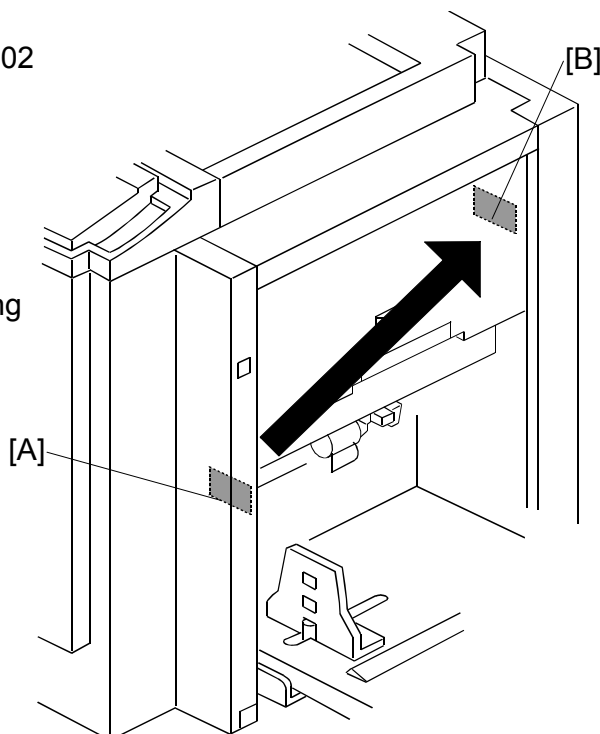
C249A045.WMF

The plate [B] is visible when the master making unit is pulled out.

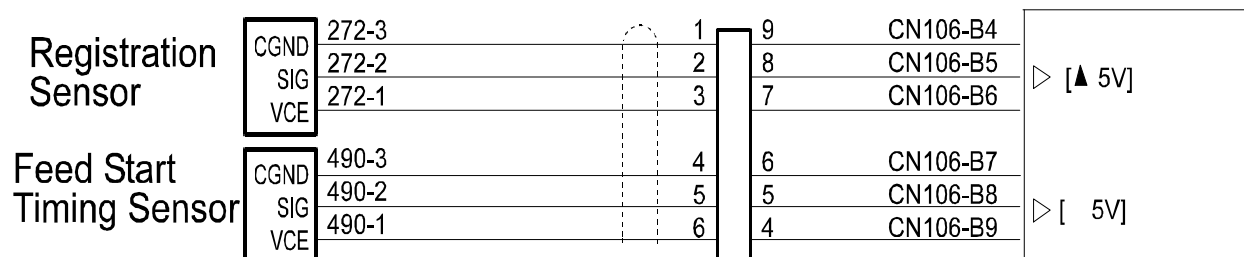
Registration and feed start timing sensors shown going to **CN 106** on the MPU.

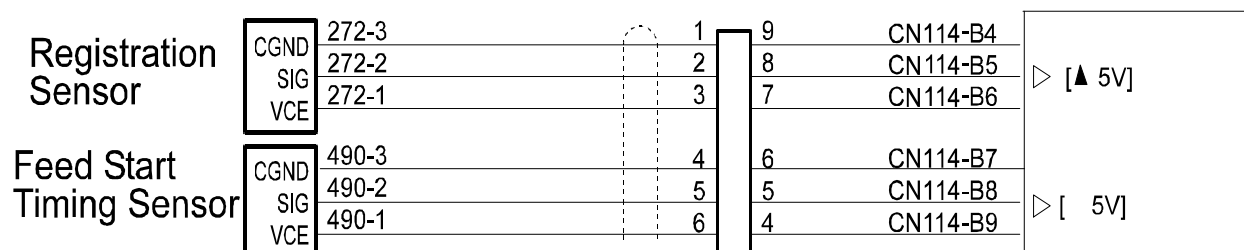
Both sensors go to MPU **CN114**.

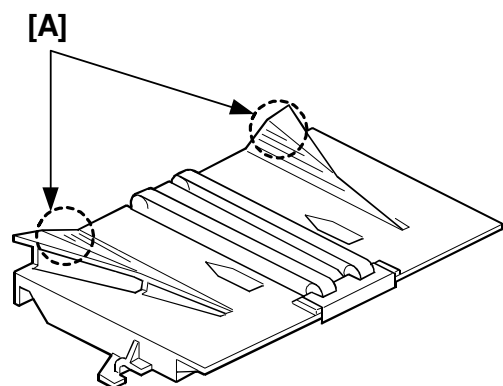
The paper delivery unit wing tips [A] are scratched by the paper, increasing the static electricity buildup in the area. The static buildup eventually overcomes the force of paper delivery, triggering the jam.

- 1) Replace the parts with the modified ones, OR
- 2) Install the metal wing set shown below.

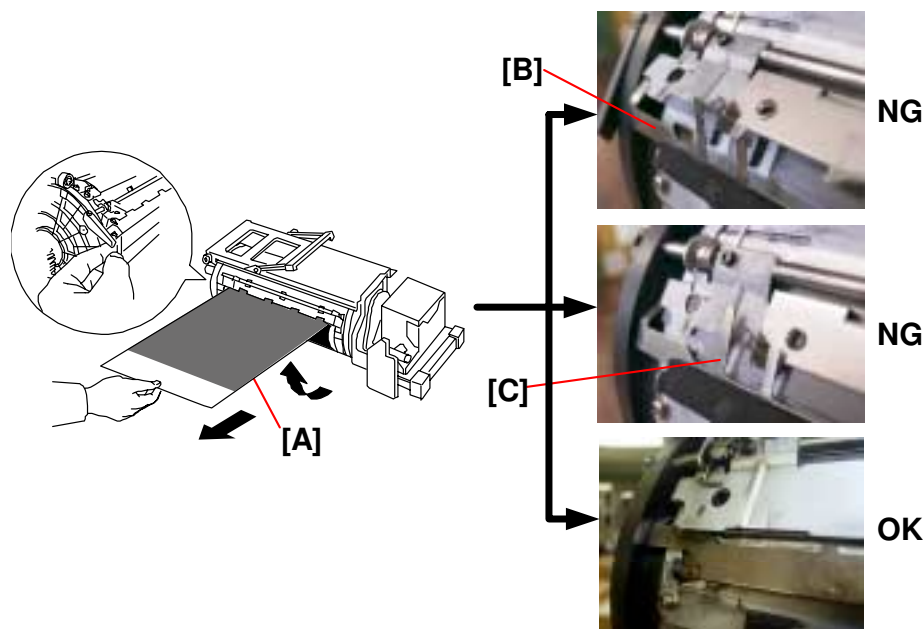
Note: Incorrect = The clumper's lower teeth are on the outside.

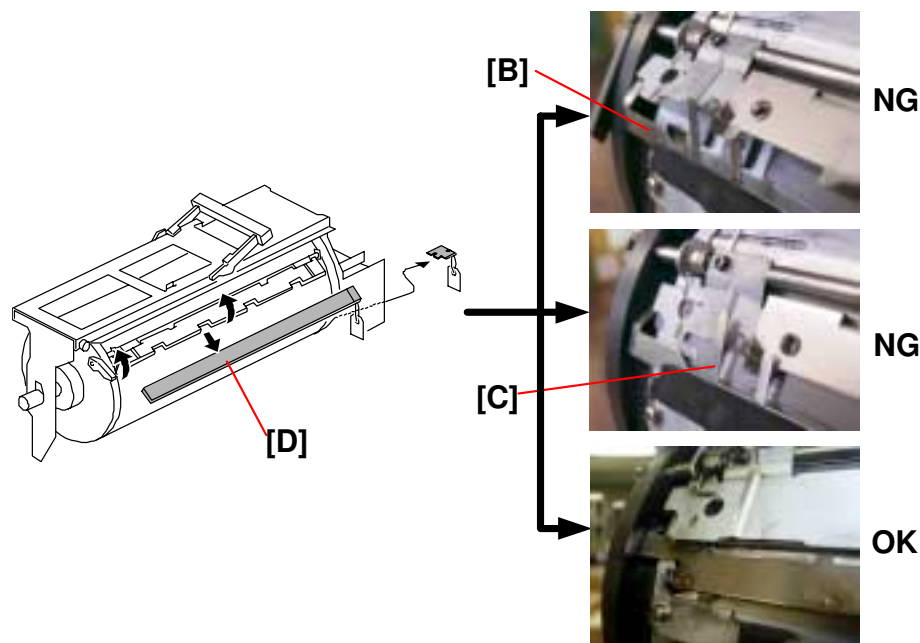
Note: Incorrect = The clasper's lower teeth are on the outside.

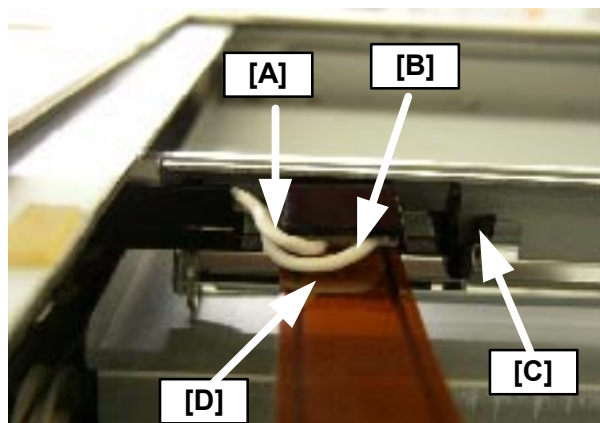
Fig. 2: Incorrect

- If the wires are like "Fig. 2: Incorrect", go to Step 3.
3. Turn OFF the main switch.
4. Remove the exposure glass.
5. Check the flexible cable [D].
 - If you see any damage to the outside of the flexible cable, replace it.

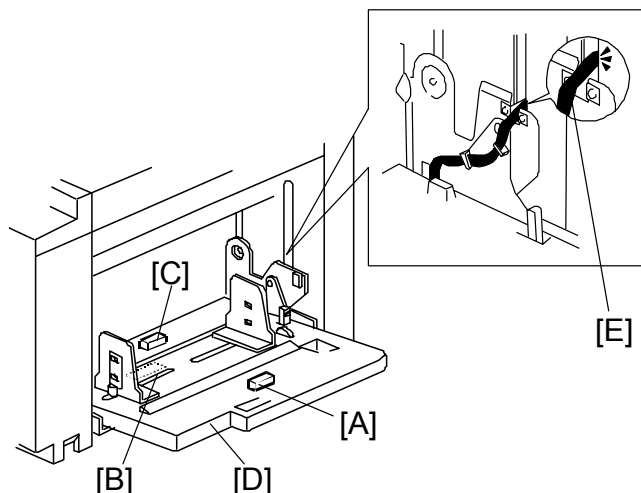
A sensor misdetection occurs (sensors [A], [B], [C]), which can sometimes damage the harness [E] for the paper feed tray.

The harness [E] rubs up against the paper size sensor stay when the paper table [D] is moved. As a result, the outer layer of the harness is damaged.

Important: When you install the new parts for the first time, install them **together as a set**.

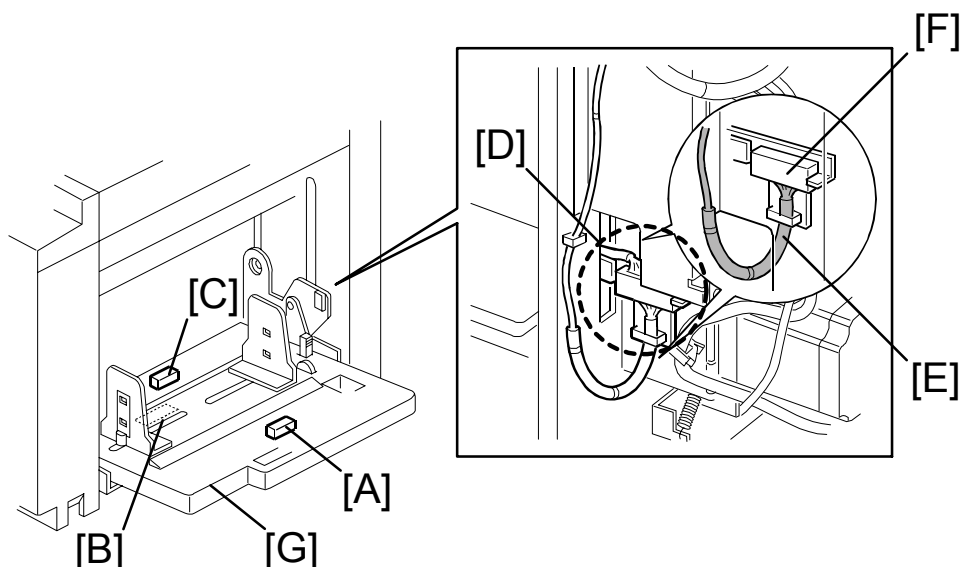
- 1) Poor connection [D] between the paper tray relay harness [E] and CN420 [F].
- 2) The paper tray relay harness [E] comes loose when the paper table [G] is lifted up or down.

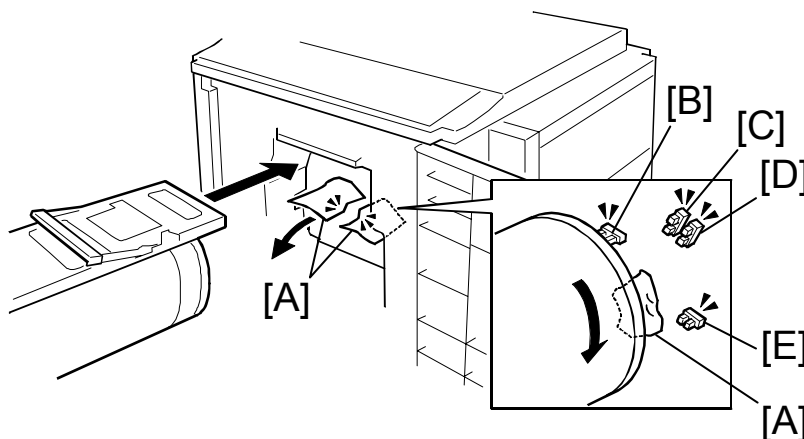
[B]: 2nd feed timing sensor, [C]: Paper exit timing sensor

Jammed paper [A] contacts one of the sensors below during a print job, and the sensor comes loose from the bracket.
