<b>Model:</b> PRIPORT HP4/HP4P		<b>Date:</b> 30-Sep-03	<b>No:</b> R-C249-001a
<b>Subject:</b> HP4/HP4P firmware history		<b>Prepared by:</b> A. Yoshida, Priport Service Planning Section	
<b>Classification:</b> <input type="checkbox"/> Troubleshooting <input checked="" type="checkbox"/> Part information <input type="checkbox"/> Action required <input type="checkbox"/> Mechanical <input type="checkbox"/> Electrical <input type="checkbox"/> Service manual revision <input type="checkbox"/> Paper path <input type="checkbox"/> Transmit/receive <input type="checkbox"/> Retrofit information <input type="checkbox"/> Other (        )			
<b>Model Name:</b> HP4: Ricoh JP4500, Gestetner CP6244, RexRotary CP6244, nashuatec CP6244, Savin 3560DNP, Standard SD420, Lanier LDD145 HP4P (China only): Ricoh JP4510P, Gestetner 6254P

The following is the firmware modification history of Priport product HP4/HP4P.

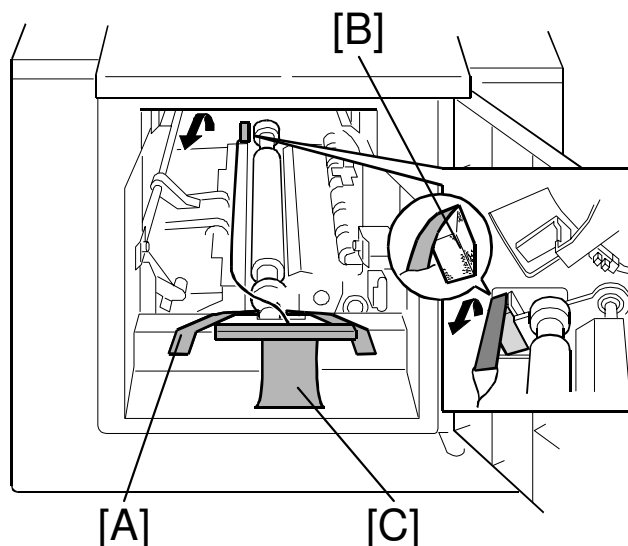
- Paper jams or blank images may occur, due to the lack of pressure on the Press Roller.
- The tape may stick to the drum screen or Press Roller.

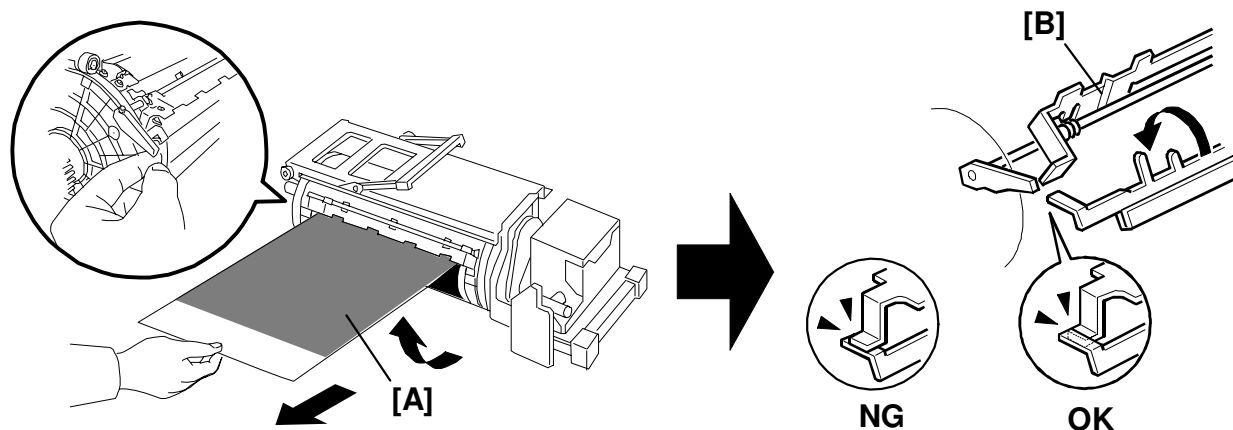
After the customer pulls out the misfed master [A] from the clamber during "B" or "E" jams, the customer attaches the master clamber [B] in reverse by mistake.

Replace the clamp assembly or the clamber exit pawls with P/N C2492309 or C2502407 (see MB #MC249007).

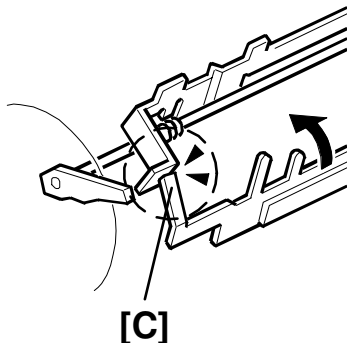
A part of the clamber exit pawls [C] has been made 3 mm longer to make it impossible to install the master clamber the wrong way.

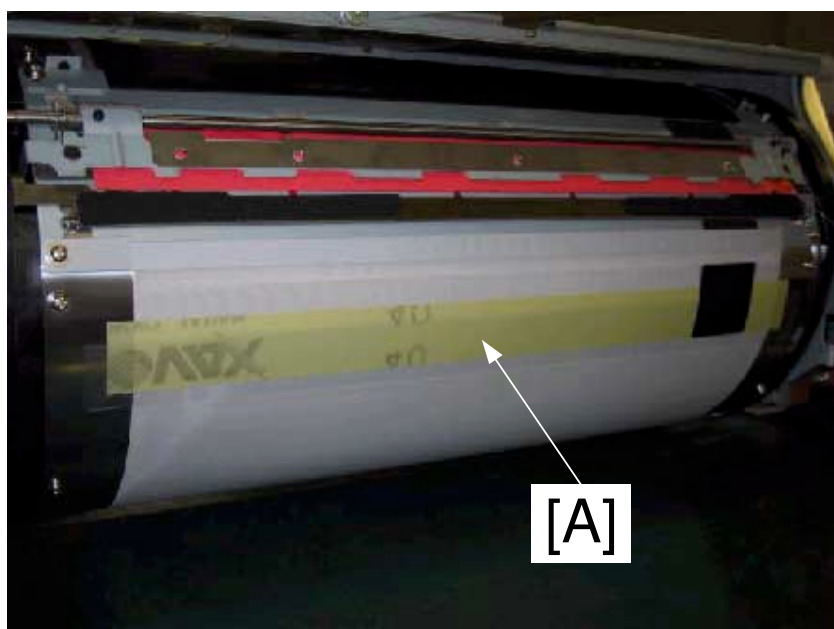
The color of the sandpaper [A] on the cloth screen was changed back to similar to its original color from Aug 2004.

**NOTE:** This color change has no effect on machine operation.

If the sandpaper is peeled off by mistake, replace the cloth screen (P/N C2492381).

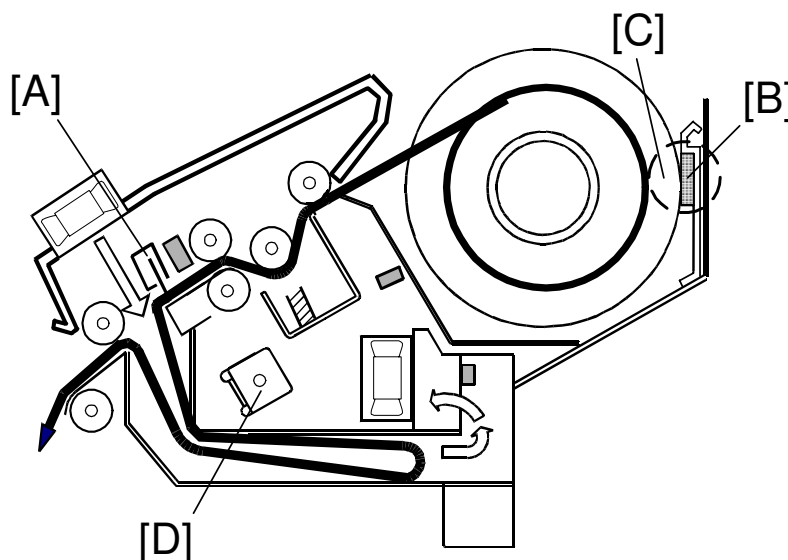
The surface of the press roller and/or rear side of the copy is stained with ink.

The cutter [A] cuts the master too short, which occurs when the friction between the brake pad [B] and master flange [C] exceeds the power of the master feed motor [D].

If this symptom is reported, please replace the master feed motor with P/N C2495841 (see MB #MC249011).

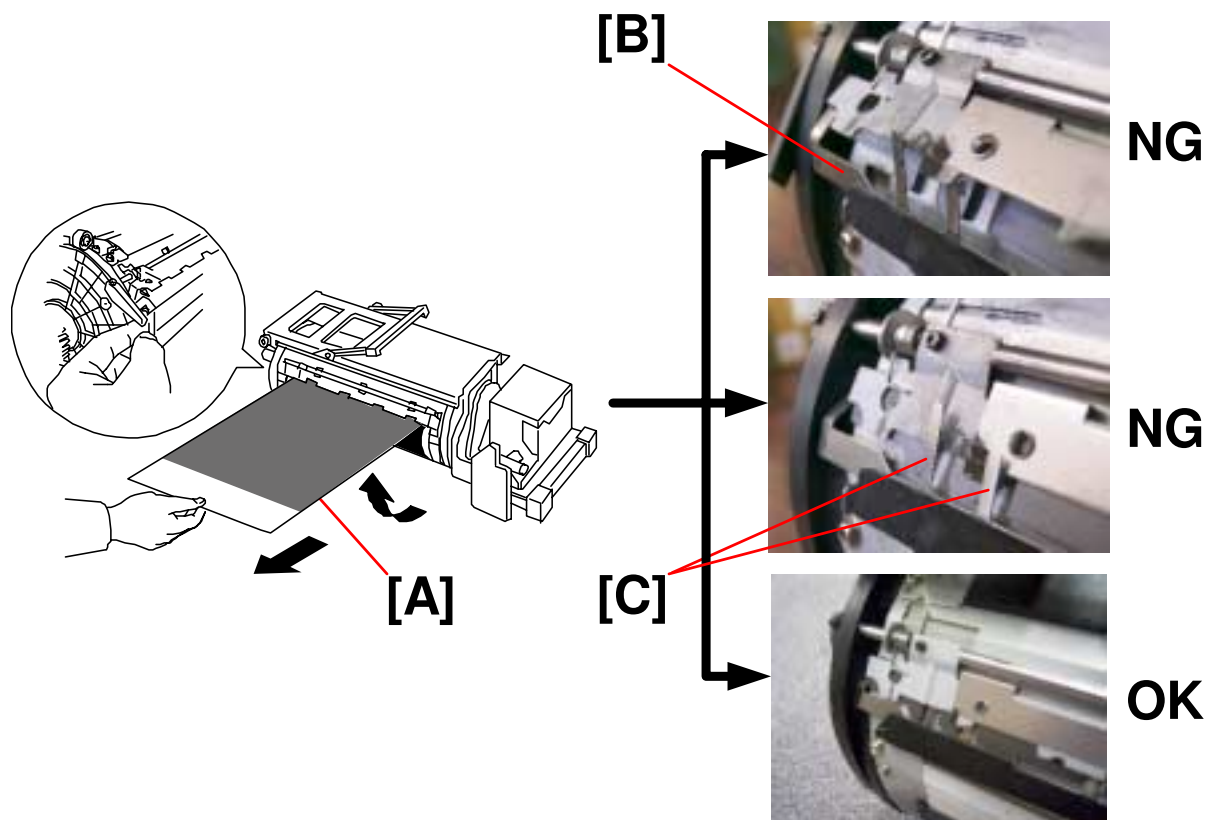
**Note:** Incorrect = The clamber's lower teeth are on the outside.

Update the main firmware to this version:

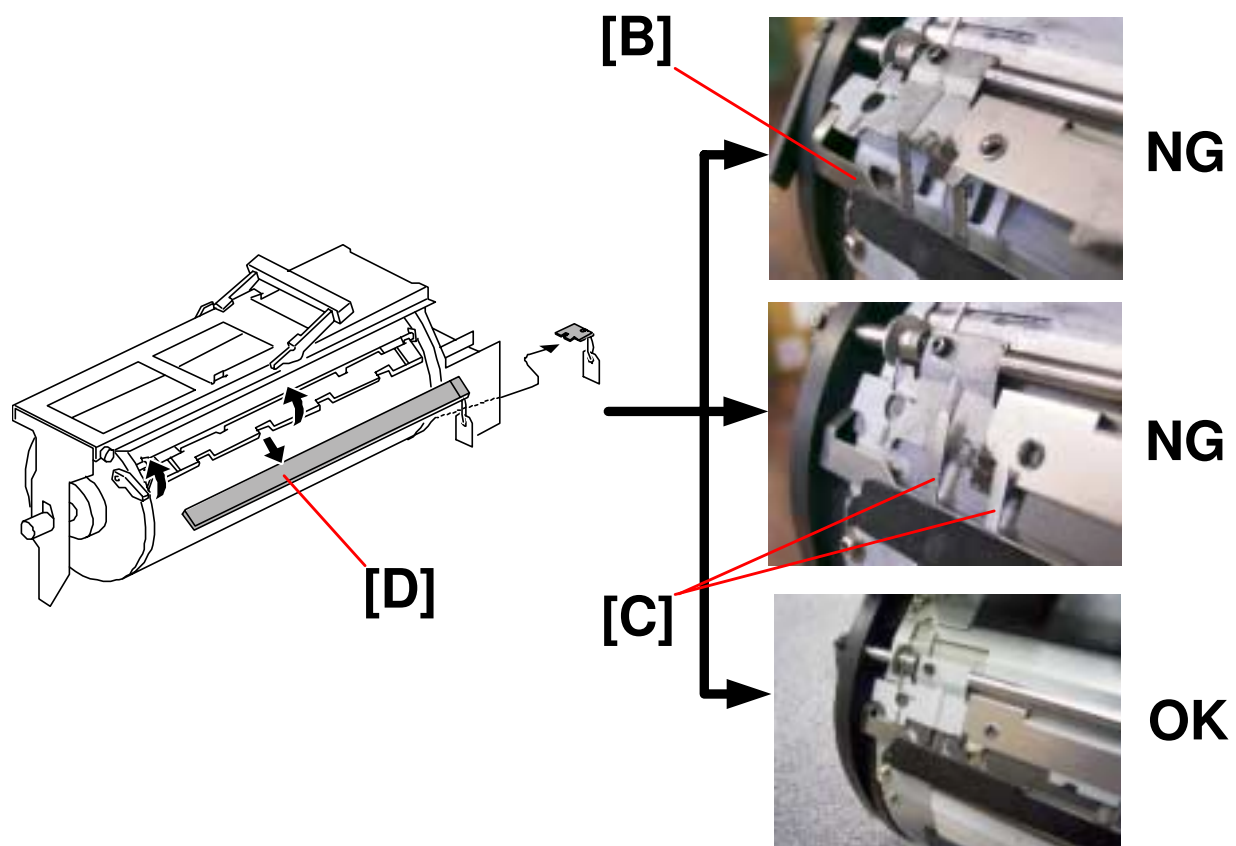
**Note:** Incorrect = The clasper's lower teeth are on the outside.

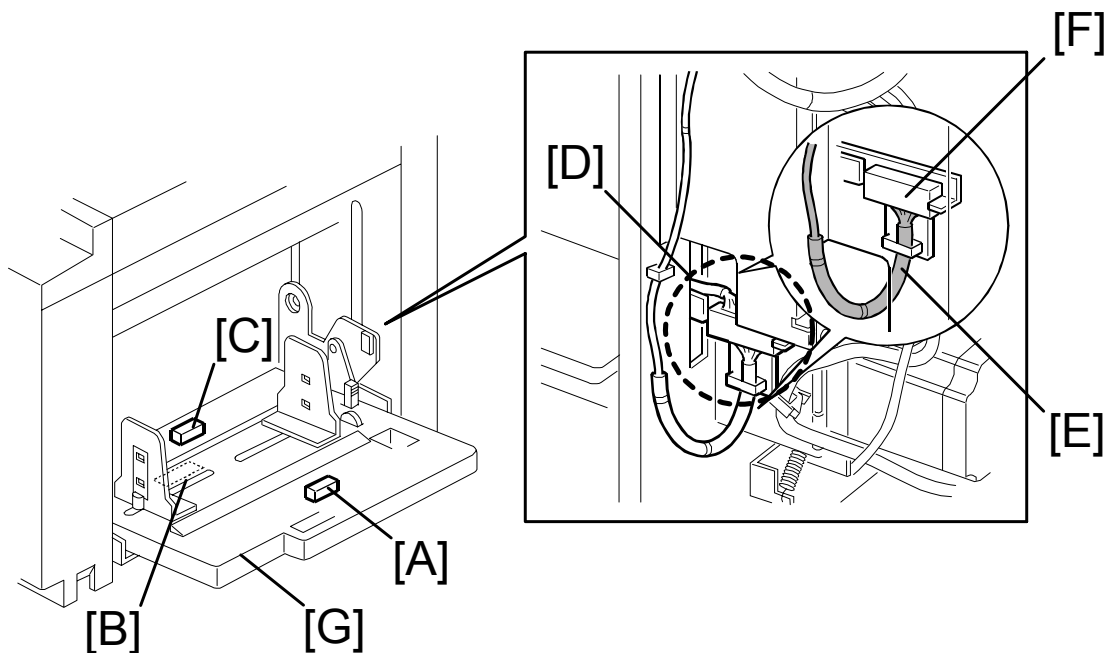
- 1) Poor connection [D] between the paper tray relay harness [E] and CN420 [F].
- 2) The paper tray relay harness [E] comes loose when the paper table [G] is lifted up or down.

Install the new paper tray relay harness listed in MB #MC249012 (P/N C2565237).

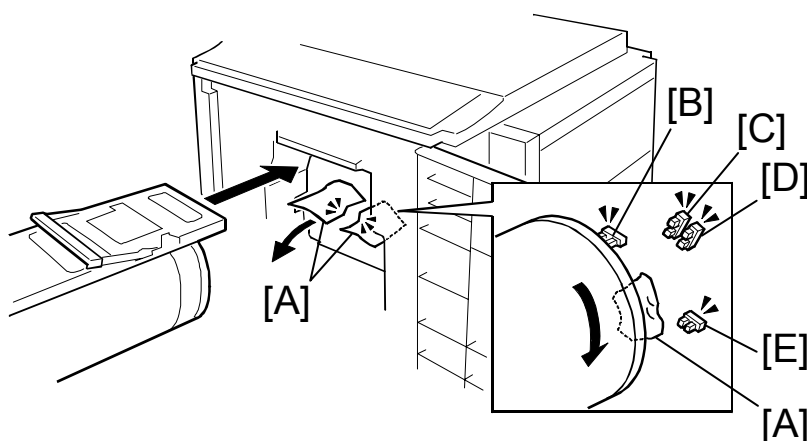
Jammed paper [A] contacts one of the sensors below during a print job, and the sensor comes loose from its bracket:

2nd feed timing sensor [B], paper exit timing sensor [C], master eject position (Drum HP) sensor [D], feed start timing sensor [E]

Install the new sensor brackets and drum position plate listed in MB #MC249014.  
(P/N: C2565613, C2565609, C2565611 and C2562375).

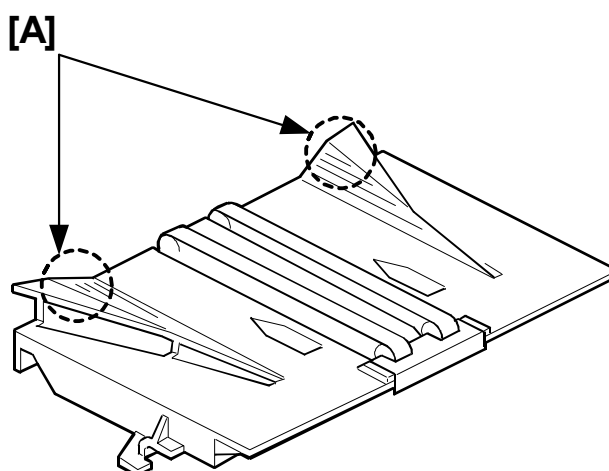
The paper delivery unit wing tips [A] are scratched by the paper, increasing the static electricity buildup in the area. The static buildup eventually overcomes the force of paper delivery, triggering the jam.

- 1) Replace the parts with the modified ones, **OR**
- 2) Install the metal wing set shown below.

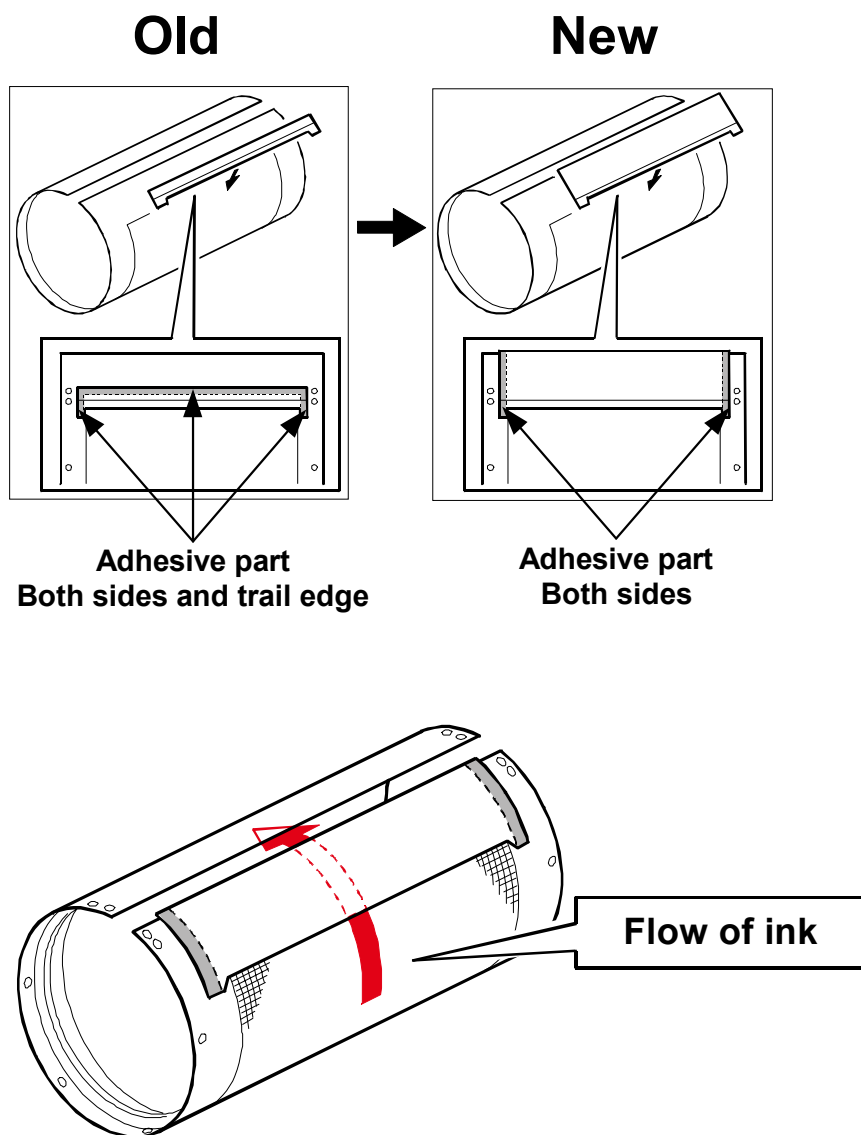
Ink leaks from the trailing edge of the metal screen.

Sometimes, the ink pressure causes part of the Mylar seal on the metal screen to peel off.

- Adhesive is applied only to the side edges of the Mylar seal for the metal screen (there is no adhesive at the trailing edge).
- As a result, the extra ink flows back into the drum from the leading edge of the new metal screen.

Replace the metal screen or Mylar seal when the symptom is reported.

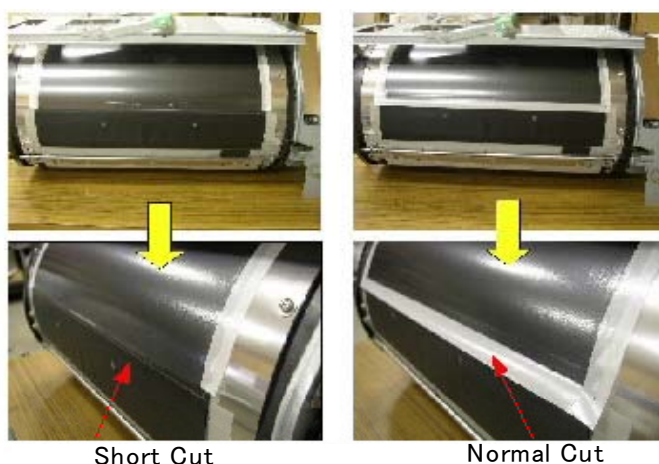
The master is cut too short, and an ink blotch can be seen on the rear side of the paper.

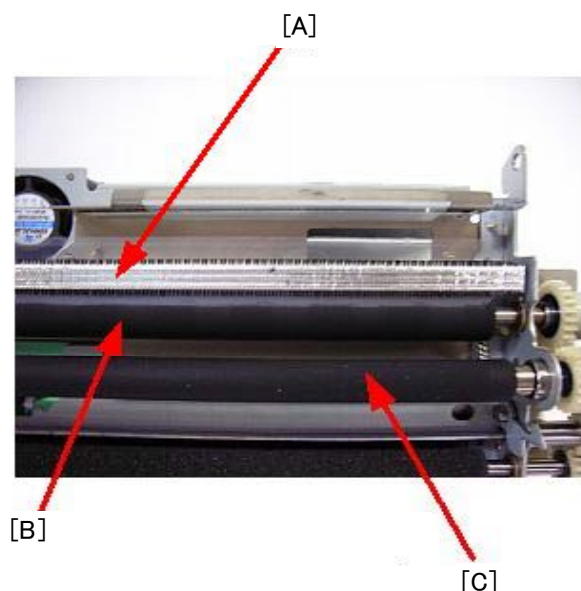
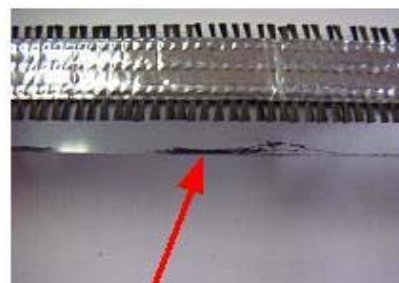
Dust [D] causes the burr on the guide sheet [A] to contact the front tension roller [B], which slows down the master feeding speed. The master is then cut short the next time it is fed.
