<b>Model:</b> PRIPORT PEARL		<b>Date:</b> 31-Dec-98	<b>No:</b> 01
<b>Subject:</b> Pressure Cylinder Maintenance Cycle		<b>Prepared by:</b> H. Kokubo,

<b>Model:</b> PRIPORT PEARL		<b>Date:</b> 31-Dec-98	<b>No:</b> 02
<b>Subject:</b> Master Feed Jams or Cutter Errors		<b>Prepared by:</b> H. Kokubo, Priport Service Planning Section	
<b>Classification:</b>	<input checked="" type="checkbox"/> Troubleshooting <input type="checkbox"/> Mechanical <input type="checkbox"/> Paper path <input type="checkbox"/> Other (      )	<input checked="" type="checkbox"/> Part information <input type="checkbox"/> Electrical <input type="checkbox"/> Transmit/receive	<input type="checkbox"/> Action required <input type="checkbox"/> Service manual revision <input type="checkbox"/> Retrofit information
<b>Model Name:</b> PEARL: Ricoh JP5000, Gestetner 5450, RexRotary 1560, nashuatec CP450, SVN 3350DNP

<b>Model:</b> PRIPORT PEARL		<b>Date:</b> 15-Sep-99	<b>No:</b> R-C229-4
<b>Subject:</b> Auxiliary Firmware Update Method - Flash memory card for updating firmware -		<b>Prepared by:</b> H. Kokubo, Priport Service Planning Section	
<b>Classification:</b>	<input type="checkbox"/> Troubleshooting <input type="che

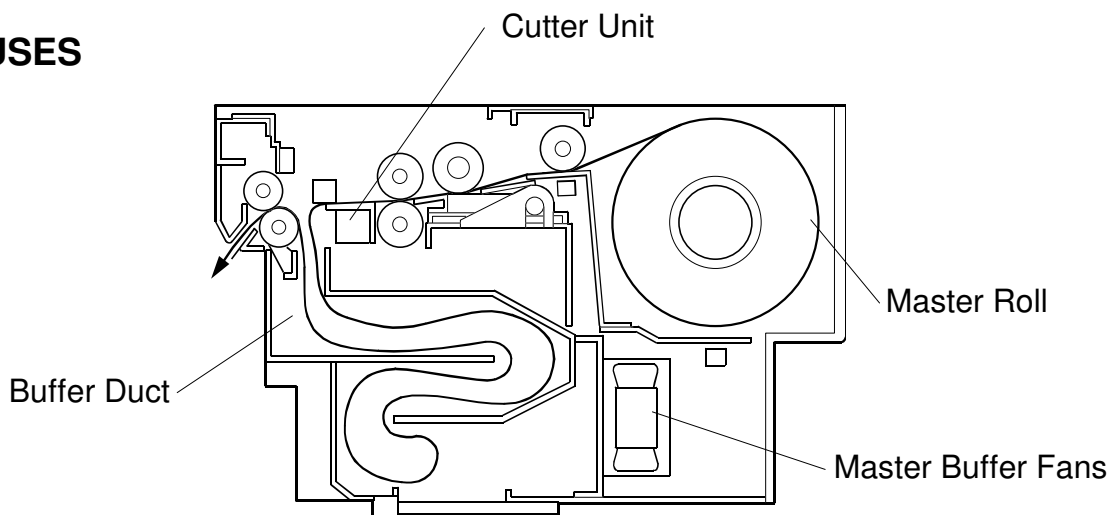
Small pieces of torn master are sucked into the master buffer duct, and the suction (generated by the three buffer fans) weakens. As a result, the master is not guided properly into the buffer duct. This can occur even if a tiny piece of master gets caught in the buffer fans.

A tiny piece of master can cause the problem. Remove the three fans by loosening the screws, and check if there are any pieces of master.

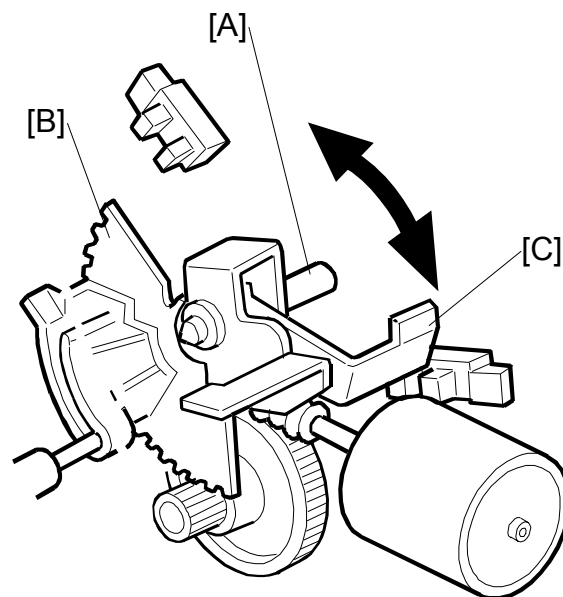
Master clamber drive unit

At the factory it was found that the grease applied to the sector gear shaft (in the master clamber drive unit) was insufficient. After investigating the production units, we found that this problem occurred from the December 1999 production of these machines.

If the sector gear shaft [A] wasn't greased or was insufficiently greased, the surface of the shaft [A] will gradually wear down, as the sector gear plate [B] and sensor actuator bracket [C] rotate along the shaft each time a new master is made.

If the shaft wears down (frictional wear), the sector gear plate [B] and/or sensor actuator bracket [C] will not work smoothly. This will cause the master clamber motor to lock or cause master clamping errors.

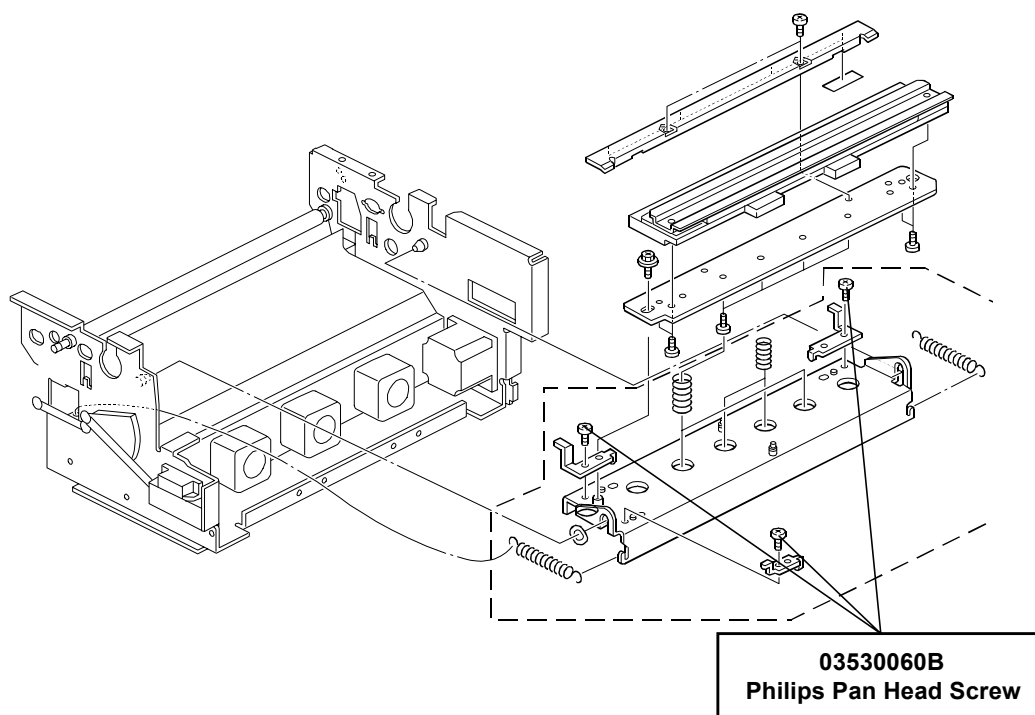
In some machines, the shape of the 3 screws under the thermal head is different from the standard ones used in the Plotter Unit, causing solid image areas to appear light.

The three screw heads were too thick, which caused them to push the thermal head slightly upward and release the pressure between the platen roller and thermal head.

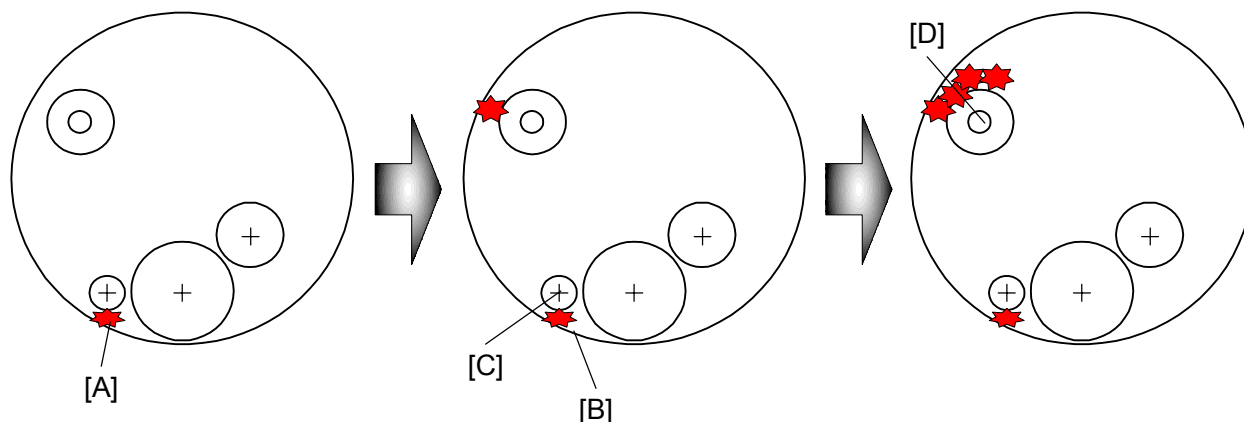
SC05-22 (No drum shift sensor pulse), SC05-32 (Ink pump sensor remains on or off), and/or an ink leak/overflow at power-up or during operation.

Producing over 2,000 prints with the same master causes an ink buildup to occur [A] between the inner surface of the drum metal screen [B] and the drum idling roller [C], after which the buildup is transferred to the area of the ink pump motor [D].

The shape of the bearing holder has been changed to ensure that ink is evenly applied to the drum screen and that ink leaks do not occur.

The home position of the drum idling roller has been increased to 3.1 mm from the drum screen, so that ink on the inner surface of the screen is applied evenly and ink leaks do not occur.

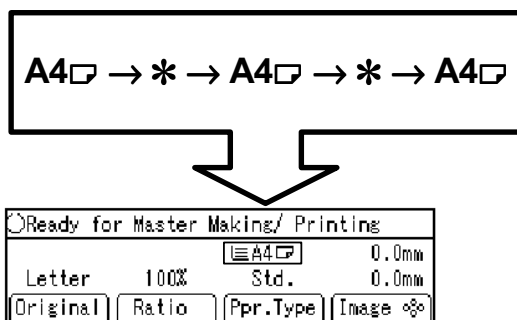
The paper size indicator on the operation panel lights on and off during operation.

The light from the fluorescent lamp causes a paper length sensor misdetection.

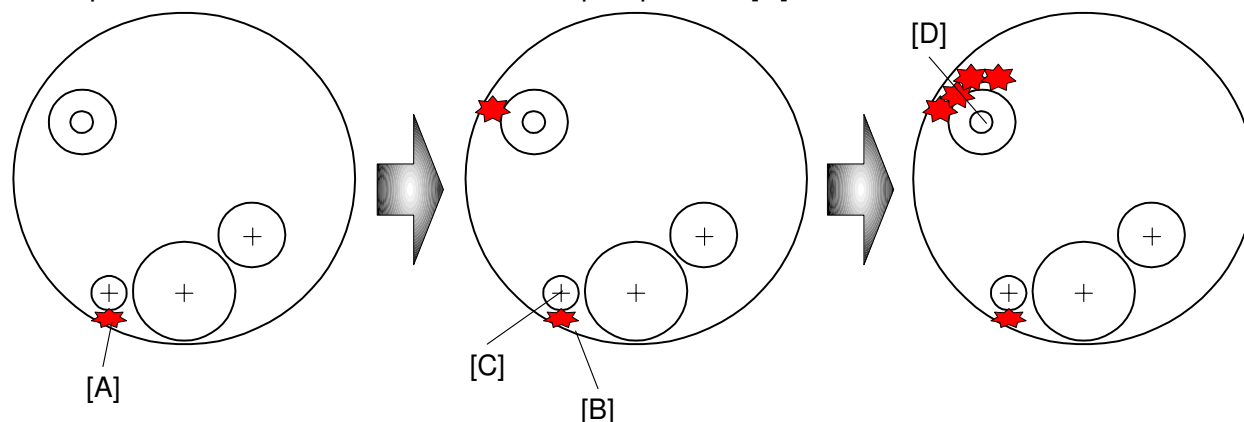
Producing over 2,000 prints with the same master causes an ink buildup [A] to occur between the inner surface of the drum metal screen [B] and the drum idling roller [C], after which the buildup is transferred to the area of the ink pump motor [D].

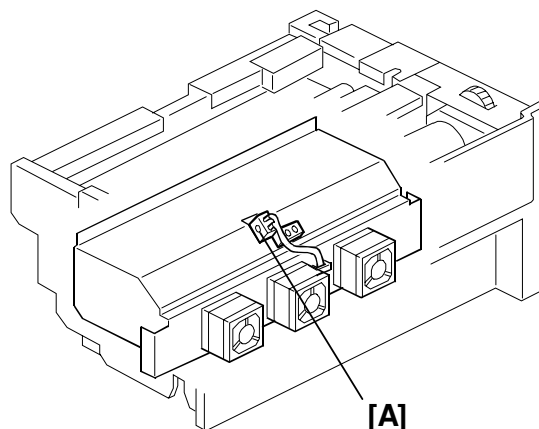
The master duct sensor [A] is too sensitive.

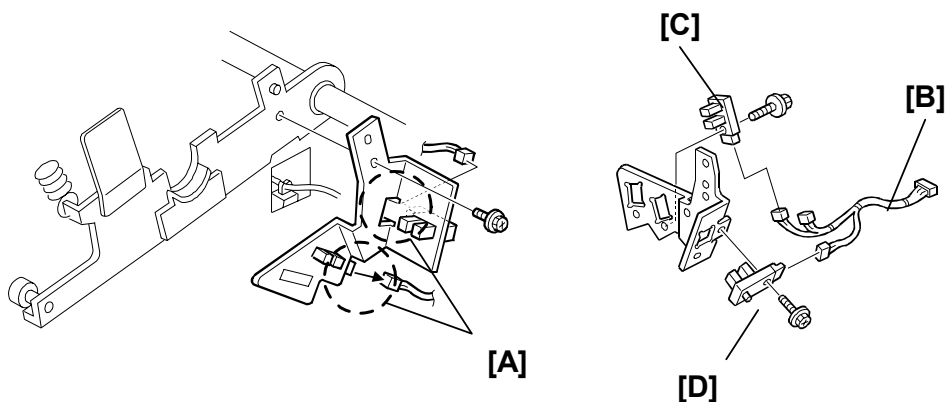
- 1) SC07-20 or sensor misdetection: Light from the fluorescent lamp.
- 2) SC07-20 or SC07-21: Poor connection [A] between the feed encoder cable and the feed start sensor [C] or feed encoder sensor [D].
