Model: PRIPORT TITANIUM		Date: 7-Apr-03	No: R-C252-001
Subject: Notes the model TT installation		Prepared by: M. Ohtsubo, Priport Service Planning Section	
Classification:	<input type="checkbox"/> Troubleshooting <input type="checkbox"/> Mechanical <input type="checkbox"/> Paper path <input type="checkbox"/> Other ()	<input type="checkbox"/> Part information <input type="checkbox"/> Electrical <input type="checkbox"/> Transmit/receive	<input type="checkbox"/> Action required <input checked="" type="checkbox"/> Service manual revision <input type="checkbox"/> Retrofit information
Model Name: Ricoh JP730/JP750/JP780C, Gestetner 6123lcp/5410c/6123cp, Lanier LDD 730, nashuatec 6123cp, RexRotary 6123cp

Model: PRIPORT TITANIUM		Date: 23-Oct-03	No: R-C252-003
Subject: Notes for model TT installation - revision		Prepared by: M. Ohtsubo, Priport Service Planning Section	
Classification:	<input type="checkbox"/> Troubleshooting <input type="checkbox"/> Mechanical <input type="checkbox"/> Paper path <input type="checkbox"/> Other ()	<input type="checkbox"/> Part information <input type="checkbox"/> Electrical <input type="checkbox"/> Transmit/receive	<input type="checkbox"/> Action required

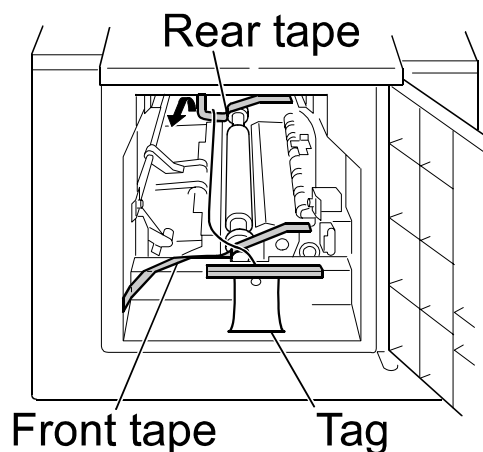
Strips of tape have been added as shown below to secure the Press Roller during transport. Please make sure to remove the tape and tag before machine operation begins. If they are not removed:

- Paper jams or blank images may occur, due to the lack of pressure on the Press Roller.
- The tape may stick to the drum screen or Press Roller.

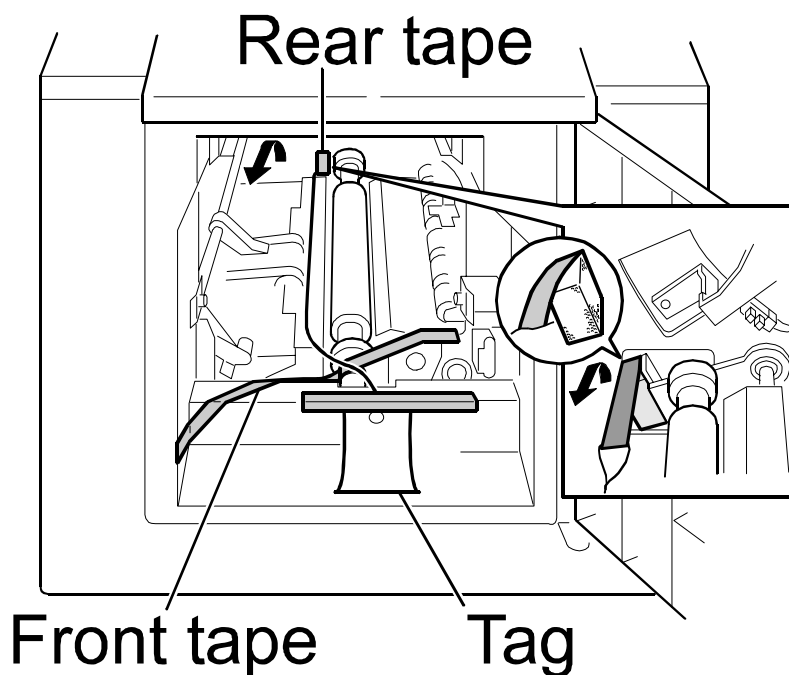
As announced in RTB #RC252-001, a Styrene foam sponge is used to ensure that the rear shipping tape stays properly fixed in place, which prevents the printing pressure release lever from unlocking. At installation, please remove the rear tape by pulling the portion shown in the photo below toward the front of the machine.

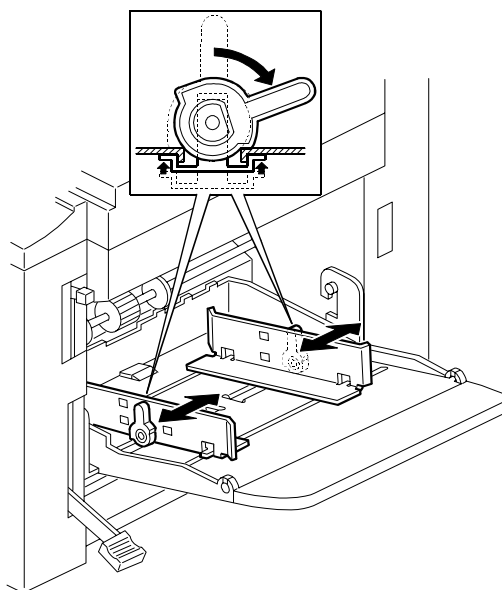
The left or/and right edges of the original can be seen on the printout as black lines.

1. The paper tray side fences are not aligned with the scanner unit side fences.

2. The original is smaller than the printing paper.

1. Measure the distance from the paper edge to the black line (X mm).
2. Move the side fences a distance of about X mm, so that the edge of the paper aligns with the edge of the original.
3. Check the print results. Repeat this until you cannot see the black line on the printout.
