Model: PRIORT PEARL/PEARL-MC/RUBY/SAPPHIRE/GARNET/SA2/SA2P		Date: 25-Jun-07	No: R-C235-001
Subject: Patchy image		Prepared by: M. Kumagai, Priort Service Planning Section	
Classification:	<input checked="" type="checkbox"/> Troubleshooting <input type="checkbox"/> Part information <input type="checkbox"/> Action required <input type="checkbox"/> Mechanical <input type="checkbox"/> Electrical <input type="checkbox"/> Service manual revision <input type="checkbox"/> Paper path <input type="checkbox"/> Transmit/receive <input type="checkbox"/> Retrofit information <input type="checkbox"/> Other ()		
Model Name: SAPPHIRE: Ricoh JP8000, Gestetner 5490, RexRotary 1395, nashuatec CP490, Savin 3450DNP, Standard SD630 GARNET: Ricoh JP5500, Gestetner 5450+/5455, RexRotary1560+, nashuatec CP450+, Savin 3360DNP, Standard SD450, Lanier LDD150 SA2: Ricoh JP8500, Gestetner 5490+/5499, RexRotary1395+, nashuatec CP490+, Savin 3460DNP, Standard SD650, Lanier LDD180 SA2P (China only): Ricoh JP8510P, Gestetner 5500P

Model: PRIPORT PEARL/PEARL-MC/RUBY/SAPPHIRE/GARNET/SA2/SA2P		Date: 3-Jul-07	No: R-C235-002
Subject: betterment for ink leakage		Prepared by: M. Kumagai, Priport Service Planning Section

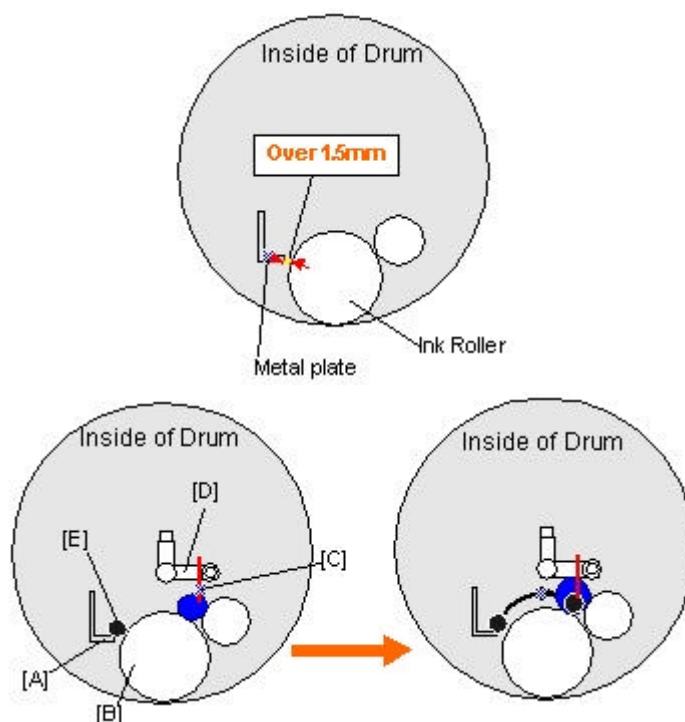
SYMPTOM: Faint images.

The gap between the metal plate [A] and ink roller [B] is too narrow (Less than 1.5mm). As a result, the ink on the ink roller builds up on the metal plate. This ink [E] then moves to the ink detection pins [C] or ink distributor [D]. If the ink builds up on the ink detection pins, the machine will mis-detect the amount of the ink inside the drum. If ink builds up on the ink distributor, ink will not flow smoothly inside the drum.

SOLUTION: Adjust the gap between metal plate and ink roller to more than 1.5 mm.

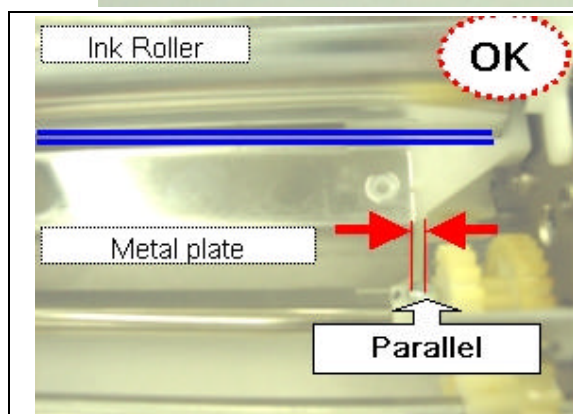
CORRECT position:

1. Both ends of the white mold parts and cleaning blade are **parallel**.
2. The gap between the edge of the cleaning blade and ink roller is **over 1.5mm**.

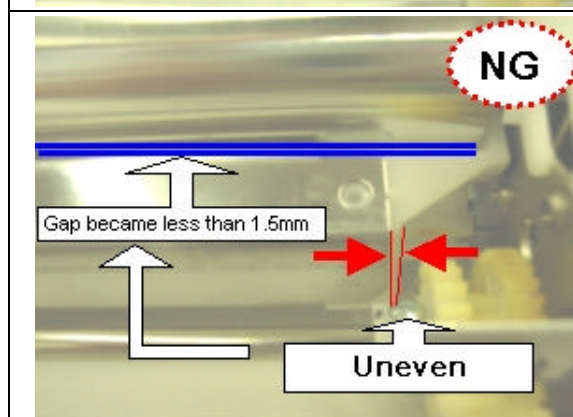
Incorrect position:

1. Both ends of the white mold parts and cleaning blade are not parallel.
2. The gap between the edge of the cleaning blade and ink roller is 1.5mm or less.
Note: This can happen if the white mold parts get jammed at the side of the ink roller and bend.

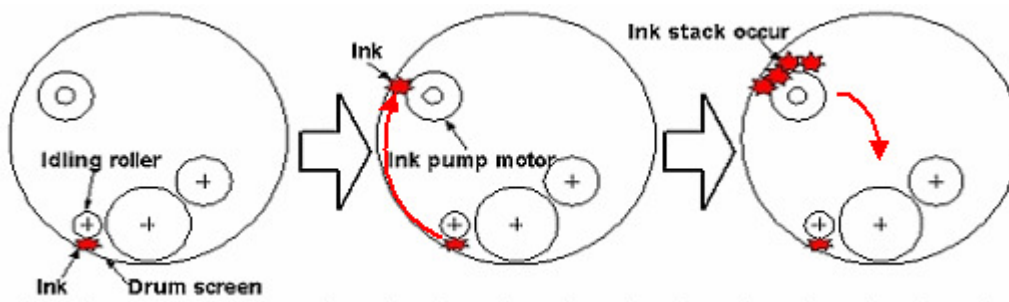
Ink leaks or sticks to the inside of the drum, generating SC5-22 (no drum shift sensor pulse) or SC5-32 (ink pump sensor remains off).

Lumps of ink build up on the ink pump motor, and eventually the ink begins dropping into the drum.

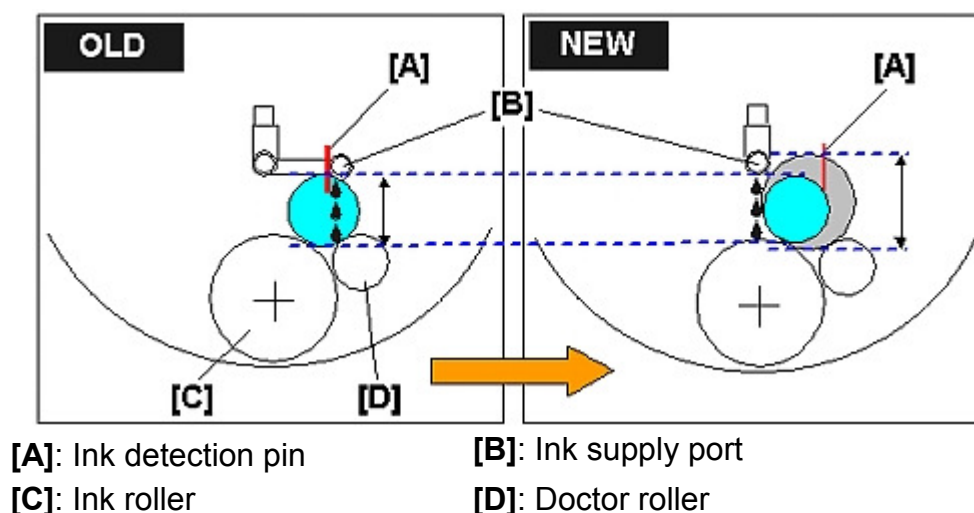
The "No ink" condition is detected by mistake.

Ink sticks to the ink roller [C], and then builds up on the ink detection pin [A] and ink distributor.

The ink distributor and attachment bracket for the **Emerald/Topaz** are now used. The distance between the ink detection pin and ink supply port [B] is wider. Also, it is harder for ink to stick to the ink detection pin and ink distributor.

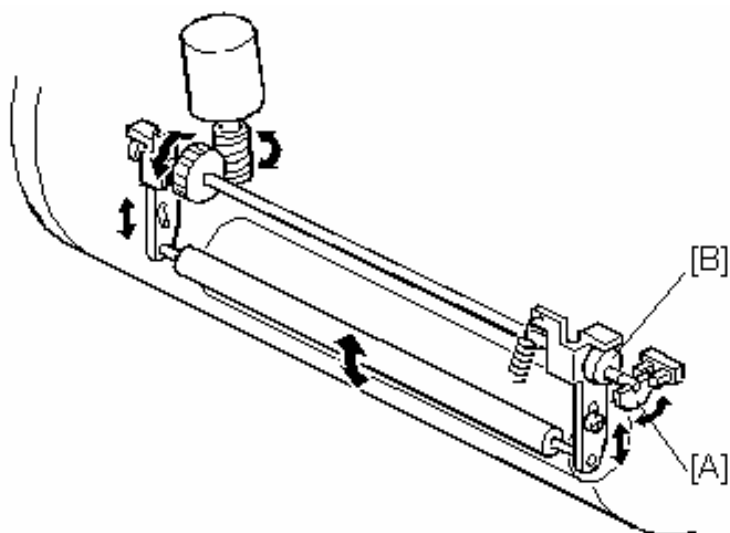
SC05-60 (Idling HP sensor remains on or off) detected falsely

The screw that attaches the actuator disk [A] and cam [B] is loose.

- The shapes of the actuator disk and cam were changed to ensure that the screw stays more securely in place (see the photos).
- The threaded part of the screw was treated with a coating that locks the screw in place.

Replace the cam (C239 only) and actuator disk, using the new screw.
