Model Name: Ricoh JP5800

Model: PRIPORT RUBY

Modified Article: Paper Guide

Modification Bulletin

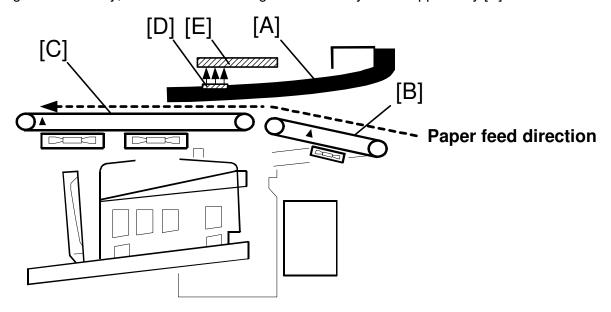
Change: Added front guide assembly [A], rear guide assembly.

Reason: To ensure that curled paper is fed smoothly in the relay transport area [B] and horizontal transport area [C].

Important: When images with many solid image areas are printed out often, light scratches can appear on the copy. For these customers, attach a piece of double-sided tape [D] to the guide assembly, and then attach the guide assembly to the upper stay [E].

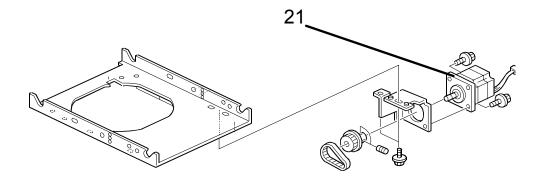
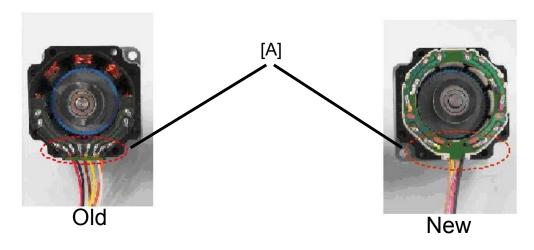
Change: The internal connection of the harness and motor was changed.

Reason: To ensure that the harness stays connected to the motor. This will ensure that a jam at the relay transport unit does not occur.

[A]: Internal connection point of the harness.
