Model: PRIPORT LCS		Date: 7-Jan-04	No: R-C625-001c
Subject: Firmware Modification History		Prepared by: K. Yamamoto, Priport Service Planning Section	
Classification: <input type="checkbox"/> Troubleshooting <input type="checkbox"/> Part information <input type="checkbox"/> Action required <input type="checkbox"/> Mechanical <input type="checkbox"/> Electrical <input type="checkbox"/> Service manual revision <input type="checkbox"/> Paper path <input type="checkbox"/> Transmit/receive <input type="checkbox"/> Retrofit information <input checked="" type="checkbox"/> Other (Firmware release)			
Model Name: Large Capacity System LS3000

Model: PRIPORT LCS		Date: 4-Mar-04	No: R-C625-002
Subject: Undefined paper non-feed		Prepared by: K. Yamamoto, Priport Service Planning Section	
Classification: <input type="checkbox"/> Troubleshooting <input type="checkbox"/> Part information <input checked="" type="checkbox"/> Action required <input type="checkbox"/> Mechanical <input checked="" type="checkbox"/> Electrical <input type="checkbox"/> Service manual revision <input type="checkbox"/> Paper path <input type="checkbox"/> Transmit/receive <input type="checkbox"/> Retrofit information <input

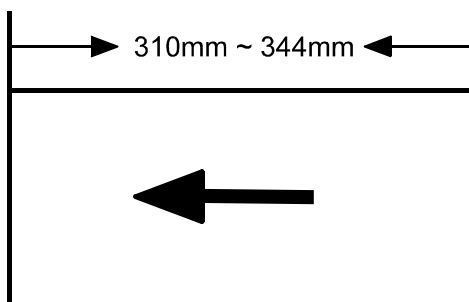
Paper 310mm to 344mm in length (not a machine-defined size) cannot be fed, resulting in an A-jam.

NOTE: 1) This symptom applies to this particular paper size only.
 2) The length (310 to 344mm) is the only factor, i.e. width does not affect this symptom at all.

Firmware bug.

The LCIT firmware has been modified to ensure that the above size can be fed correctly.

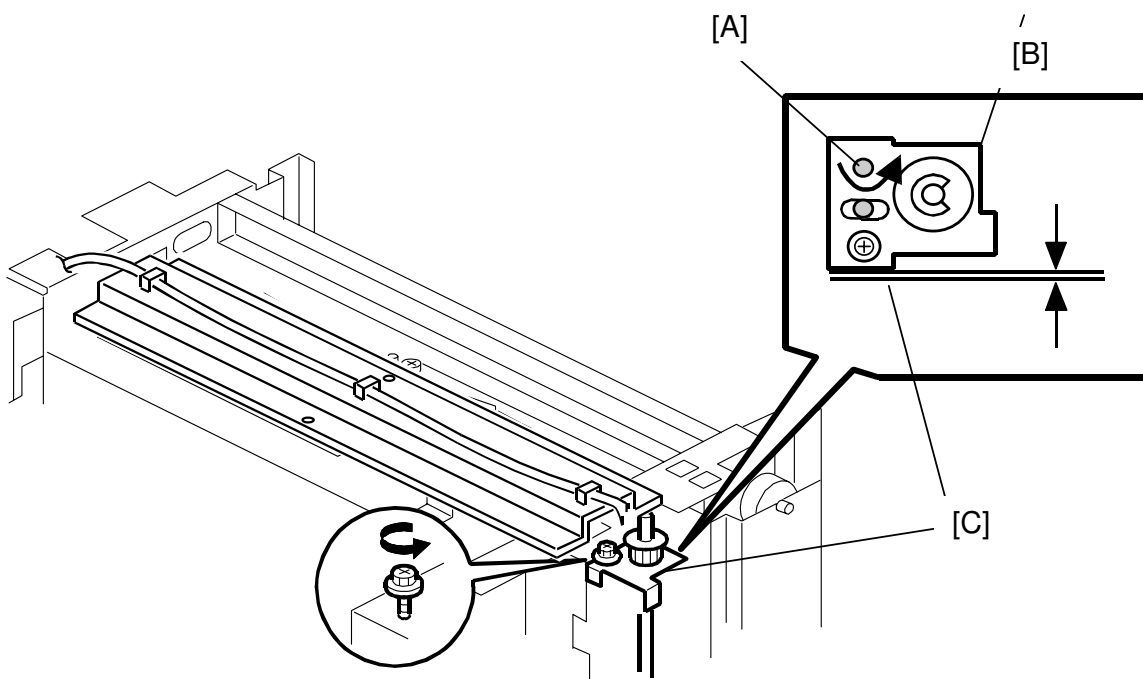
Note: The top opening [A] in the bracket [B] is used as a pivot point to rotate the bracket and adjust the tension of the side fence belt. The bracket should be aligned parallel with the side fence [C], which will ensure the proper belt tension.

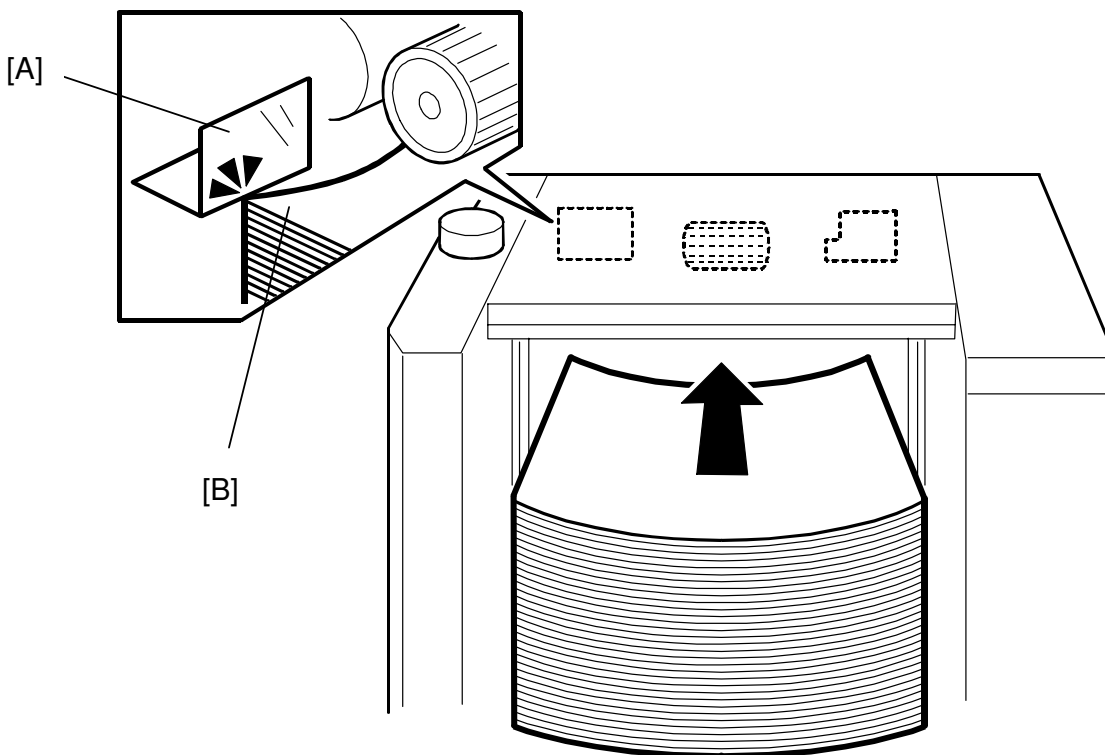
An A-jam occurs at the paper feed section if the paper is stacked near capacity (approximately 3,000 sheets) and the sheets are curled.

The paper [B] contacts the guide board sheet [A] due to the height of the stack and the curl in the paper, and the paper is fed skewed. (This curl is exaggerated with increased paper stack height).

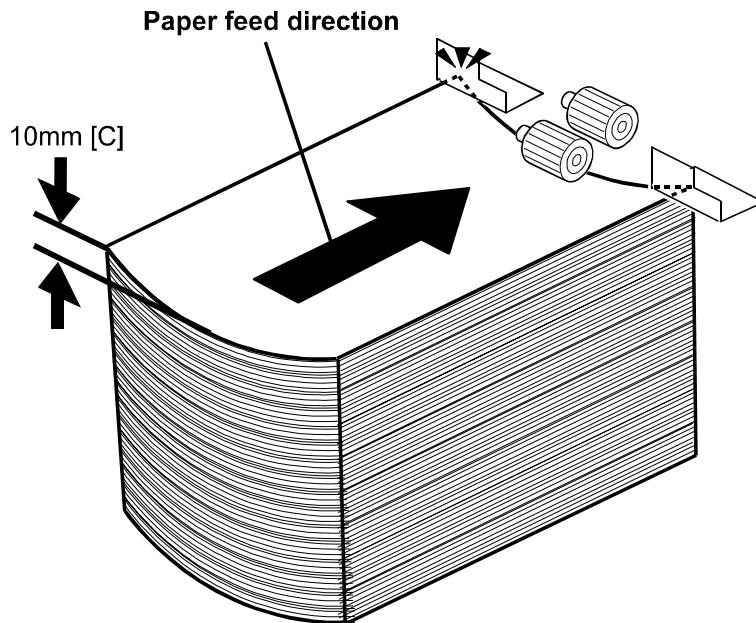
Paper stack condition leading to skewed feed:

- The curl in each individual sheet is amplified as the height of the stack increases.
- With close to 3,000 sheets, a sheet gap of about 10 mm [C] can result, which tends to trigger the skewed feed and paper jam.

Please advise customers to use paper that is not curled, as described in the Operator's Instructions. To offset the effect from curling, it is often effective to load the paper upside down in the tray and/or fan the paper before loading.

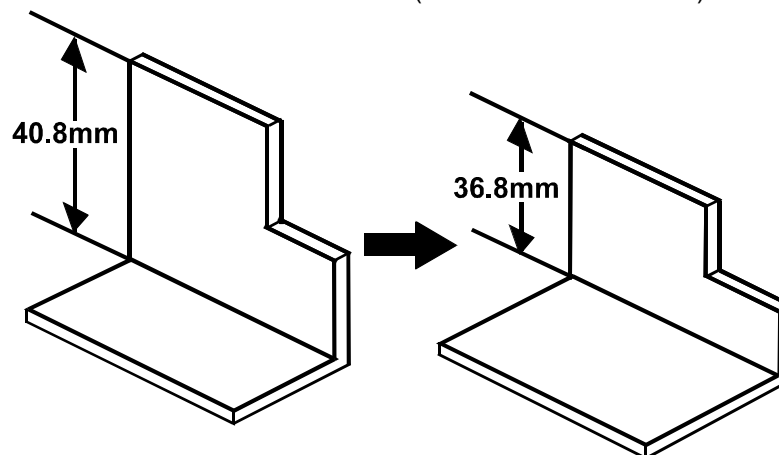
The shape of the guide board sheet has been changed to improve paper feed even when the sheets are already curled and are stacked near paper feed table capacity.

- This modification ensures proper paper feed even when the sheet gap [C] is higher than 10mm (i.e. up to approximately 15mm).
- New guide board sheet P/N: C6252921 (see MB #MC625006).

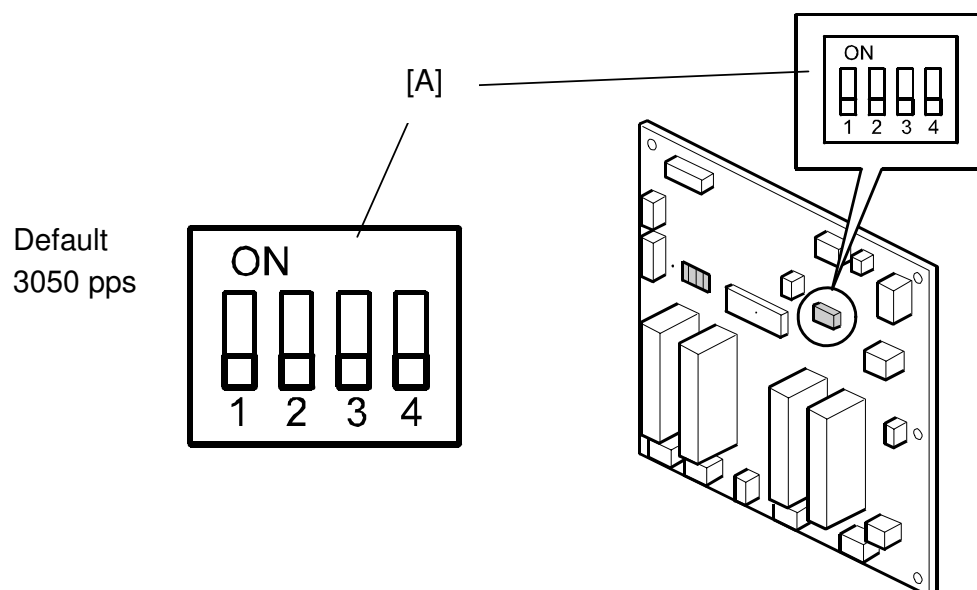
If A-jams are reported from the field, increase the paper pickup speed with the dip switch on the MPU board.

1. Turn off the main switch, and then disconnect the power plug.
2. Remove the rear cover.
3. Set the dip switch [A] on the LCIT MPU as follows.

NOTE: If A-jams still occur after you increase the speed to 3500 pps, replace the paper feed roller for the LCIT. If this is not effective enough, replace the intermediate under feed rollers.

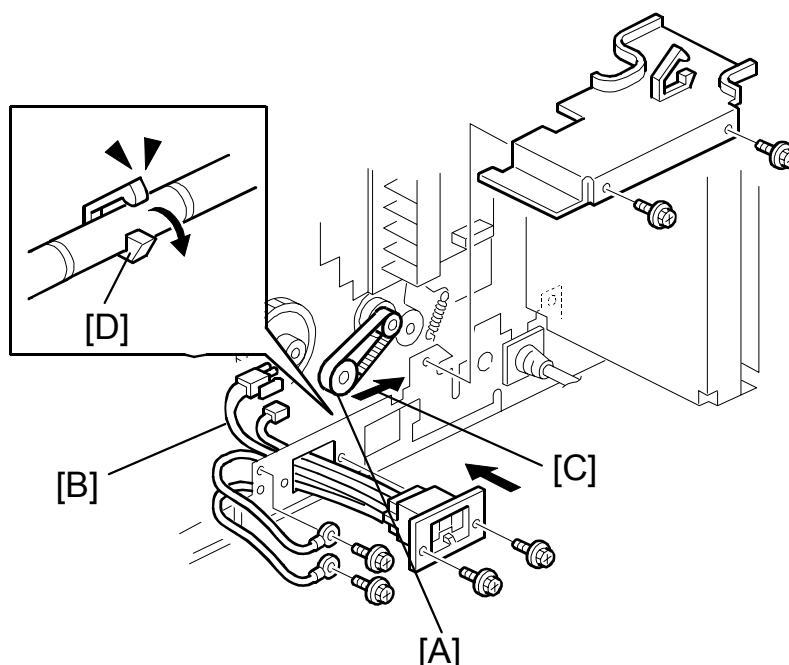
The harness [B] might touch the belt and gear [A] when you install the LCOT socket in the Emerald.

The harness [A] does not have any tension.

Pull the harness [B] in the direction of the arrow [C] until there is no slack in the harness.

A clamber [D] is added on the bottom plate, and the harness is bundled by the clamber [D].

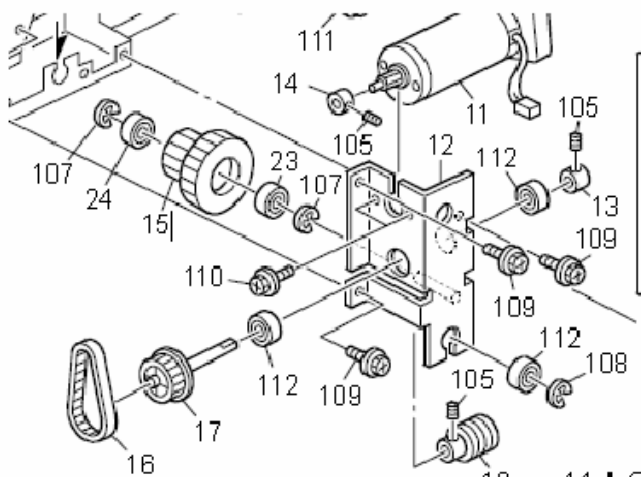
Change/Reason: The part number in the catalog was incorrect.

Correct: C5633344
Wrong: C5633350
