Model: PRIPORT OPAL/OPAL-MC		Date: 25-Dec-03	No: R-C593-001
Subject: New model Opal-MC information		Prepared by: A. Yoshida, Priport Service Planning Section	
Classification:	<input type="checkbox"/> Troubleshooting <input type="checkbox"/> Mechanical <input type="checkbox"/> Paper path <input checked="" type="checkbox"/> Other (New machine information)	<input type="checkbox"/> Part information <input type="checkbox"/> Electrical <input type="checkbox"/> Transmit/receive	<input type="checkbox"/> Action required <input type="checkbox"/> Service manual revision <input type="checkbox"/> Retrofit information
Model Name: TC-II

Model: PRIPORT OPAL/OPAL-MC/HQ-OPAL		Date: 20-Jan-06	No: R-C593-002
Subject: Drive Gear Damage		Prepared by: A. Yoshida, Priport Service Planning Section	
Classification:	<input checked="" type="checkbox"/> Troubleshooting <input type="checkbox"/> Mechanical <input type="checkbox"/> Paper path <input type="checkbox"/> Other ()	<input type="checkbox"/> Part information <input type="checkbox"/> Electrical <input type="checkbox"/> Transmit/receive	<input type="checkbox"/> Action required <input type="checkbox"/> Service manual revision <input type="checkbox"/> Retro

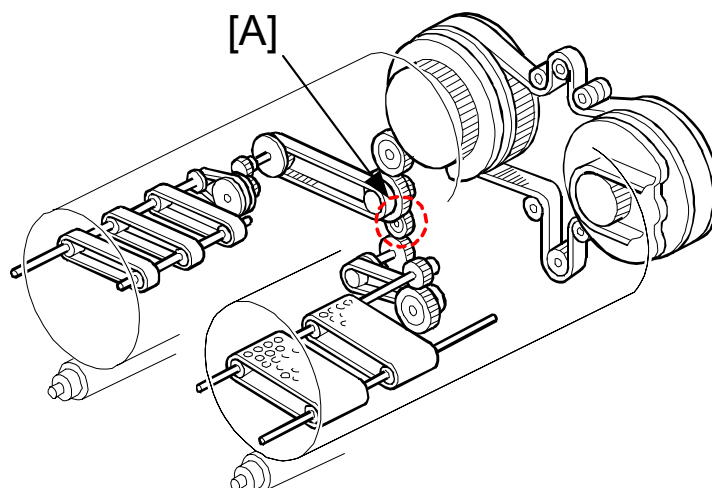
The drive gear [A] for the relay transport unit and paper delivery section is damaged during printing.

The drive gear [A] comes loose from the ball bearing.

- 1) The length of the gear shaft was decreased by 2mm
- 2) A washer was added between the gear and e-ring.

Install the new gear shaft and the washer listed in MB #MC593006.
