SUBJECT: Paper jams caused when one-way clutch slips

FROM: Copier Technical Support Section

SS 810/830

Ges 5110

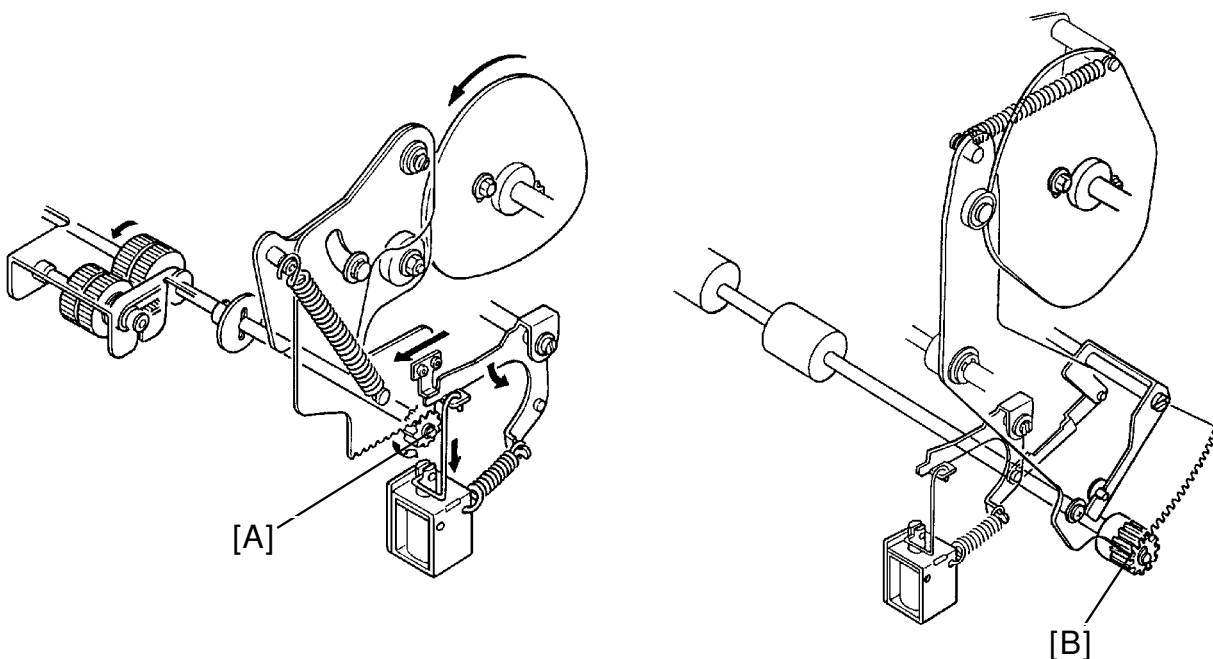
The one-way clutches inside the paper feed and second feed roller gears have worn the roller shafts smooth. The clutch slips and paper jams or is not fed. This tends to occur during high speed printing and is more likely to occur on machines that exceed the recommended monthly copy volume. When the feed mechanism is manually operated to check the paper feed, paper feeds correctly.

1. Remove the paper feed roller gear [A] and the second feed roller gear [B].
2. With fine sandpaper, lightly sand the roller shaft surface at the point where it comes into contact with the one-way clutch. This increases the coefficient of friction.
3. If paper jams continue to occur, replace the one-way clutch.
4. If paper jams continue to occur, replace the roller shaft together with the one-way clutch.

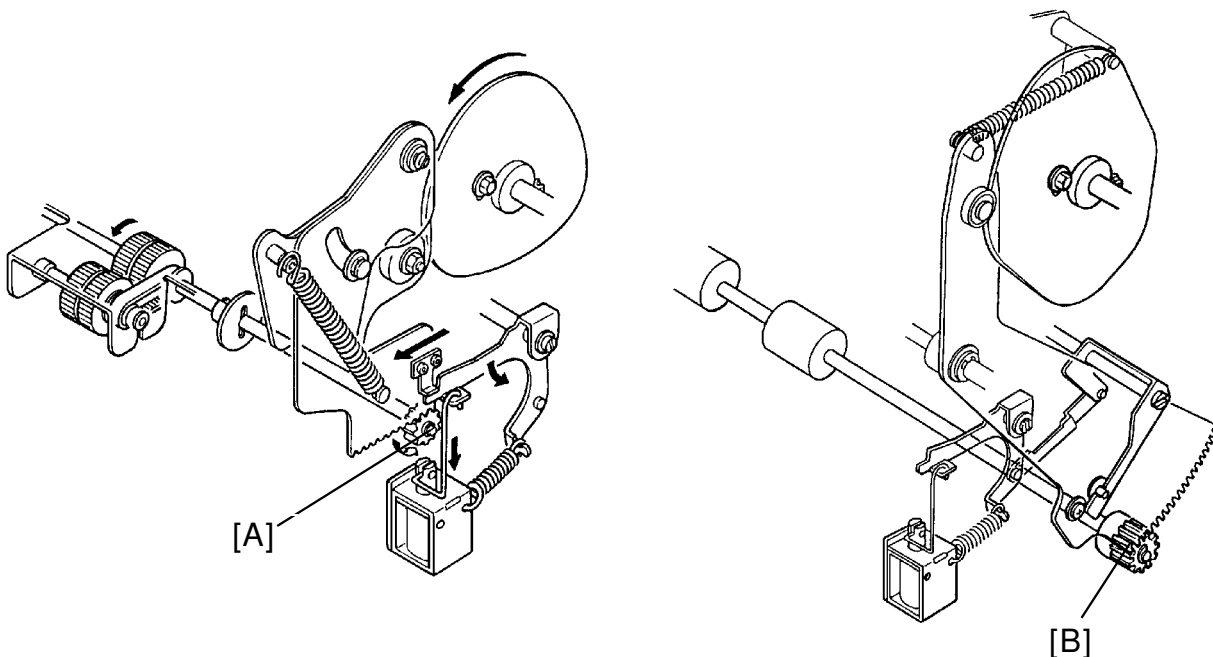
The one-way clutches inside the paper feed and second feed roller gears have worn the roller shafts smooth. The clutch slips and paper jams or is not fed. This tends to occur during high speed printing and is more likely to occur on machines that exceed the recommended monthly copy volume. When the feed mechanism is manually operated to check the paper feed, paper feeds correctly.

1. Remove the paper feed roller gear [A] and the second feed roller gear [B].
2. With fine sandpaper, lightly sand the roller shaft surface at the point where it comes into contact with the one-way clutch. This increases the coefficient of friction.
3. If paper jams continue to occur, replace the one-way clutch.
4. If paper jams continue to occur, replace the roller shaft together with the one-way clutch.
