SUBJECT: Ink Cartridge Seal

FROM: Copier Technical Support Section

SS915/930/950

SUBJECT: Drum Retrofit to prevent Ink Leakage (Refer to M/B No. 63)

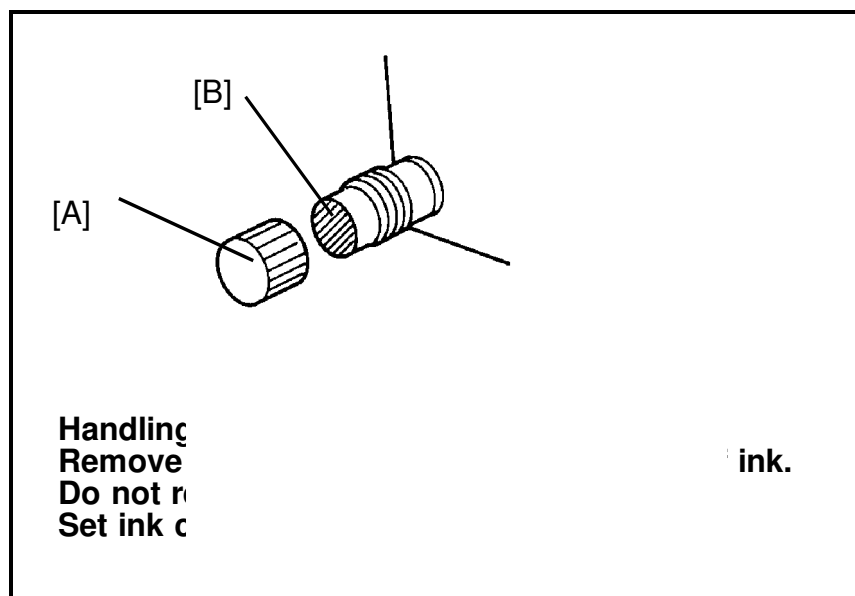
A transparent seal will be added to the exit of the ink cartridge (all colors) to prevent ink from being spilled on the floor during cartridge installation. It is not necessary to remove this seal; a projection on the ink pump inlet breaks this seal when the cartridge is set into the drum cartridge holder.

This modification will be implemented in the December production run. The following illustration and instructions will be printed on all ink cartridges early next year. This instructs the customers not to remove the seal at installation.

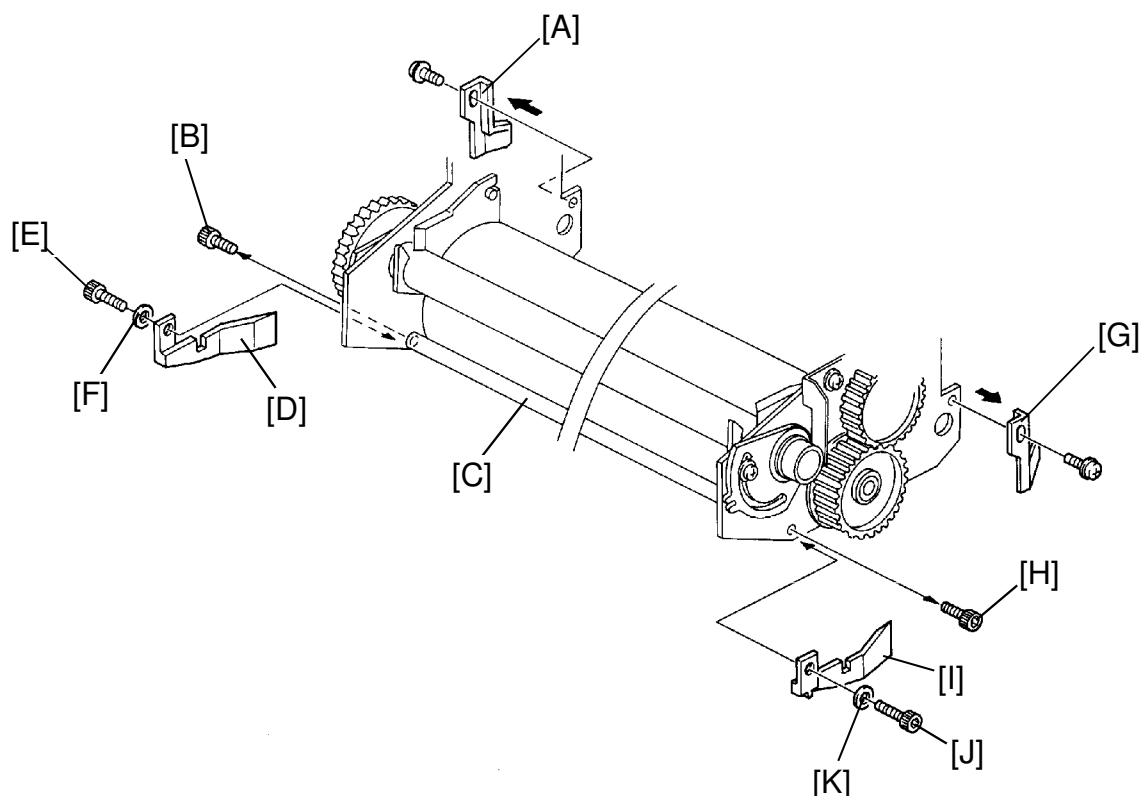
A drum blades kit has been registered as a spare part. With this retrofit kit, technicians can quickly and easily correct the drum ink leakage problem in the field.

1. Remove the drum clumper assembly.
2. Remove the tetron screens from the drum.
3. Remove the stainless steel screen from the drum.
4. Remove the old front drum blade (C2004745) [A] (1 screw).
5. Remove the internal hexagon head screw (M4 x 6) [B] securing the ink roller shaft stay [C], then install the new front drum blade (C2074745) [D] and secure it with the internal hexagon head screw (M4 x 8) [E] and the flat washer [F].
6. Remove the old rear drum blade (C2004746) [G] (1 screw).
7. Remove the internal hexagon head screw (M4 x 6) [H] securing the ink roller shaft stay [C], then install the new rear drum blade (C2074746) [I] and secure it with the internal hexagon head screw (M4 x 8) [J] and the flat washer [K].
8. Reverse the procedure to reassemble.

Note: Do not re-use the old front and rear drum blades.

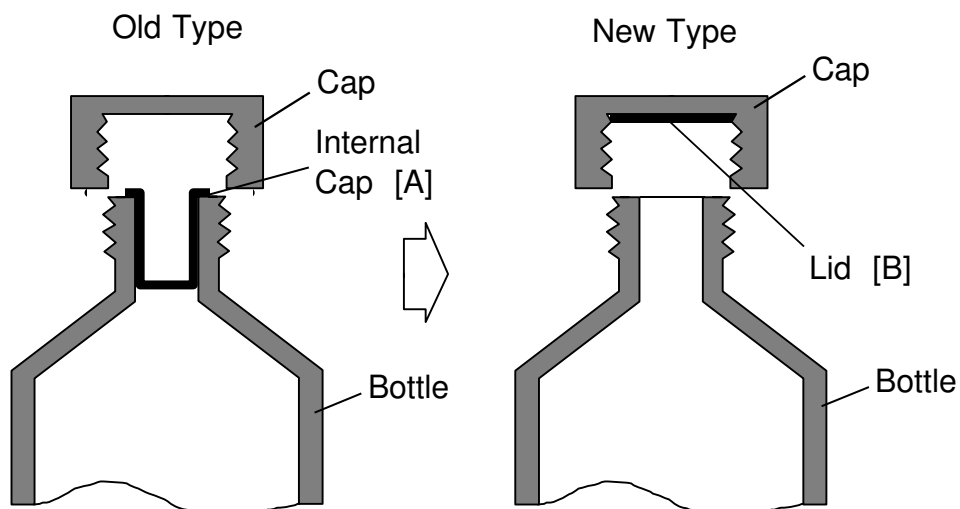
There has been a problem with the internal cap [A] getting stuck inside the thermal head cleaner bottle and it is difficult to pull it out.

The internal cap has been changed to a lid [B] as illustrated below:

*After the cap is removed, the internal cap must be pulled out.

* The lid remains inside the cap

This modification has been implemented since the November '90 production run. Please note that the part number of the thermal head cleaner remains the same.

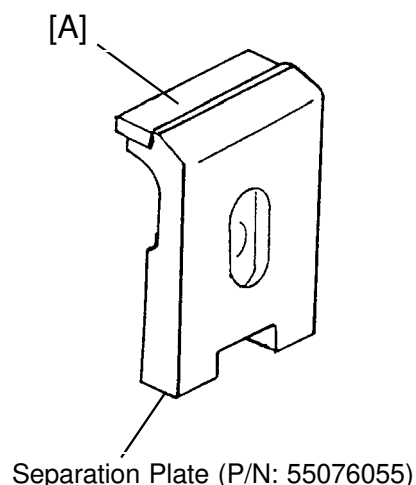
There have been reports in the field of the rubber separation pad [A] easily coming off the separation plate (P/N: 55076055) [B]. This occurred with separation plates that had been supplied as spare parts.

When installing a new separation plate, check the bond between the pad and the plate. If the bond is not sufficiently strong, apply a strong adhesive (super glue).

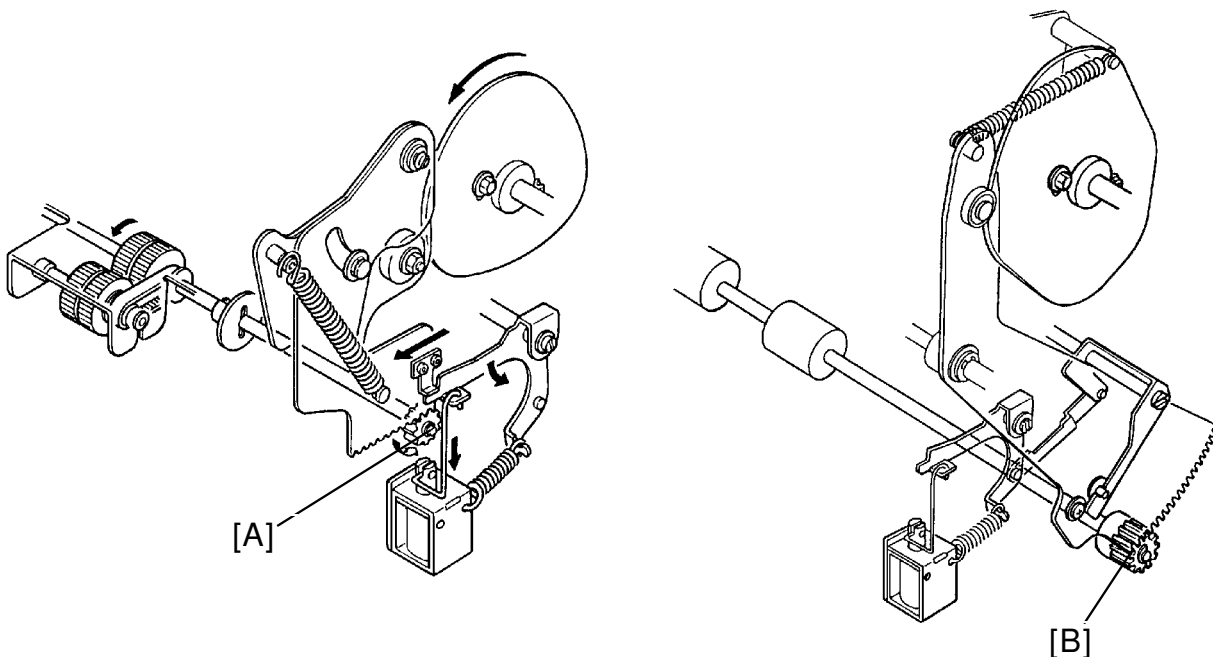
The one-way clutches inside the paper feed and second feed roller gears have worn the roller shafts smooth. The clutch slips and paper jams or is not fed. This tends to occur during high speed printing and is more likely to occur on machines that exceed the recommended monthly copy volume. When the feed mechanism is manually operated to check the paper feed, paper feeds correctly.

1. Remove the paper feed roller gear [A] and the second feed roller gear [B].
2. With fine sandpaper, lightly sand the roller shaft surface at the point where it comes into contact with the one-way clutch. This increases the coefficient of friction.
3. If paper jams continue to occur, replace the one-way clutch.
4. If paper jams continue to occur, replace the roller shaft together with the one-way clutch.
