SUBJECT: Ink Cartridge Seal

FROM: Copier Technical Support Section

SS935/955

SUBJECT: Drum Retrofit to prevent Ink Leakage (Refer to M/B No. 21)

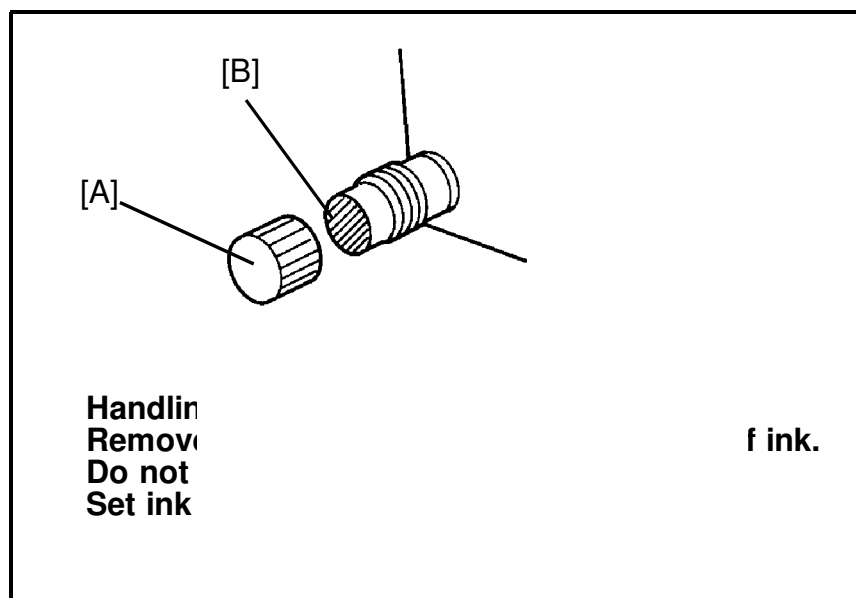
A transparent seal will be added to the exit of the ink cartridge (all colors) to prevent ink from being spilled on the floor during cartridge installation. It is not necessary to remove this seal; a projection on the ink pump inlet breaks this seal when the cartridge is set into the drum cartridge holder.

This modification will be implemented in the December production run. The following illustration and instructions will be printed on all ink cartridges early next year. This instructs the customers not to remove the seal at installation.

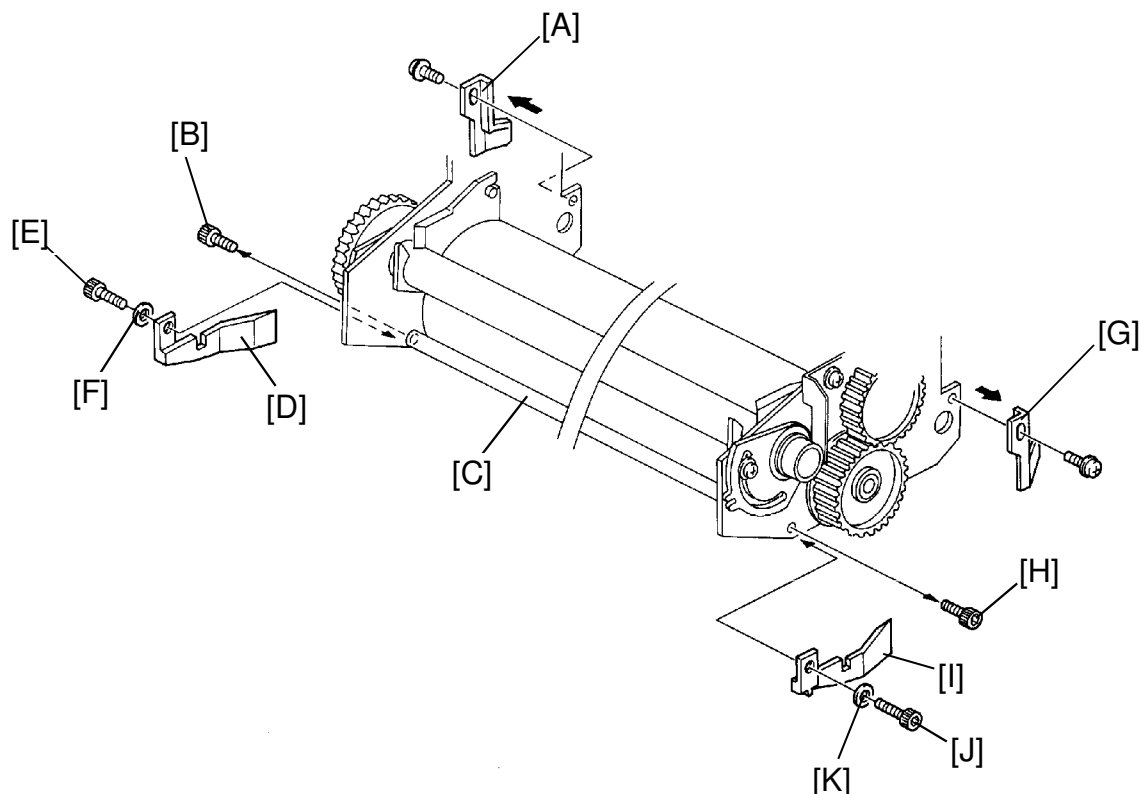
A drum blades kit has been registered as a spare part. With this retrofit kit, technicians can quickly and easily correct the drum ink leakage problem in the field.

1. Remove the drum clumper assembly.
2. Remove the tetron screens from the drum.
3. Remove the stainless steel screen from the drum.
4. Remove the old front drum blade (C2004745) [A] (1 screw).
5. Remove the internal hexagon head screw (M4 x 6) [B] securing the ink roller shaft stay [C], then install the new front drum blade (C2074745) [D] and secure it with the internal hexagon head screw (M4 x 8) [E] and the flat washer [F].
6. Remove the old rear drum blade (C2004746) [G] (1 screw).
7. Remove the internal hexagon head screw (M4 x 6) [H] securing the ink roller shaft stay [C], then install the new rear drum blade (C2074746) [I] and secure it with the internal hexagon head screw (M4 x 8) [J] and the flat washer [K].
8. Reverse the procedure to reassemble.

Note: Do not re-use the old front and rear drum blades.

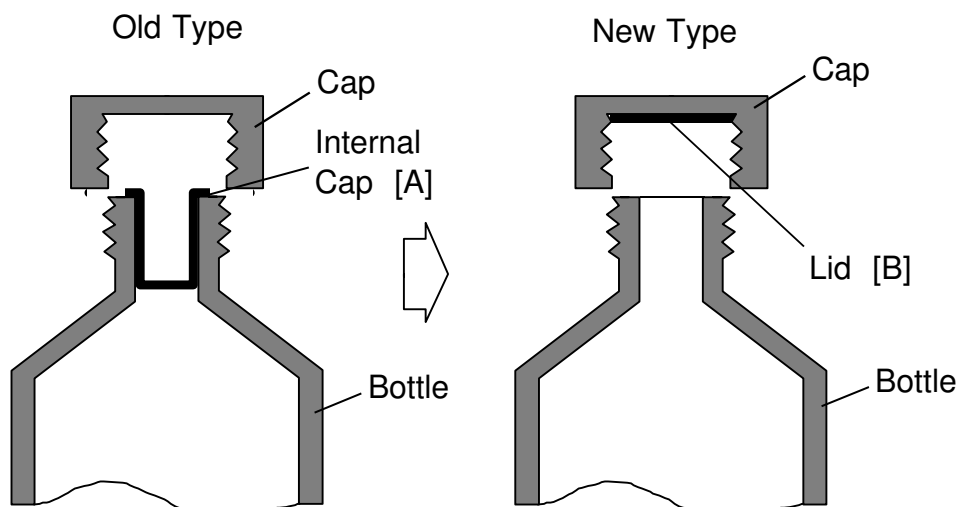
There has been a problem with the internal cap [A] getting stuck inside the thermal head cleaner bottle and it is difficult to pull it out.

The internal cap has been changed to a lid [B] as illustrated below:

*After the cap is removed, the internal cap must be pulled out.

* The lid remains inside the cap

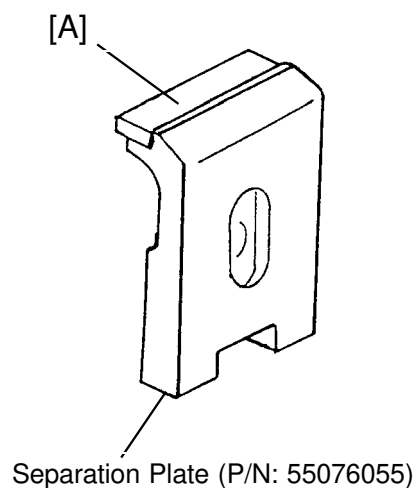
There have been reports in the field of the rubber separation pad [A] easily coming off the separation plate (P/N: 55076055) [B]. This occurred with separation plates that had been supplied as spare parts.

When installing a new separation plate, check the bond between the pad and the plate. If the bond is not sufficiently strong, apply a strong adhesive (super glue).

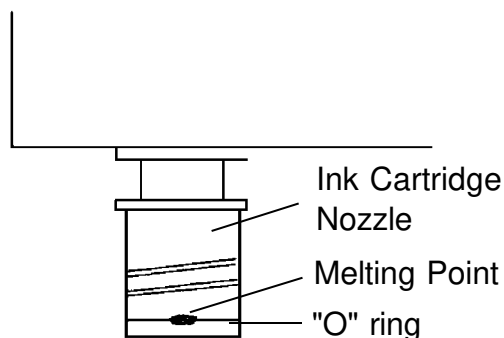
There has been a problem with the "O" ring inside the ink cartridge nozzle. The "O" ring comes off and remains on the nozzle of the ink pump when the ink cartridge is replaced, or it comes off and stays in the cartridge cap when the cap is removed. This occurs when the temperature changes radically making the "O" ring contract.

Note: To prevent the "O" ring from coming off, more than 2 points between the "O" ring and the ink cartridge nozzle were soldered as shown above. This melting process has been implemented since the March '91 production run. For a mark of the melting process, a black circle has been stamped on the end of the lot number. (Example: Lot No. 1911932 0)

1. Make sure that the "O" ring does not stay on the nozzle of the ink pump before a new ink cartridge is installed.
If it remains on the nozzle, remove it; otherwise the new ink cartridge cannot be set properly.
2. Make sure that the "O" ring does not stay in the cartridge cap when the cap is removed from the ink cartridge nozzle.
If the "O" ring stays in the cartridge cap, remove the "O" ring from the cartridge cap and install it inside the cartridge nozzle.

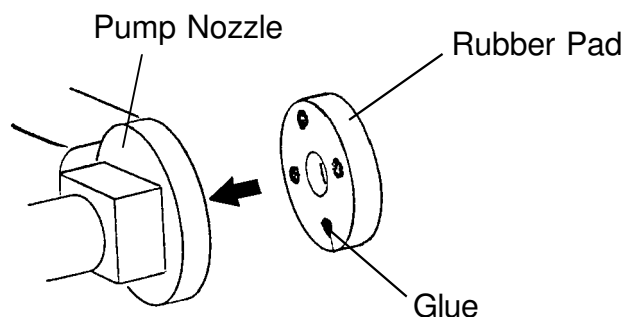
There has been a problem with the rubber pad located on the ink pump nozzle. It comes off when the ink cartridge is removed. When no rubber pad remains on the ink pump nozzle, ink inside the cartridge may not be pumped to the drum even if a new ink cartridge is installed. This problem does not happen very often.

1. Remove the rubber pad with a small screwdriver.
2. Clean the rubber pad and the ink pump nozzle (contacting place of the rubber pad) with cloth. If stains remain, clean them off with the thermal head cleaner.
3. Apply a little super glue to the 4 points on the rubber pad as shown.

Note: Do not apply too much glue. This is because the rubber pad cannot be inserted correctly if there is too much glue.

4. Insert the rubber pad into the pump nozzle.

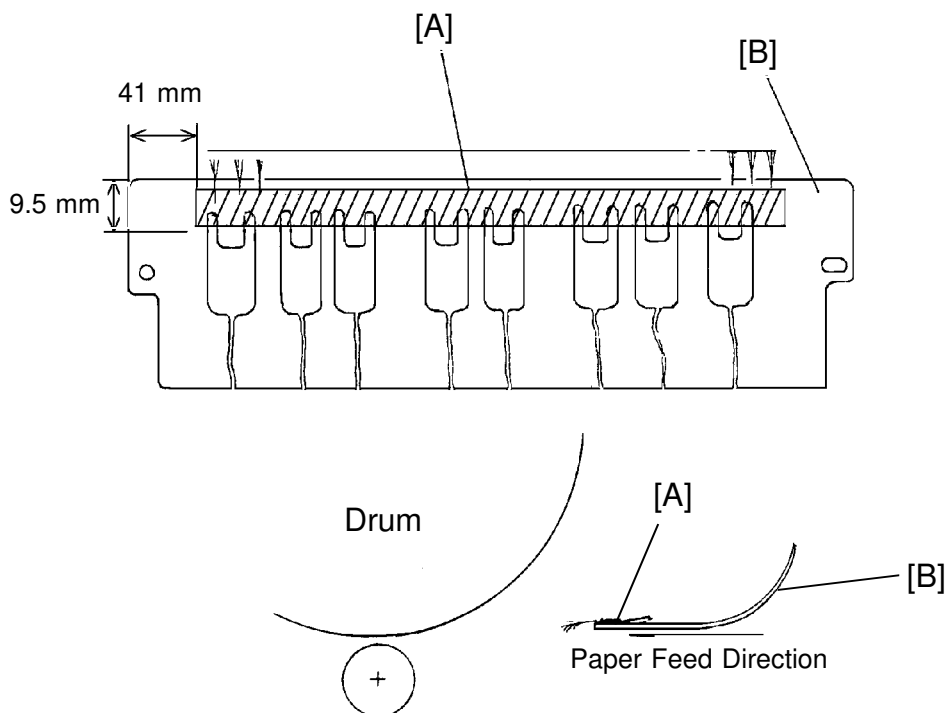
Paper jamming occurs around the drum because of static electricity when the machine is used under low humidity conditions. Heavy static charges will build up around the master during the printing run. This happens particularly when thin paper is being used at high speed rotations. This also happens if the original (and therefore the master on the drum) is changed.

Stick the antistatic brush (P/N: C2079010) [A] on the upper second feed roller guide plate [B] as illustrated below: (The antistatic brush has been registered as a spare part.)

Note: Depending on the type of paper and/or the environment, paper might still jam even though the antistatic brush was installed on the guide plate. The occurrence ratio varies according to the environment. If possible, improve the environmental conditions or move the machine to a better place.
