SUBJECT: Master Feed Jams

SUBJECT: Master Eject Jams

SUBJECT: Ink Pump Improvement

SUBJECT: Paper Leading Edge Dirty with Ink

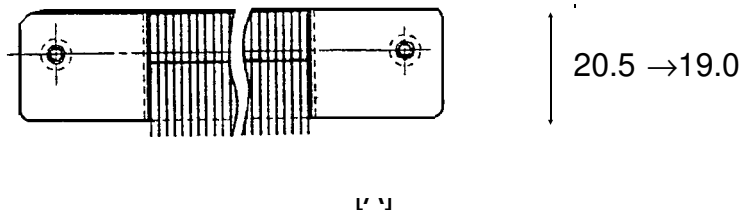
It was found that the antistatic brush sometimes interferes with master transportation and causes master feed jams. To ensure smooth master feed, the position of the antistatic brush [A] sticking on the inner cover [C] has been changed.

The sticking position is as shown below. Even if the antistatic brush does not contact the master surface, it functions to remove electrostatic charges on the master.

The antistatic brush assembly has been registered as a service part (C2174064). Please refer to MB No. 11.

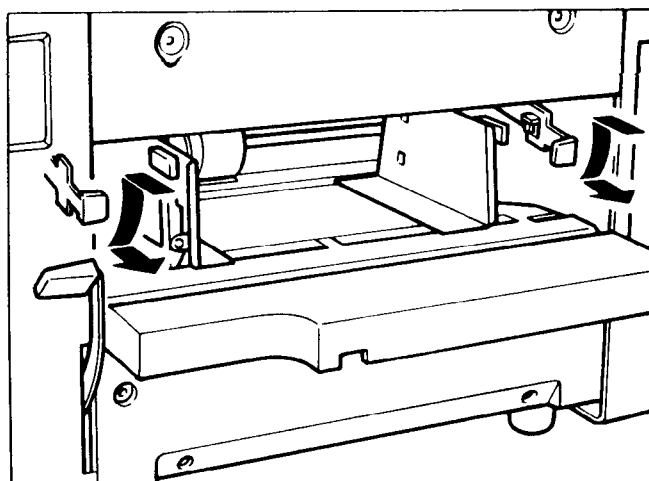
When 500 sheets of standard paper (80g/m²) is set on the paper table, paper misfeeds would occur. This is because not enough feed roller pressure is applied due to friction between the paper stack (leading edge side) and the lower paper feed guide which guides the leading edge of the paper stack.

In this case, advise your customer to change the position of the pressure adjustment levers, as shown below, to increase paper feed pressure.

We confirmed that even if the pressure adjustment levers are in the lower position, normal paper (70g/m to 200g/m) would be fed properly. So from August '93 production, the pressure adjustment levers have been set in the lower position (stronger pressure) in the factory.

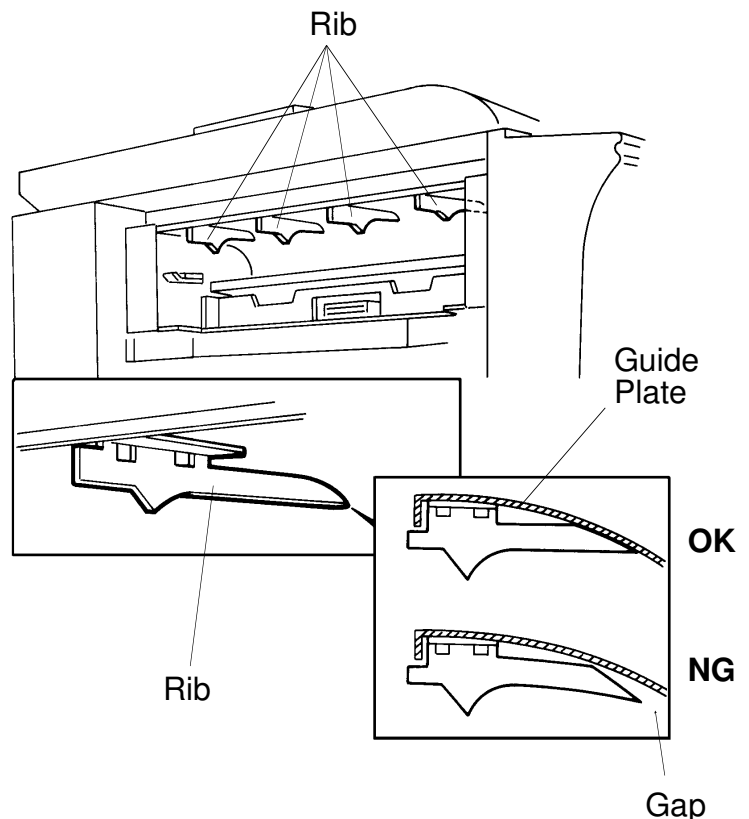
1. Frequent master eject jams at location "F".
2. The master wraps around the upper and/or lower master eject rollers.
3. "F" jam cannot be reset because the actuator (feeler) of the master eject sensor remains pushed down by the pressure plate. (The actuator comes under the pressure plate.)

There are 4 ribs to guide the ejected master in the master eject unit. There is a small gap at the leading edge of the ribs against the guide plate.

Due to a part variation, if the gap is too big, the master tends to be caught by the ribs. A jam or other problems may occur as per the following sequence:

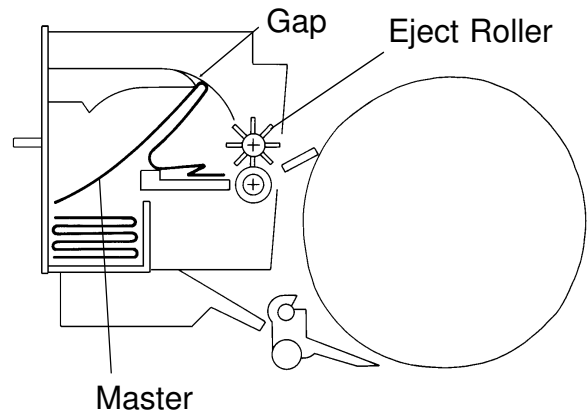
1. While the master is being removed from the drum, the leading edge of the master goes properly into the master eject unit. At this point, however, while the pressure plate moves to compress the master in the eject box, the middle part of the master tends to rub against the ribs. If there are any gaps, the master is caught by the ribs. (The master therefore remains caught by the ribs.)

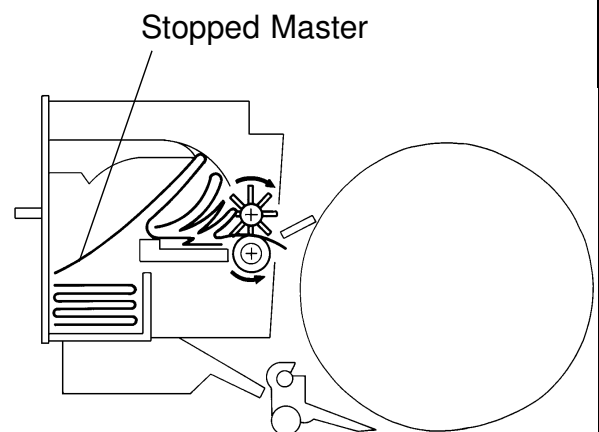
2. If no jam is detected by the machine after the above situation has occurred, the machine can carry out the next master eject. However, the next ejected master interferes with the master caught by the ribs and is stopped just behind the eject rollers.

As result, "F" jam will be indicated. Otherwise, if there is no space for the master to proceed (due to the previous master jam), the master is again caught by and wraps around the eject rollers. If the master is stopped just on the master eject sensor, the sensor feeler remains pushed down while the pressure plate is traveling. After the pressure plate returns to its home position, the sensor feeler comes under the plate. ("F" jam is then indicated and cannot be reset.)

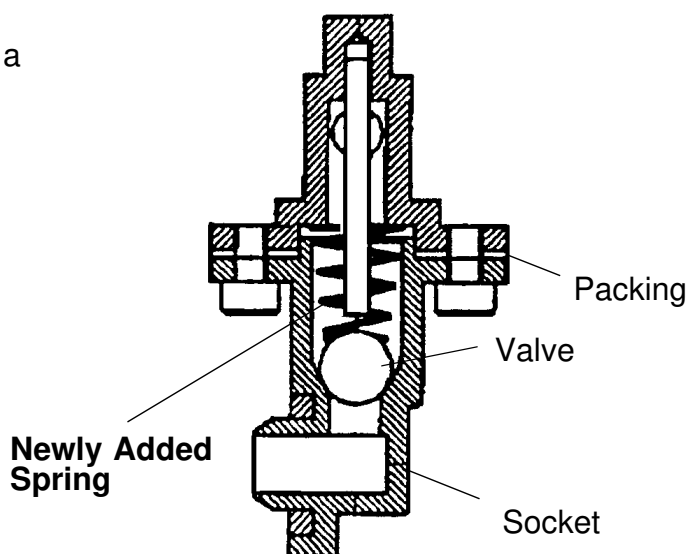
Cross-section of the Bottom Part of the Ink Pump

To ensure that all ink in the cartridge is supplied, a spring has been added inside the ink pump as shown to the right. The spring ensures that the small ball, which is used as a valve, is pushed back properly.

This modification has been applied from the September 1995 production runs of all Priport series models. The part numbers of the ink pump assemblies remain the same. (Note that the N850 and RN925 have been using the new type from the first mass production.)

For the field machines, you can install the spring after removing the socket (with two screws). (It takes longer to replace the whole pump assembly.)

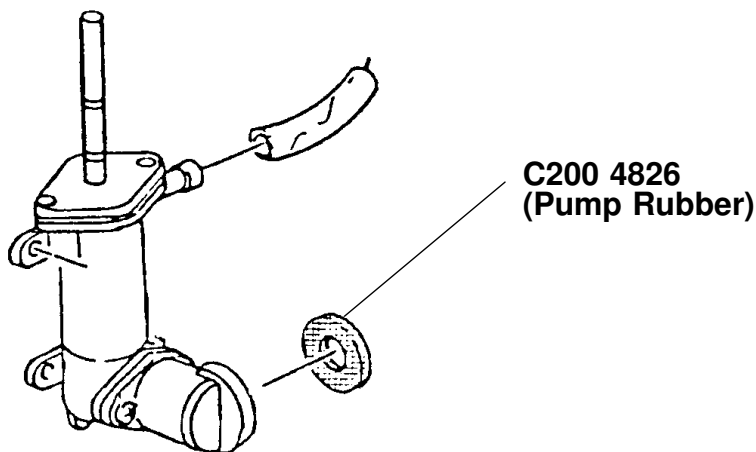
2. A rubber packing is used as shown below in order to ensure that the nozzle of the ink cartridge tightly contacts the pump socket. Check if this part is dislocated. The rubber packing used in the N810, the N865, and the other later models is adhered with glue, but it is not adhered for the other older models.

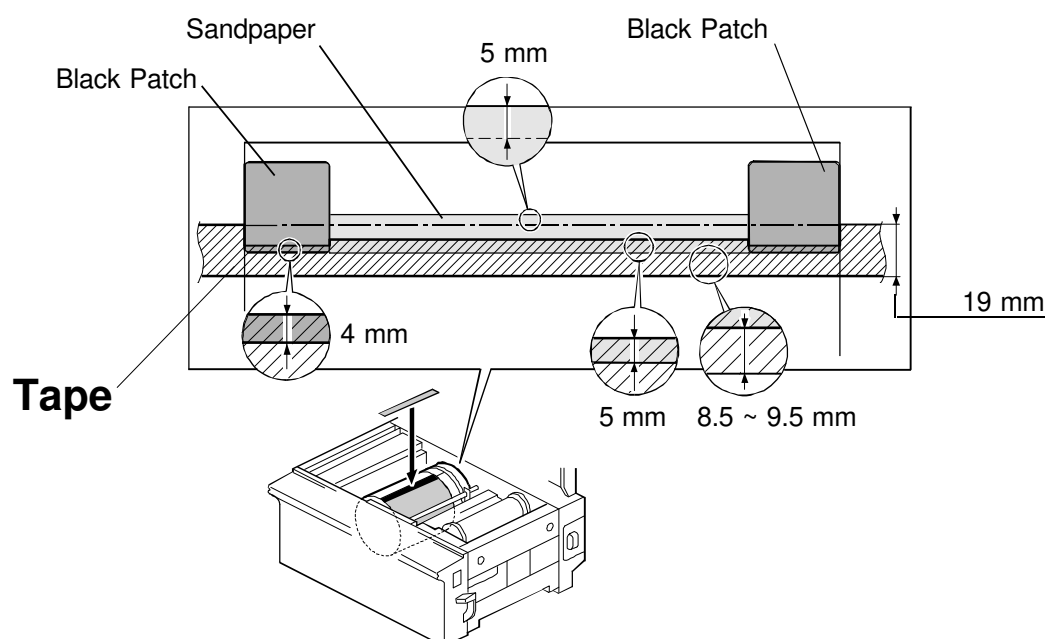
For N810 and N810-II Models

During a long printing run, unwanted ink appears at the leading edge of copies. At first, it is very hard to see, but it becomes more visible as the printing continues.

Due to rough edges of the paper, the master wrapped around the drum becomes damaged.

Just when the leading edge of the paper reaches under the drum, it is pressed against the drum surface, so that the master is wrapped around by the press roller. Due to this repeating action, the master's surface is gradually torn where the paper leading edge contacts it.

3. Cover the leading edge part of the cloth screen on the drum with tape, so that ink does not leak even when the master is damaged.

- Cut the tape where it covers the sandpaper as shown. (The indicated area must be left as shown to hold the tape on the screen firmly.) Be careful not to damage the cloth screen surface.
- **Also, cut the tape where it covers the black patches (for the drum master detection sensor) as shown. If they are covered, drum master detection does not work properly.**
- Cut both edges of the tape at the edge of the metal screen. Do not let the tape ride over the drum flanges.
- Even if the sandpaper is not used on the cloth screen (the old type cloth screen), install tape at the same position by measuring the distance from the edge of the black patch to the lower edge of the tape (between 8.5 and 9.5 mm).
