SUBJECT: Black Ink Cartridge Seal

FROM: Copier Technical Support Section

VT3500
Ges 5375/Rex 1280
NSA CP375

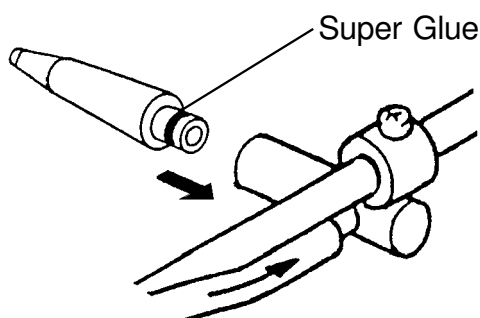
During the printing run, the paper exit pawl slightly comes off and it contacts the drum screen. This causes a black line on copies. In the worst case, the exit pawl contacts the master clamber and the clamber may be damaged.

[Causes]:

Variation of amount of glue

1. Check whether the exit pawl comes off or not.
2. Make sure that the exit pawl does not come off by pulling it out with light force (with fingers).
3. If it comes off, apply super glue one turn around the joint area and insert it as shown.

Note: Before applying super glue, place a sheet of paper on the vacuum unit to prevent glue from dropping on the vacuum belt.

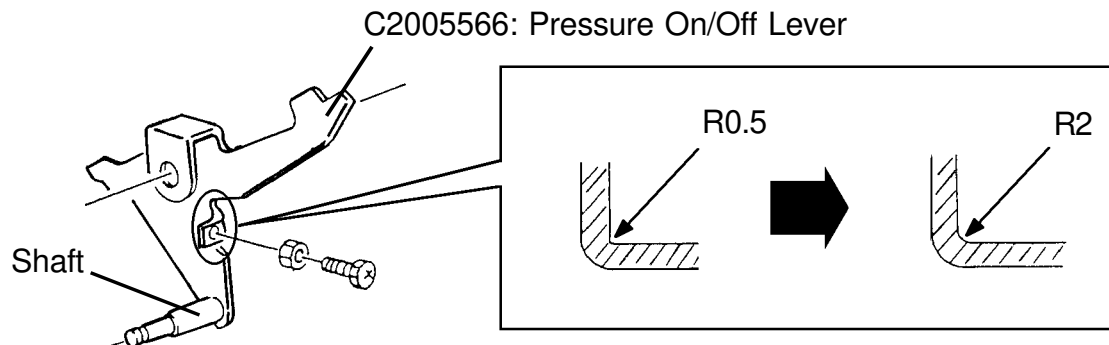
It was reported that the adjusting screw tab of the pressure on/off lever is sometimes broken.

The pressure on/off lever (part number: C200 5566) is commonly used for all the series models, but this problem is typical only on this model. This is because the pressure roller's pressure of this model is higher than that of the other models due to the A3 size printing.

To increase the durability of the lever, the angle has been rounded as shown in the illustration. This will reduce the stress on the adjusting screw tab. The new type lever has been applied since the May '92 production. The cut-in serial numbers are as follows:

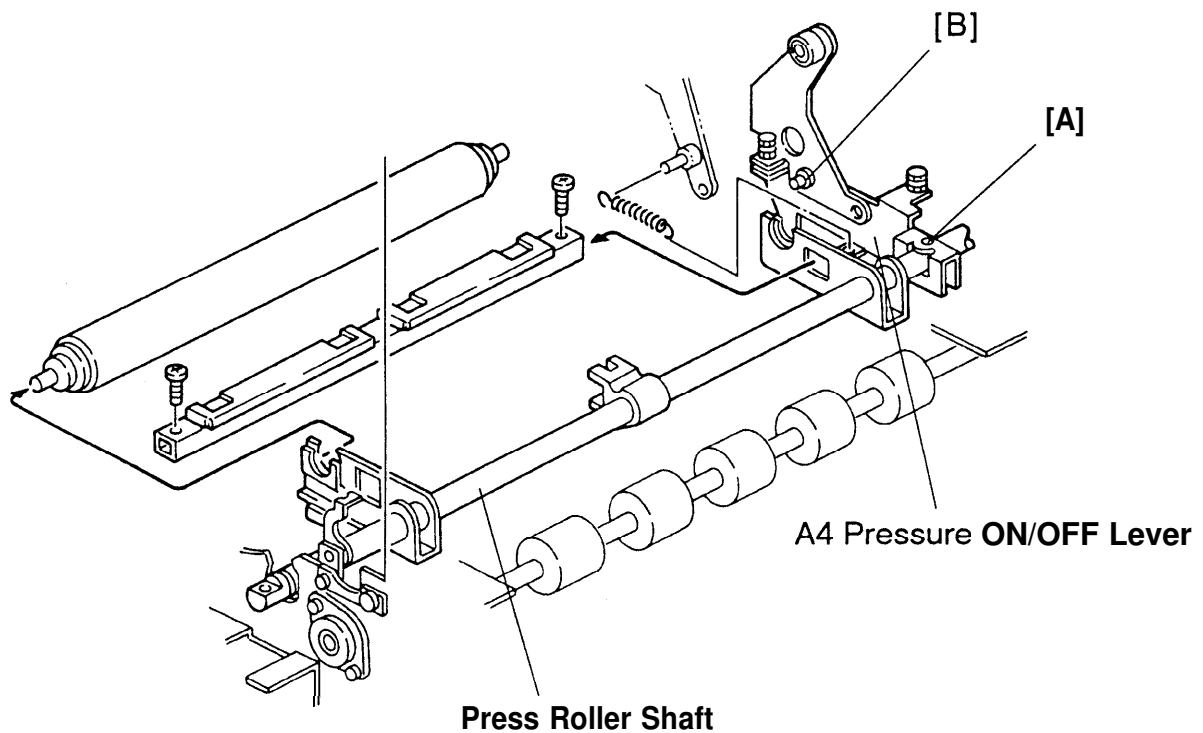
It was reported that the bolt (M5x14 hexagonal hole head bolt) that secures the A4 pressure on/off lever on the press roller shaft breaks. This will cause the exit pawl to hit the drum surface because the exit pawl drive cam is fixed with the A4 pressure on/off lever.

Since August 1992, the torque to tighten the bolt has been reduced and controlled to 40 to 50 kgfcm on the production line. In the past, it was around 100 kgfcm. It was found that there was possibility of the bolt breaking while using the optional A4 drum. The cut-in serial numbers are as follows:

When the optional A4 drum is installed for a machine produced before the cut-in serial numbers listed in the preceding page, perform the following:

1. Replace the bolt [A] with a new one (P/N: 05950140E).
2. Be sure that the bolt [B] (M4x6 hexagonal hole head bolt) is firmly tightened. If this is loose, the A4 pressure on/off lever does not operate properly.

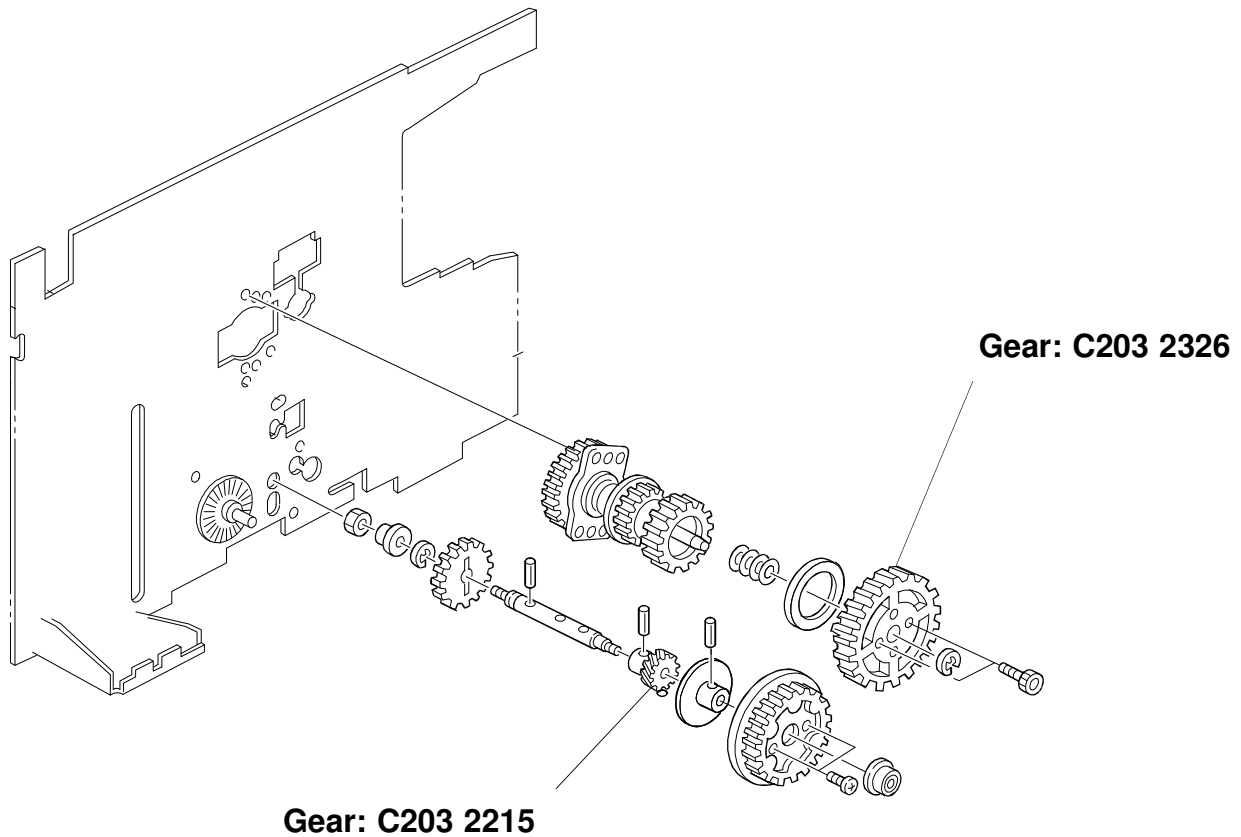
It was found that gears C2032215 and C2032326 (see the illustration on the next page) can rapidly wear out if they are not greased. In particular, gear C2032215 wears out faster (after about 30,000 to 50,000 copies).

It was also found on the production lines that some machines which were manufactured during the period from the end of 1994 to May 1995 have a lack of greasing for these gears. From April 1995, an inspection process was added to check the greasing of these gears.

1. For the machines detailed above (the NA3 and NB2 manufactured between the end of 1994 and May 1995), check if grease is properly applied and grease if necessary.
2. Grease the gears every time when they are replaced.
3. Grease at yearly PM intervals (as mentioned in the service manual).

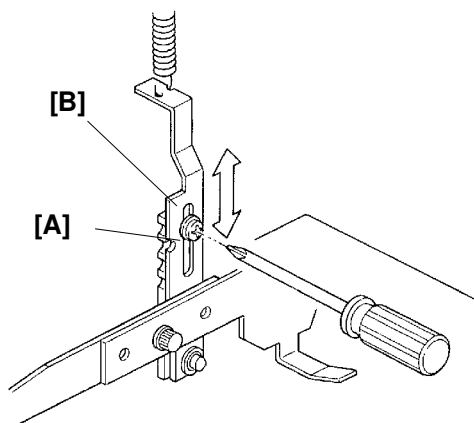
The paper feed roller pressure is too low. It was found that on the production line the adjustment was performed improperly, for some units. Therefore, this problem can occur in the NA33 model only.

1. Check the original position first, then loosen the screw [A] while holding the lower adjustment plate [B].
2. Shift the lower adjustment plate [B] up by one notch to increase the paper feed roller pressure. Then, re-tighten the screw [A].

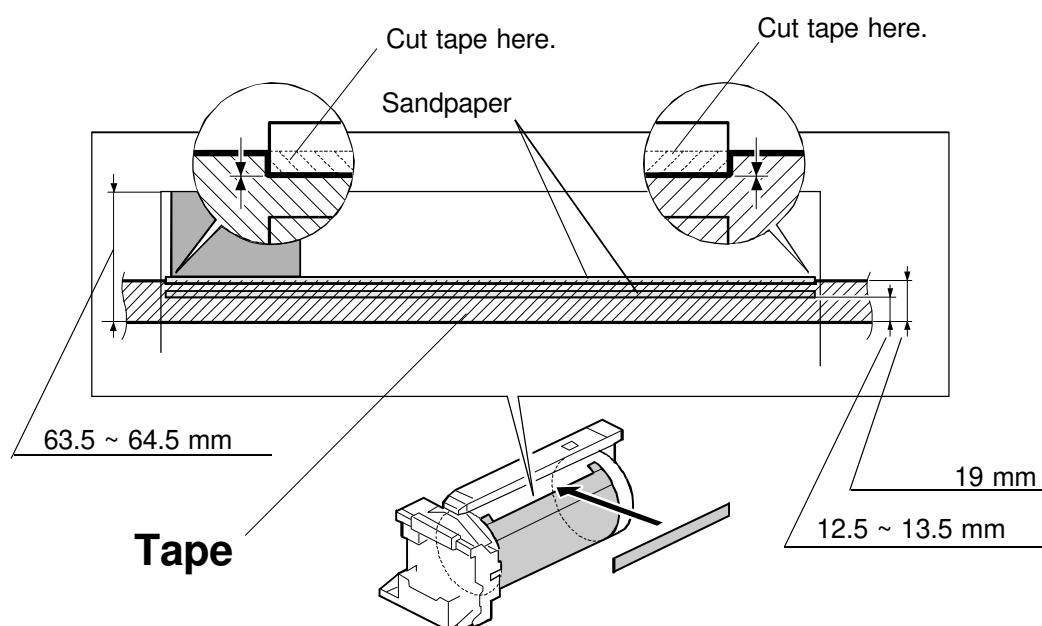
For NA33 model

Due to rough edges of the paper, the master wrapped around the drum becomes damaged.

Normally, even if the master is damaged, there is no ink around the area beneath the master where the paper leading edge contacts it (there are no holes in the metal screen). However, after a long printing run, ink leaks onto this area and is transferred to the paper through the damaged part of the master.

- Cut the tape where it covers the upper strip of sandpaper as shown. Be careful not to damage the cloth screen surface.
- Cut both edges of the tape at the edge of the metal screen. Do not let the tape ride over the drum flanges.

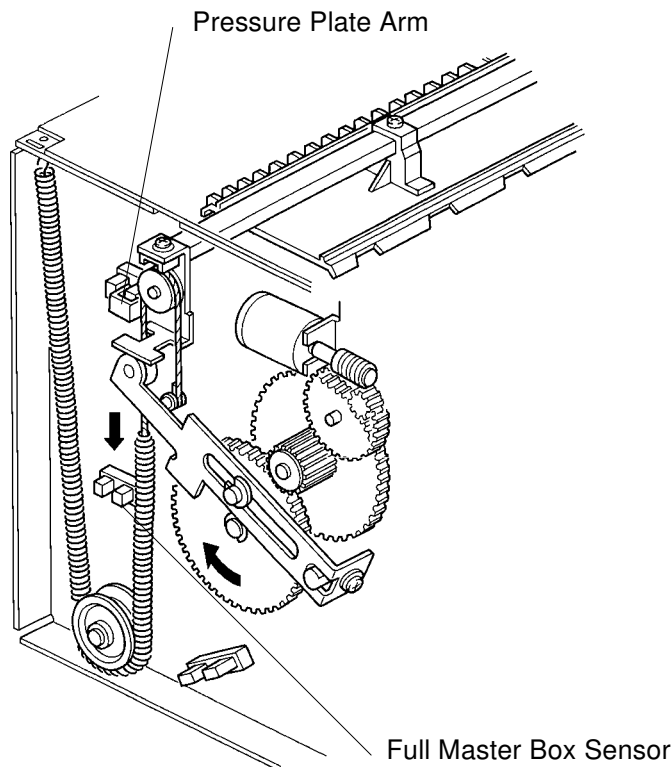
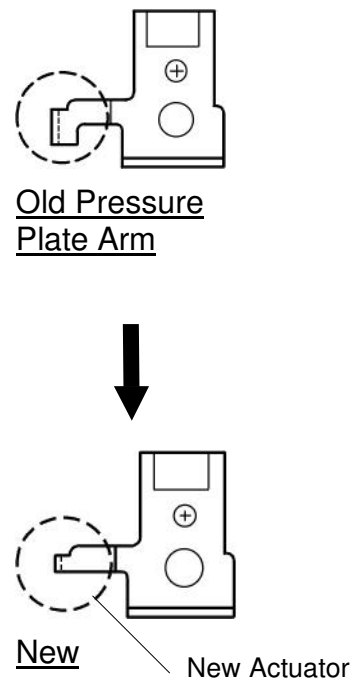
VIEW FROM OPERATION SIDE

We found that the master eject belt may slip off in the following situation:

The new part has a narrower actuation plate as shown below. This means that the full master condition will be detected earlier than before.

If SOLUTION 1 is not good enough, install the new part on the operation side of the master eject unit (see below).

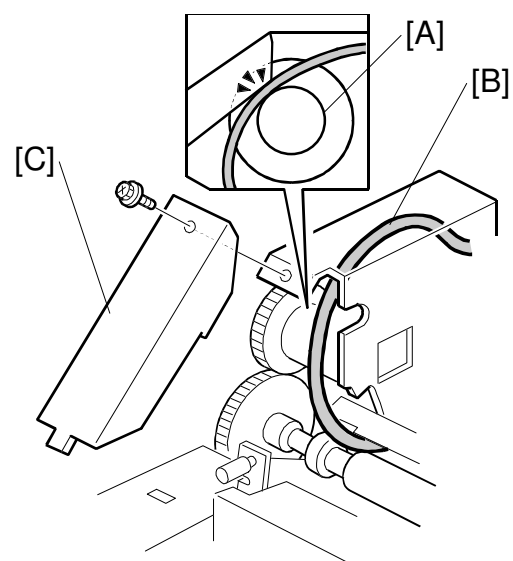
1. Master feed jam (location C jam).
2. The length of the master that wraps around the drum is shorter than normal. This causes a master eject jam during the next master making process. This is because the master eject rollers cannot catch the trailing edge of the master on the drum.

There is a torque limiter [A] built into the gear on the upper master feed roller. If the wire harness [B] from the cutter unit is run (installed) improperly when the gear cover [C] is installed, the gear cover may catch and press the wire harness against the sleeve of the torque limiter.

NOTE: The torque limiter is used in the NA6 only, and this problem does not occur in other PRIPORTs.

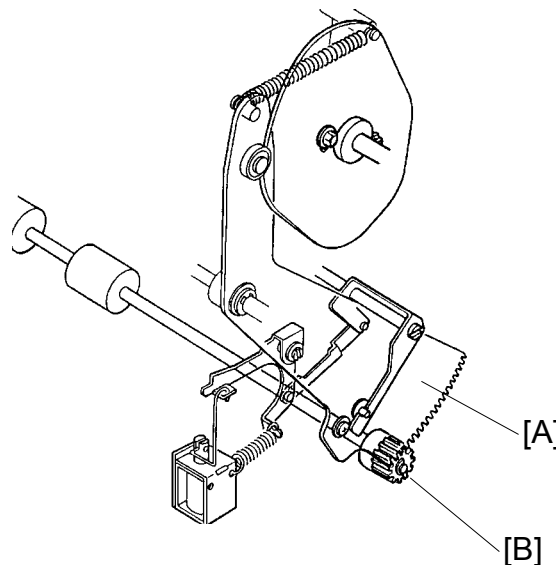
Case 1:

A worn 2nd sector gear and/or 2nd feed roller gear causes paper feed jams.

This also causes the 2nd feed roller lifting mechanism to not work properly. In this case, printed images will be distorted. (Images are not transferred to paper properly because of the lifting mechanism failure.)

The sector gear [A] and the feed roller gear [B] ran out of lubricant. Because of this, the sector gear [A] will not be able to oscillate back and forth correctly.

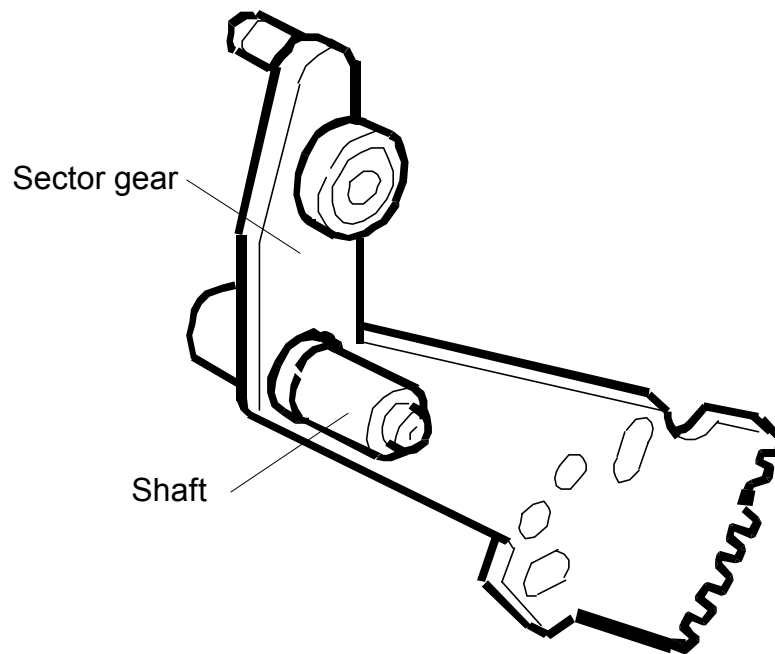
**Case 2:**

There is too much thrust play, and the sector gear is oscillating on the shaft.

Due to this, the sector gear will not be able to oscillate back and forth correctly. As a result, the sector gear does not move correctly on the 2nd feed roller gear and damages the teeth of the gear.
