Model: Soleil-PJ1a/Soleil-PJ1b/Soleil-PJ2/ Altair-PJ1/ Altair-PJ2/Soleil-PJ2.5	Date: 19-Oct-12	No.: RY011003f
---	-----------------	----------------

Subject: Firmware Release Note: Backup Tool		Prepared by: A. Iwaori	
From: VC Products Support Sec., Solution Support Dept.			
Classification:	<input type="checkbox"/> Troubleshooting <input type="checkbox"/> Mechanical <input type="checkbox"/> Paper path <input type="checkbox"/> Product Safety	<input type="checkbox"/> Part information <input type="checkbox"/> Electrical <input type="checkbox"/> Transmit/receive <input checked="" type="checkbox"/> Other (Firmware)	<input type="checkbox"/> Action required <input type="checkbox"/> Service manual revision <input type="checkbox"/> Retrofit information <input checked="" type="checkbox"/> Tier 2

Model: Soleil-PJ2a/b		Date: 30-May-16	No.: RY033003
Subject: Service manual revision: Keystone Calibration & Troubleshooting		Prepared by: Takuma. Sakakibara	
From: VC Tech Service Sect., MFP/Printer Tech Service Dept.			
Classification:	<input type="checkbox"/> Troubleshooting <input type="checkbox"/> Mechanical <input type="checkbox"/> Paper path <input type="checkbox"/> Product Safety	<input typ

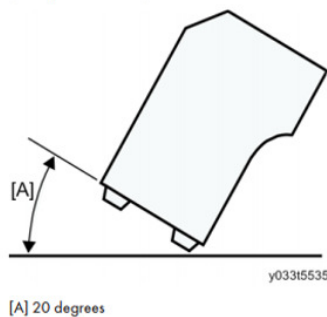
Wrong

4. Keep the projector at 20 degrees.
When the adjustment is successfully completed, the values changes from the default [0-0-2048].
(Example: See below)

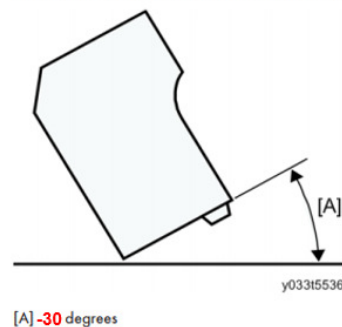
Correct

4. Keep the projector at **-30** degrees after removing the stand in the front of projector.

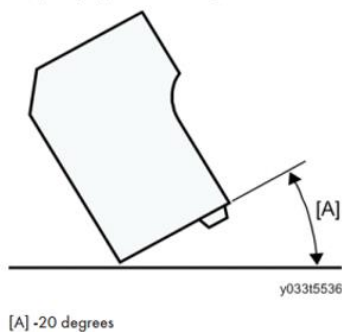
Wrong

7. Keep the projector at -20 degrees after removing the stand in the front of projector.

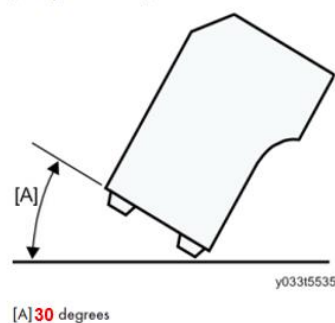
Correct

7. Keep the projector at **30** degrees.
When the adjustment is successfully completed, the values changes from the default [0-0-2048].
(Example: See below)
