Model: Basil		Date: 28-Oct-05	No.: RA768001
Subject: Firmware Release History		Prepared by: Yuji Urushihara	
From: 1st Tech. Support Sec. Service Support Dept.			
Classification:	<input type="checkbox"/> Troubleshooting <input type="checkbox"/> Part information <input type="checkbox"/> Action required <input type="checkbox"/> Mechanical <input type="checkbox"/> Electrical <input type="checkbox"/> Service manual revision <input type="checkbox"/> Paper path <input type="checkbox"/> Transmit/receive <input type="checkbox"/> Retrofit information <input checked="" type="checkbox"/> Other ()

Model: Basil		Date: 7-Feb-06	No.: RA768002
Subject: RC Gate new function		Prepared by: Yuji Urushihara	
From: 1st Tech. Support Sec. Service Support Dept.			
Classification:	<input type="checkbox"/> Troubleshooting <input type="checkbox"/> Mechanical <input type="checkbox"/> Paper path <input type="checkbox"/> Product Safety	<input type="checkbox"/> Part information <input type="checkbox"/> Electrical <input type="checkbox"/> Transmit/receive <input type="checkbox"/> Other ()	<input type="checkbox"/> Action required <input checked="" type="checkbox"/> Service manual revision <input type="checkbox"/>

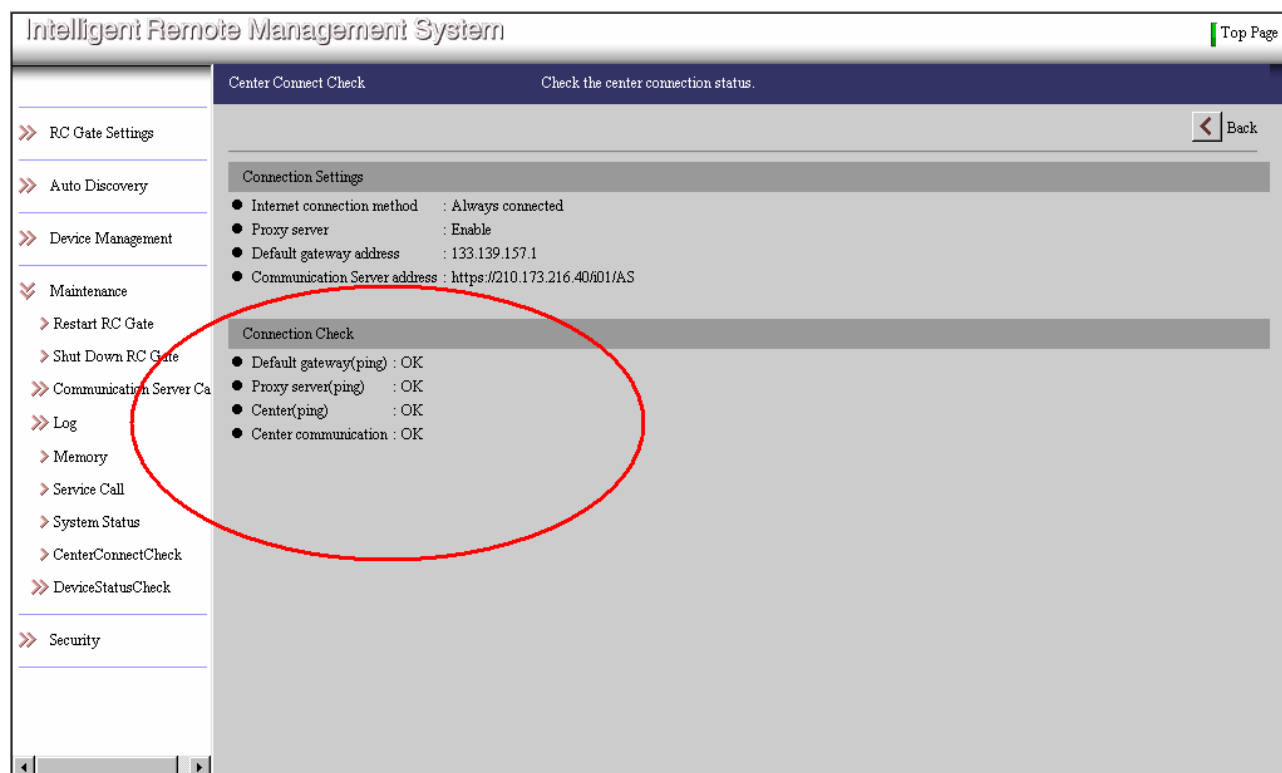
4. Check the connection status in the red circle shown below.

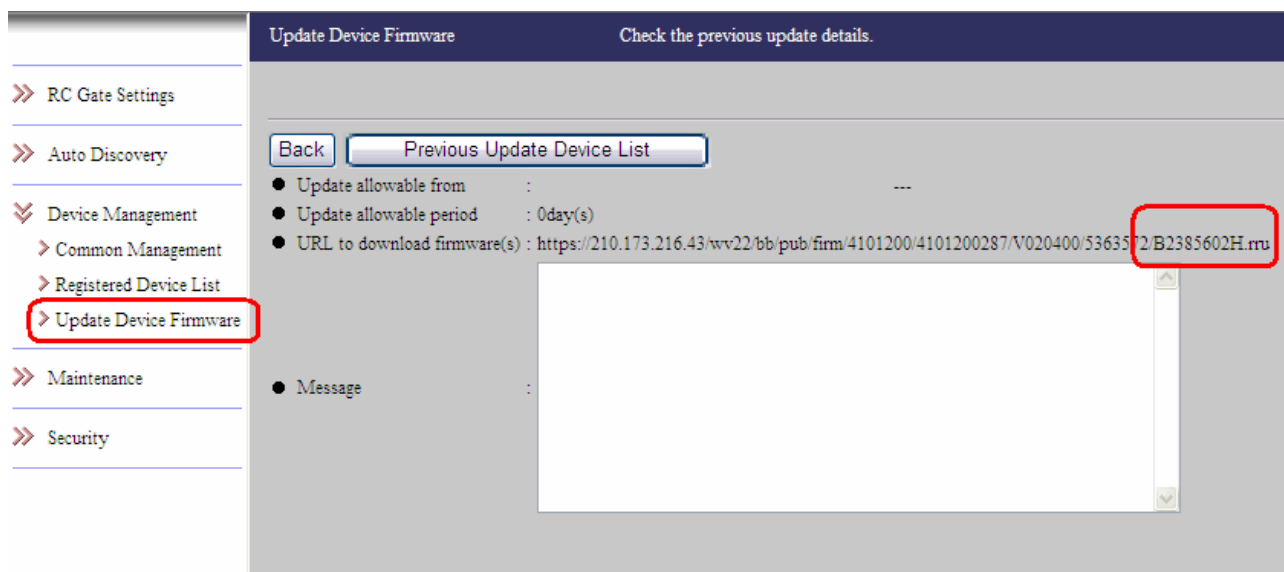
1. Check to see if the RC Gate already contains the **System firmware** for one of the models listed above. To do this, access the “Update Device Firmware” screen in the RC Gate GUI (below).

Note: In this example, firmware B2385602H (fax firmware for the AT-C1) is currently saved in the internal SD card.

2. If the RC Gate **does not contain** System firmware for one of the models listed above, as in this example, update the RC Gate firmware to **ver3.50-1.15**.
