Model: Ricoh Communication Gate A2		Date: 25-Mar-16	No.: RD3AR002
Subject: Manual correction: Configuration for CC-Certified environment		Prepared by: Tatsuya Suzuki	
From: 2nd Tech Service Sect., MFP/P Tech Service Dept.			
Classification:	<input type="checkbox"/> Troubleshooting <input type="checkbox"/> Mechanical <input type="checkbox"/> Paper path <input type="checkbox"/> Product Safety	<input type="checkbox"/> Part information <input type="checkbox"/> Electrical <input type="checkbox"/> Transmit/receive <input type="checkbox"/> Other ()	<input type="checkbox"/> Action required <input checked="" type="checkbox"/> Service manual revision <input type="checkbox"/> Retrofit information <input type="checkbox"/> Tier 2

Model: Ricoh Communication Gate A2		Date: 19-Apr-16	No.: RD3AR003
Subject: Devices registering problem		Prepared by: K. Yamamoto	
From: 2nd Tech Service Sect., MFP/P Tech Service Dept.			
Classification:	<input checked="" type="checkbox"/> Troubleshooting <input type="checkbox"/> Part information <input type="checkbox"/> Action required <input type="checkbox"/> Mechanical <input type="checkbox"/> Electrical <input checked="" type="checkbox"/> Service manual revision <

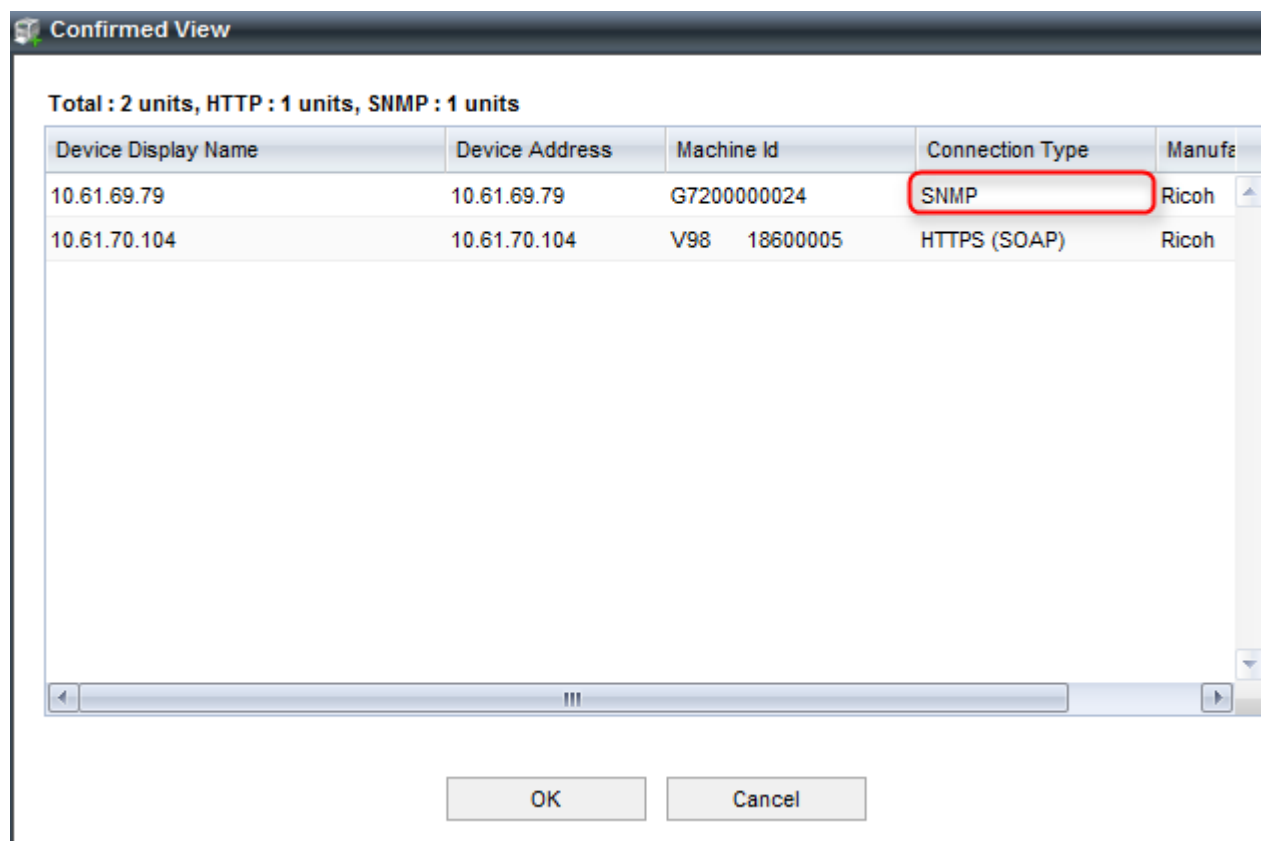
Fig. 1

The device will be stuck in a “registering” status if it is registered as an SNMP device (see **Fig. 1**) while the Device Encryption Level is set to 2048 bit (see **Fig. 2**) with RCGA2 v1.0.1.

1. Register the SNMP device with the 512 encryption setting, and then change the setting to 2048 bit after registration is complete, **or**
2. Register the SNMP device remotely or using the Auto Manage function.

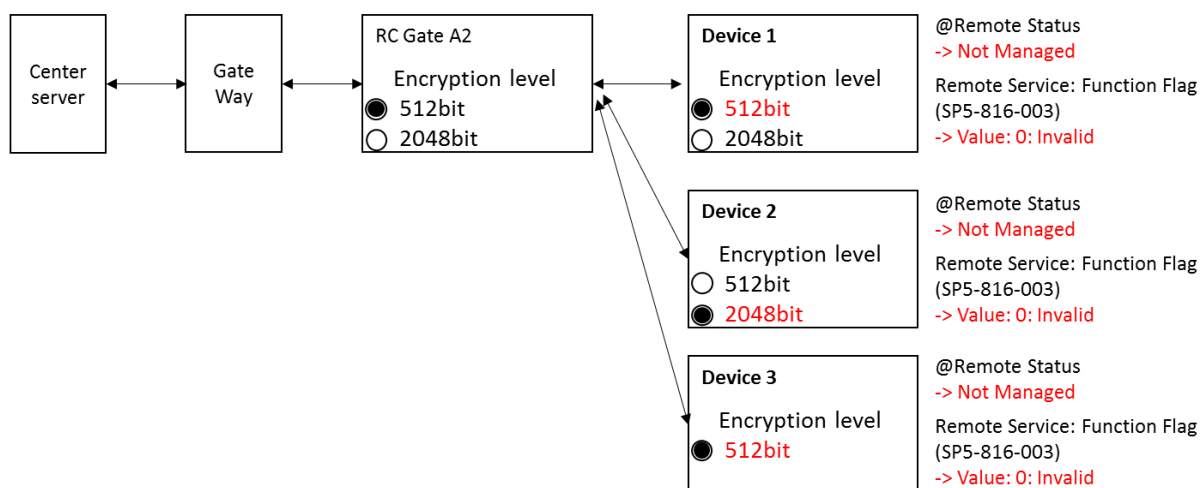
Configuration BEFORE device registration

If the encryption level is different between the RC Gate A2 and device upon device registration, the remote service function flag (SP5-816-003) does not change to "1: Valid" until the center server performs the connection check at 0 or 12 o'clock (UTC).

- Set the RC Gate A2 and devices with the same encryption level when registering devices.
- If the symptom has occurred, do either of the following two procedures.
 - (1) Manually change the function flag setting (SP5-816-003) to “1: Valid”, **or**
 - (2) Wait until the center server performs the connection check. This will automatically change the function flag setting from “Invalid” to “Valid” if the device registration procedure has been completed. The interval of the connection check is set to 43200 sec (12 hours) as default; check timing at 0 and 12 o'clock (UTC).

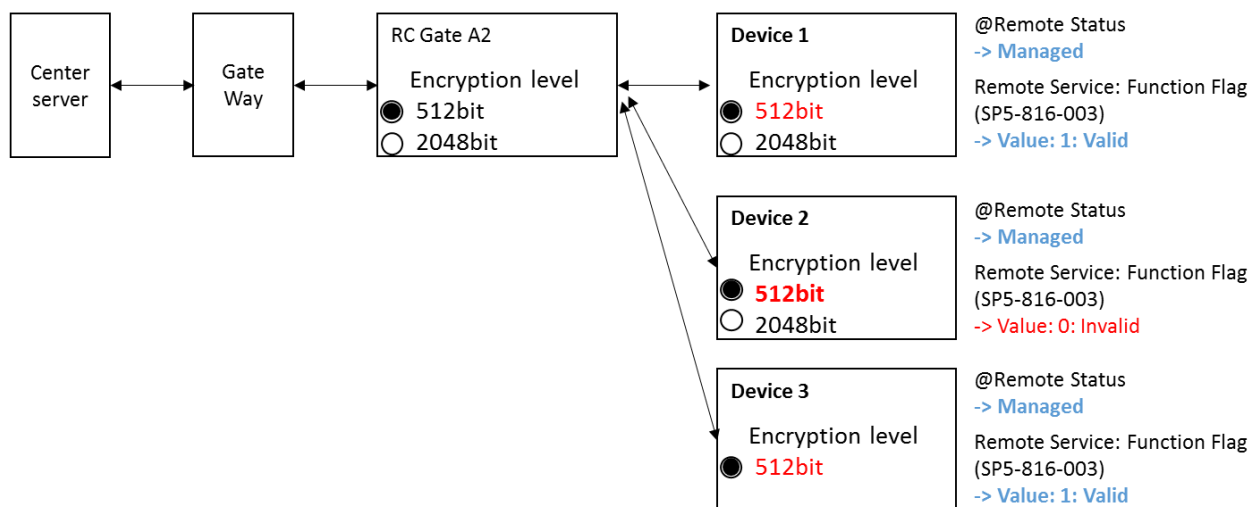
Configuration AFTER device registration

Encryption level of Device 2 has been changed automatically from “2048 bit” to “512 bit” but the function flag (SP5-816-003) remains “0: Invalid.”

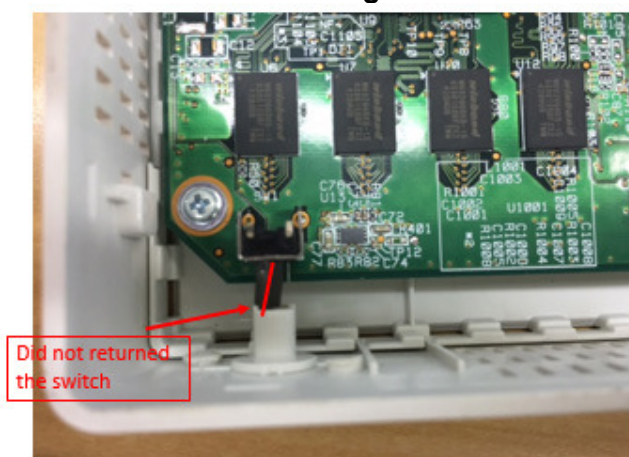
Wrong

Note: When the cover is opened / closed, be careful to check the switch.

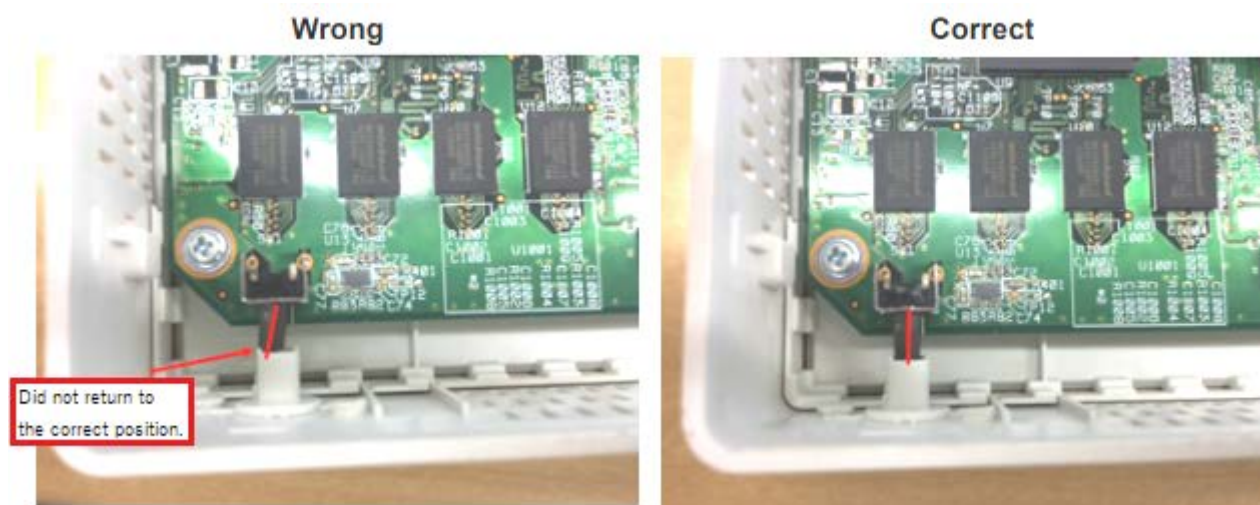
The push switch on the main board may not return to correct position as shown in the following picture. As a result, power switch keeps pressed and this cause RC Gate A2 to display the new SC 901/Detail Code 901523.

1. Shut down the RC gate A2 via the User Interface
2. Plug off the power cable and wait until all the lights of the device turned off
3. Open the cover.
4. Refer to the following picture and confirm the position of the switch.

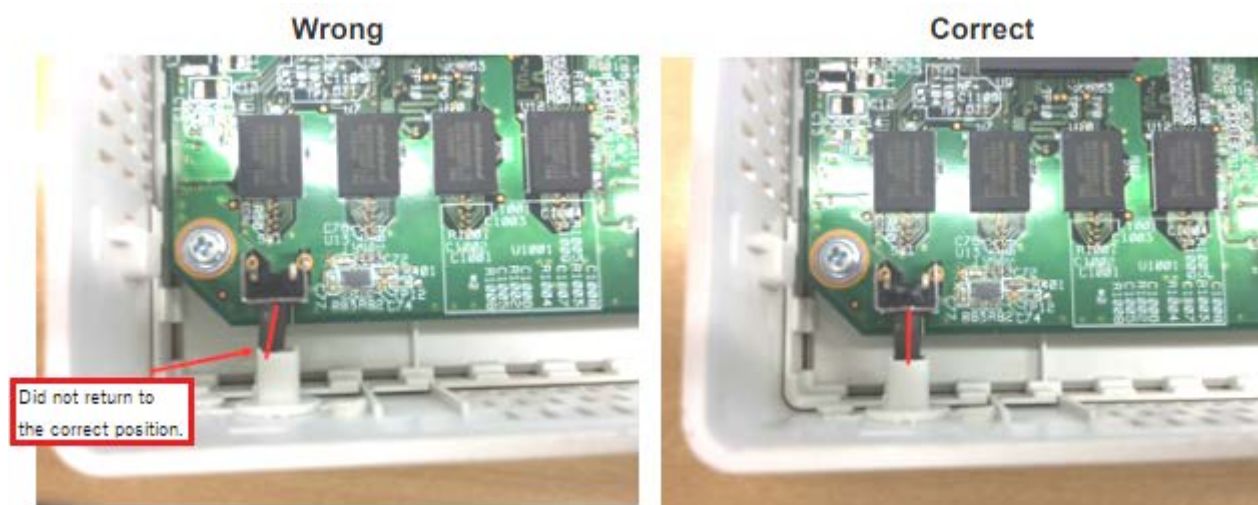
The push switch on the main board may not return to correct position as shown in the following picture. As a result, power switch keeps pressed and this cause RC Gate A2 to display the new SC 901/Detail Code 901523.

1. Shut down the RC gate A2 via the User Interface
2. Plug off the power cable and wait until all the lights of the device turned off
3. Open the cover.
4. Refer to the following picture and confirm the position of the switch.
