Model: Uz-A1	Date: 22-Jan-10	No.: RD459001p
---------------------	-----------------	----------------

Subject: Firmware Release Note: Application		Prepared by: M. Yoneda	
From: 2nd Tech Service Sect., MFP/Printer Tech Service Dept.			
Classification:	<input type="checkbox"/> Troubleshooting <input type="checkbox"/> Mechanical <input type="checkbox"/> Paper path <input type="checkbox"/> Product Safety	<input type="checkbox"/> Part information <input type="checkbox"/> Electrical <input type="checkbox"/> Transmit/receive <input checked="" type="checkbox"/> Other (Firmware)	<input type="checkbox"/> Action required <input type="checkbox"/> Service manual revision <input type="checkbox"/> Retrofit information <input checked="" type="checkbox"/> Tier 2

Model: Uz-A1 (RC Gate A)	Date: 25-August-10	No.: RD459003a
--------------------------	--------------------	----------------

Subject: A failure with Auto Discovery		Prepared by: T. Takahashi	
From: : Innovation Planning Sec. S S Innovation Dep.			
Classification:	<input checked="" type="checkbox"/> Troubleshooting <input type="checkbox"/> Mechanical <input type="checkbox"/> Paper path <input type="checkbox"/> Product Safety	<input type="ch

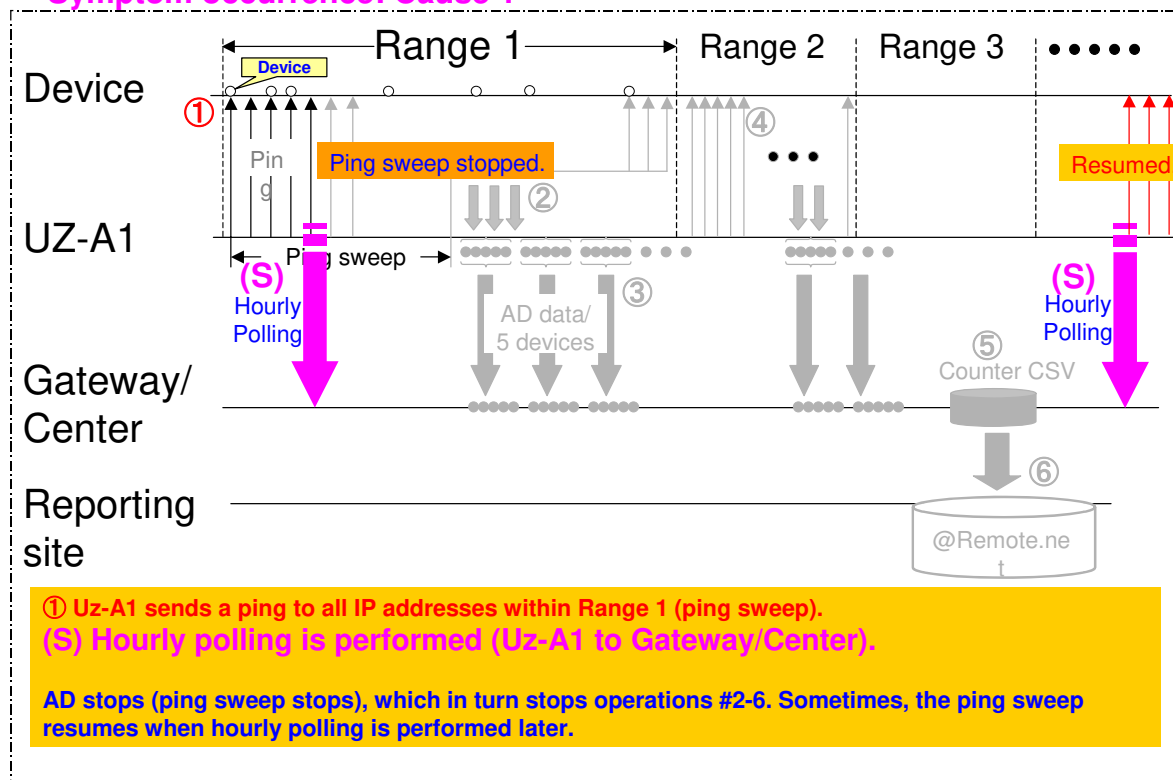
Symptom occurrence: Cause 1

1. Hourly polling is performed during a ping sweep. As a result, the ping does not function normally (it may stop temporarily).

Set the ping send permission to "Do not permit". In other words, do not use a ping sweep as the device search method.

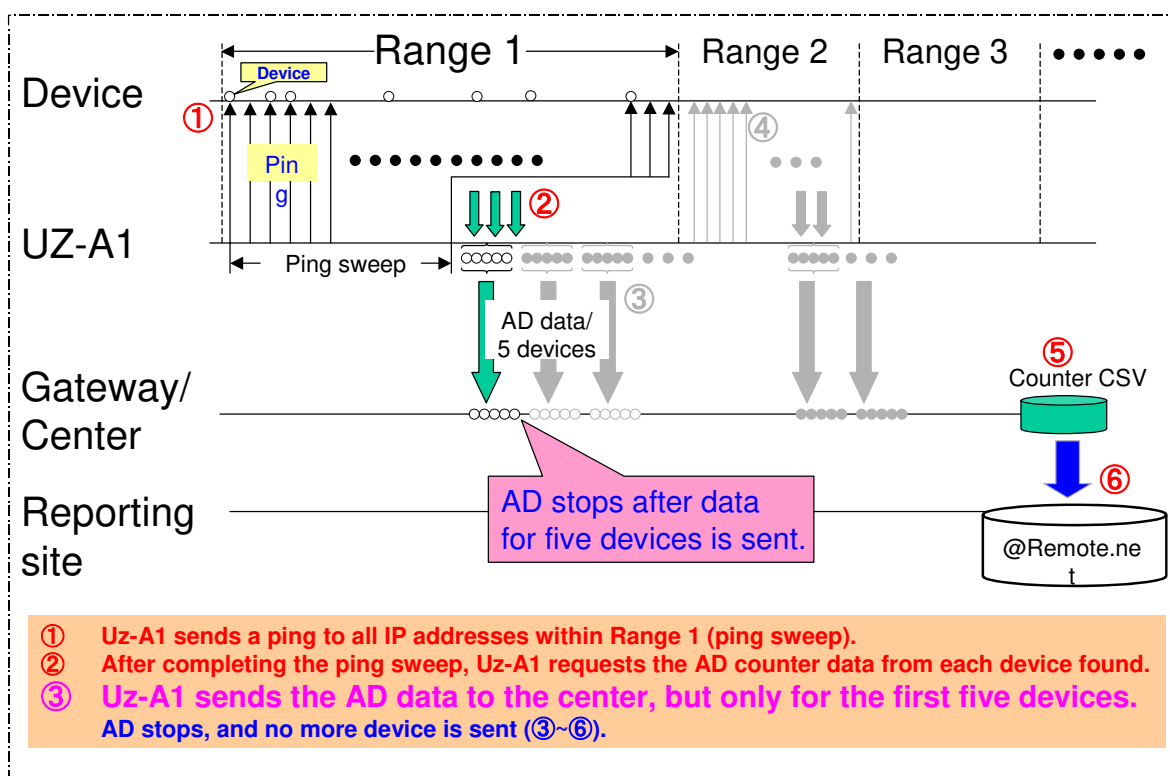
Symptom occurrence: Cause 2

- In the Uz-A1 GUI, the AD setting is changed to "Use", then to "Do not use", and finally back to "Use". Under these conditions, only five devices are discovered.

Note: This condition can be cleared temporarily by turning the power OFF/ON.

Turn the power of the RC Gate A OFF and then ON again.

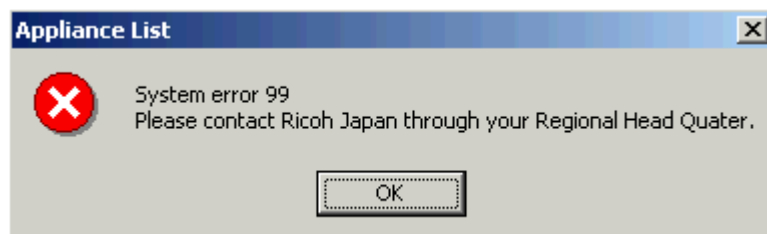
“System error 99” appears when an @Remote Center operator clicks on an appliance listed in the Appliance List of the Center GUI.

In rare cases, not all of the setting information needed for registration can be sent from the RC Gate A to the Gateway/@Remote Center.

- To avoid this symptom:
Whenever you finish performing the RC Gate A registration procedure, confirm that registration was successful, and then do a Service Test Call.

- If the symptom occurs:
System Error 99 cannot be cleared in the field, so please request your supervisor to contact IT/S in Japan.
